Manhole Inspection Report

Date:	04/24/2018	Weather:		Coding:	RZMACP
MH#:	M-606-013	Owner:	NA	Len. Surveyed:	10.8
P.O.#:		Surveyor:	John Kuglmaier	Rim to Invert:	11.1
Customer:	8.7	Cert. #:	U-1215-07002349	Wall Material:	Concrete (reinforced)

Street:	8th Pl. 200' East of Henry Ct.	Project:	Hobart, IN
City:	Hobart, IN	GPS Northing:	0.0
Location:		GPS Easting:	0.0
Drain Area:	Southwest	GPS Accuracy:	Nearest Meter
Cover Shape:	Circular	Evidence of Surcharge:	Yes
Cover Size:	22.5	Potential for Runoff:	None
Comments:

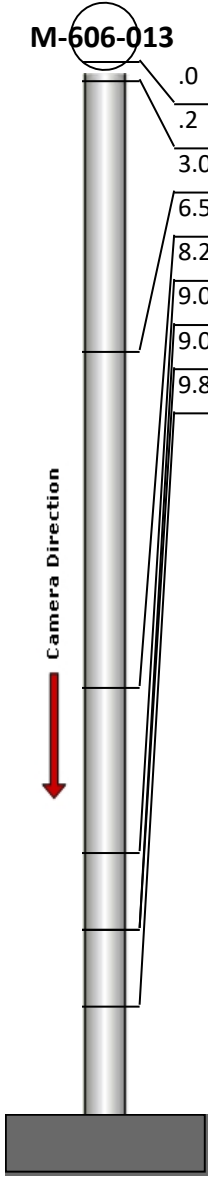
.0	MGP	General Photo	10	NA
	.2	DAGS	Deposits Attached Grease	22	M 2
	3.0	MGP	General Photo	41	NA
	6.5	IS	Infil Stain	62	NA
	8.2	DAZ	Deposits Attached Other	77	M 3
	9.0	IS	Infil Stain	90	NA
	9.0	IS	Infil Stain	101	NA
	9.8	MGO	General Observation	115	NA

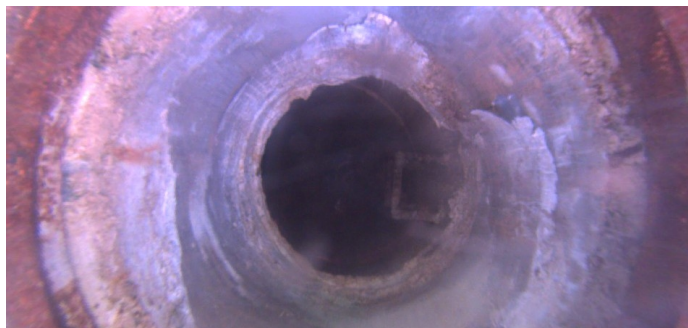
Code: **MGP**
Description: **General Photo**

Distance (ft): **.0**
Structural Grade: **0**
O&M Grade: **0**
Clock Start/From:
Clock To:
1st Value:
2nd Value:
Value Percent:
Step: **NO**
Remarks:

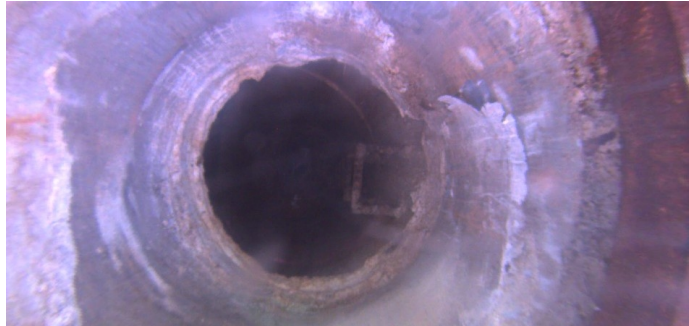
Code:	DAGS
Description:	Deposits Attached Grease
Distance (ft):	.2
Structural Grade:	0
O&M Grade:	2
Clock Start/From:	12
Clock To:	12
1st Value:	
2nd Value:	
Value Percent:	5.000
Step:	NO
Remarks:

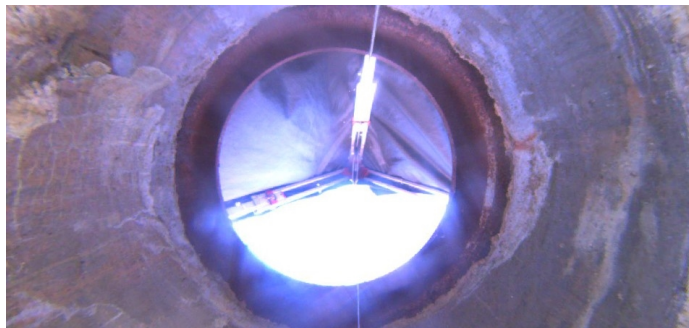
Code:	MGP
Description:	General Photo
Distance (ft):	3.0
Structural Grade:	0
O&M Grade:	0
Clock Start/From:	
Clock To:	
1st Value:	
2nd Value:	
Value Percent:	
Step:	NO
Remarks:

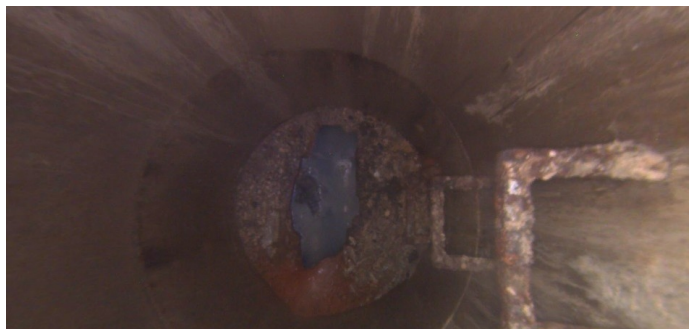
Code:	IS
Description:	Infil Stain
Distance (ft):	6.5
Structural Grade:	0
O&M Grade:	0
Clock Start/From:	8
Clock To:	2
1st Value:	
2nd Value:	
Value Percent:	
Step:	NO
Remarks:

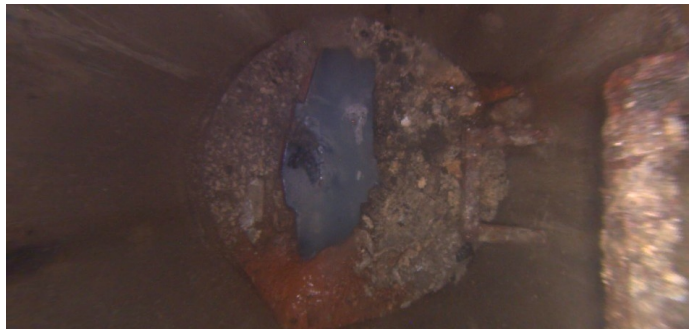
Code: **DAZ**
Description: **Deposits Attached Other**

Distance (ft): **8.2**
Structural Grade: **0**
O&M Grade: **3**
Clock Start/From: **12**
Clock To: **12**
1st Value:
2nd Value:
Value Percent: **15.000**
Step: **NO**
Remarks: **Mixed materials**

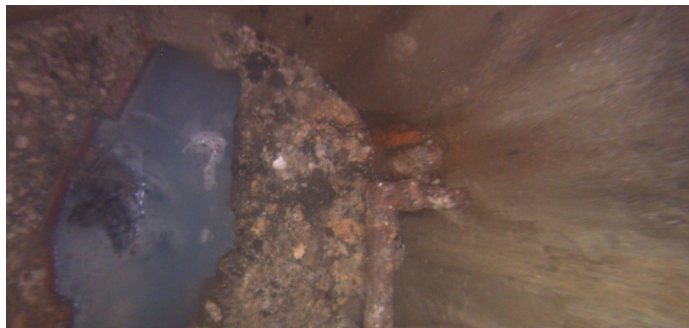
Code: **IS**
Description: **Infil Stain**

Distance (ft): **9.0**
Structural Grade: **0**
O&M Grade: **0**
Clock Start/From: **2**
Clock To:
1st Value:
2nd Value:
Value Percent:
Step: **NO**
Remarks:

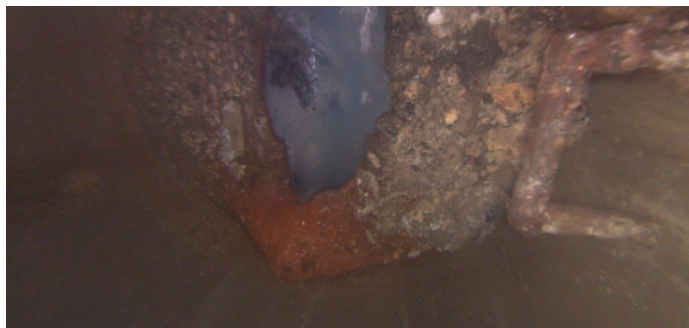
Code: **IS**
Description: **Infil Stain**

Distance (ft): **9.0**
Structural Grade: **0**
O&M Grade: **0**
Clock Start/From: **5**
Clock To: **7**
1st Value:
2nd Value:
Value Percent:
Step: **NO**
Remarks:

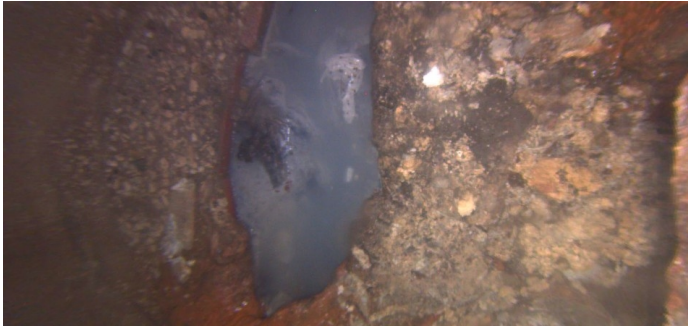
Code:	MGO
Description:	General Observation
Distance (ft):	9.8
Structural Grade:	0
O&M Grade:	0
Clock Start/From:	
Clock To:	
1st Value:	
2nd Value:	
Value Percent:	
Step:	NO
Remarks:	Ins. Comp.
