Date:	04/27/2018	Weather:		Coding:	RZMACP
MH#:	M-606-023	Owner:	NA	Len. Surveyed:	10.7
P.O.#:		Surveyor:	Jen Costello	Rim to Invert:	11.5
Customer:		Cert. #:	U-907-5518	Wall Material:	Concrete (reinforced)
Street:	Intersection of Ash St. and 8th St.		Project:	Hobart, IN	
City:	Hobart, IN		GPS Northing:	2903196.574	
ocation:		GPS Easting: 2903196.574	2903196.574		
Drain Area:			GPS Accuracy: Evidence of Surcharge:	Sub-Meter	
Cover Shape:				No	
Cover Size: Comments:	22.5		Potential for Runoff:	None	
O&M Index:	2.00	O&M Quick:	2100	O&M Rating:	2.00
Structural Index:	0.00	Structural Qu	iick: 0000	Structural Rating:	0.00
Overall Index:	2.00	Overall Quick	c: 2100	Overall Rating:	2.00

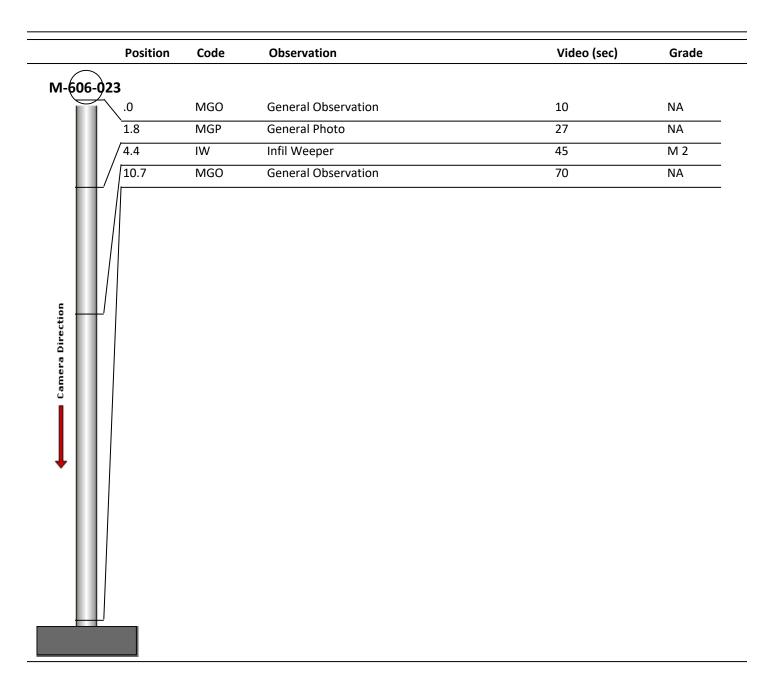
Code: Description:	MGO General Observation
Distance (ft):	.0
Structural Grade:	0
O&M Grade:	0
Clock Start/From:	
Clock To:	
1st Value:	
2nd Value:	
Value Percent:	
Step:	NO
Remarks:	ACCESS MH
