# Manhole Inspection Report

Date:	<b>04/26/2018</b>	Weather:		Coding:	<b>RZMACP</b>
MH#:	<b>M-606-051</b>	Owner:	<b>NA</b>	Len. Surveyed:	<b>13.2</b>
P.O.#:		Surveyor:	<b>Jen Costello</b>	Rim to Invert:	<b>13.6</b>
Customer:		Cert. #:	<b>U-907-5518</b>	Wall Material:	<b>Concrete (reinforced)</b>

Street:	<b>Intersection of 8th St. and Riverside</b>	Project:	<b>Hobart, IN</b>
City:	<b>Hobart, IN</b>	GPS Northing:	<b>2902908.938</b>
Location:		GPS Easting:	<b>2902908.938</b>
Drain Area:	<b>Southwest</b>	GPS Accuracy:	<b>Sub-Meter</b>
Cover Shape:	<b>Circular</b>	Evidence of Surcharge:	<b>No</b>
Cover Size:	<b>22.5</b>	Potential for Runoff:	<b>None</b>
Comments:

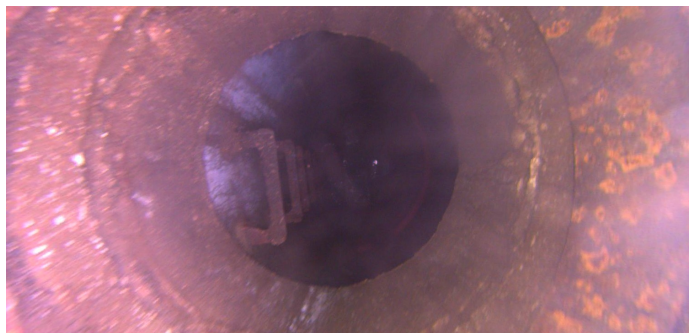
Code: **MGO**  
Description: **General Observation**

Distance (ft): **.0**  
Structural Grade: **0**  
O&M Grade: **0**  
Clock Start/From:  
Clock To:  
1st Value:  
2nd Value:  
Value Percent:  
Step: **NO**  
Remarks: **access MH**

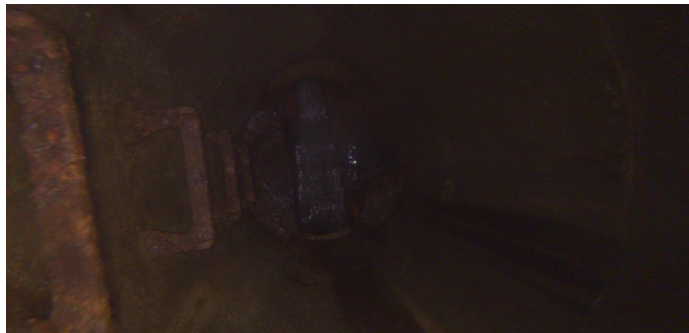
Code: **IW**  
Description: **Infil Weeper**

Distance (ft): **6.5**  
Structural Grade: **0**  
O&M Grade: **2**  
Clock Start/From: **4**  
Clock To: **8**  
1st Value:  
2nd Value:  
Value Percent:  
Step: **NO**  
Remarks:

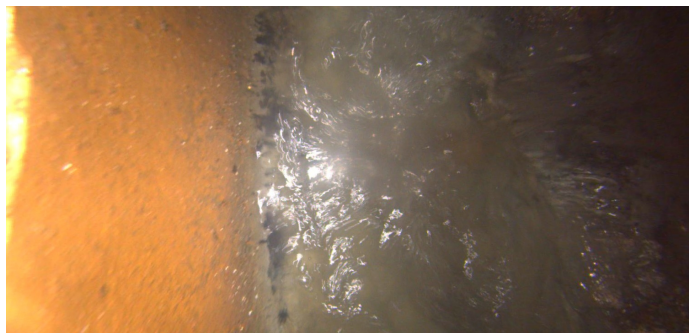
Code: **MGO**  
Description: **General Observation**

Distance (ft): **13.2**  
Structural Grade: **0**  
O&M Grade: **0**  
Clock Start/From:  
Clock To:  
1st Value:  
2nd Value:  
Value Percent:  
Step: **NO**  
Remarks: **END SURVEY**
