Manhole Inspection Report

Date:	09/29/2022	Weather:		Coding:	RZMACP
MH#:	M-606-053	Owner:	NA	Len. Surveyed:	14.6
P.O.#:		Surveyor:	Jen Costello	Rim to Invert:	15.7
Customer:		Cert. #:	U-907-5518	Wall Material:	Concrete (cast in place)

Street:	Intersection of Riverside Dr. and Lag	Project:	Hobart, IN
City:	Hobart, IN	GPS Northing:	2286815.592
Location:	Local Rural Streets	GPS Easting:	2902988.66
Drain Area:	Southwest	GPS Accuracy:	Sub-Meter
Cover Shape:	Circular	Evidence of Surcharge:	No
Cover Size:	24.0	Potential for Runoff:	None
Comments:

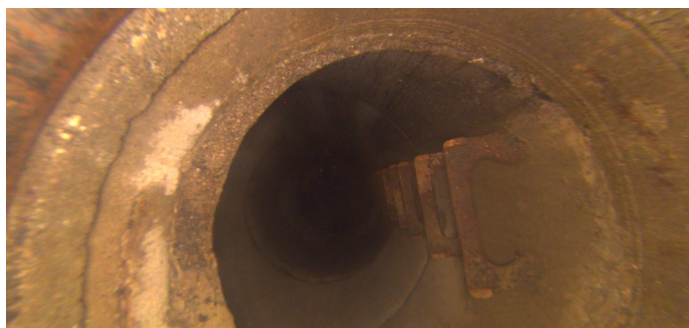
Code: **MGO**
Description: **General Observation**

Distance (ft): **.0**
Structural Grade: **0**
O&M Grade: **0**
Clock Start/From:
Clock To:
1st Value:
2nd Value:
Value Percent:
Step: **NO**
Remarks: **access mh**

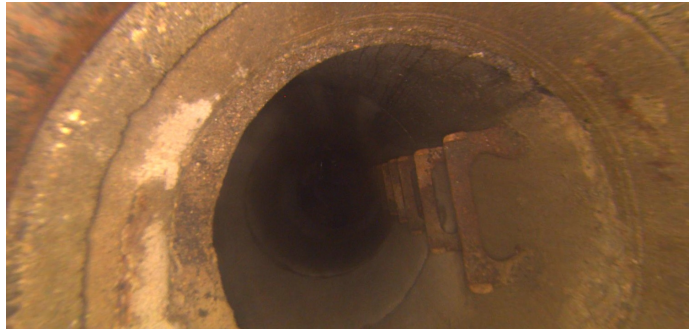
Code: **SRI**
Description: **Surface Roughness Increased**

Distance (ft): **.0**
Structural Grade: **1**
O&M Grade: **0**
Clock Start/From: **12**
Clock To: **12**
1st Value:
2nd Value:
Value Percent:
Step: **NO**
Remarks:

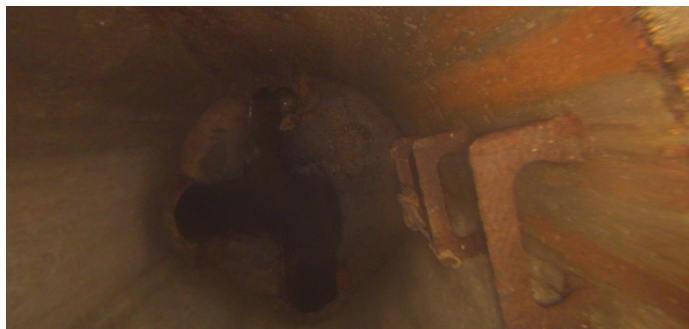
Code: **IW**
Description: **Infil Weeper**

Distance (ft): **10.7**
Structural Grade: **0**
O&M Grade: **2**
Clock Start/From: **8**
Clock To: **4**
1st Value:
2nd Value:
Value Percent:
Step: **NO**
Remarks:

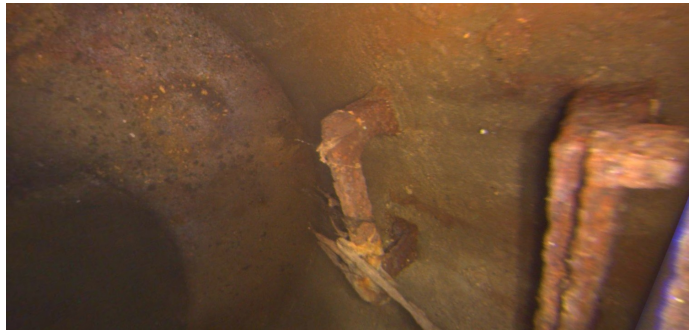
Code:	DAR
Description:	Deposits Attached Ragging
Distance (ft):	12.7
Structural Grade:	0
O&M Grade:	2
Clock Start/From:	4
Clock To:	
1st Value:	
2nd Value:	
Value Percent:	5.000
Step:	YES
Remarks:
