Manhole Inspection Report

Street:	8th St. 154' West of Sunset St.	Project:	Hobart, IN
City:	Hobart, IN	GPS Northing:	2902358.477
Location:		GPS Easting:	2902358.477
Drain Area:	Southwest	GPS Accuracy:	Sub-Meter
Cover Shape:	Circular	Evidence of Surcharge:	No
Cover Size:	22.5	Potential for Runoff:	None
Comments:

M-606-056

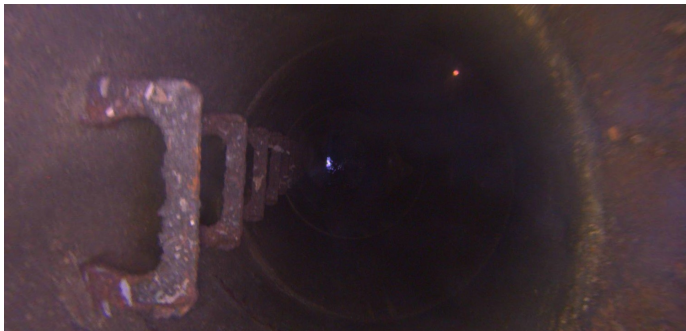
Code:	MGO
Description:	General Observation
Distance (ft):	.0
Structural Grade:	0
O&M Grade:	0
Clock Start/From:	
Clock To:	
1st Value:	
2nd Value:	
Value Percent:	
Step:	NO
Remarks:	ACCESS MH

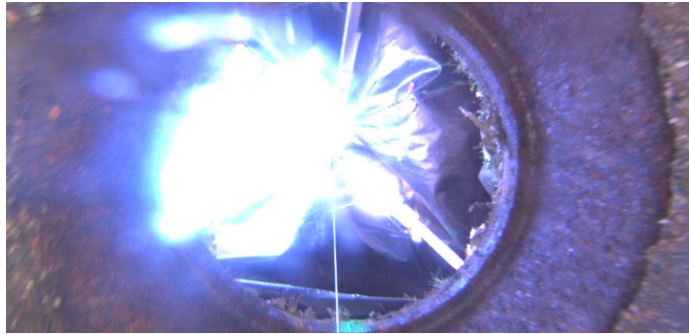
Code:	MGO
Description:	General Observation
Distance (ft):	1.8
Structural Grade:	0
O&M Grade:	0
Clock Start/From:	
Clock To:	
1st Value:	
2nd Value:	
Value Percent:	
Step:	NO
Remarks:	UNDERSIDE OF FRAME

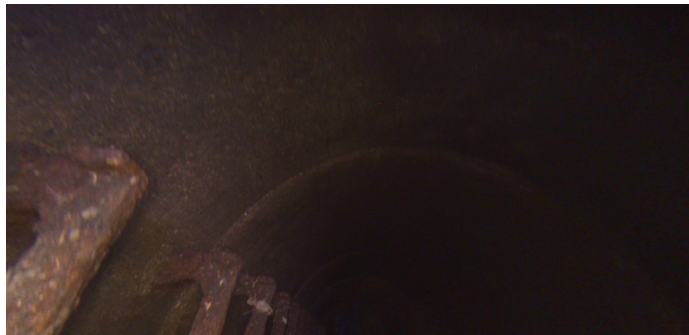
Code:	SAV
Description:	Surface Aggregate Visible
Distance (ft):	1.8
Structural Grade:	3
O&M Grade:	0
Clock Start/From:	12
Clock To:	12
1st Value:	
2nd Value:	
Value Percent:	
Step:	NO
Remarks:

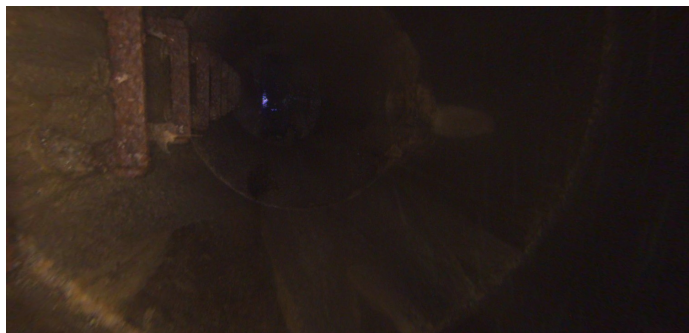
Code:	IW
Description:	Infil Weeper
Distance (ft):	6.6
Structural Grade:	0
O&M Grade:	2
Clock Start/From:	4
Clock To:	8
1st Value:	
2nd Value:	
Value Percent:	
Step:	NO
Remarks:

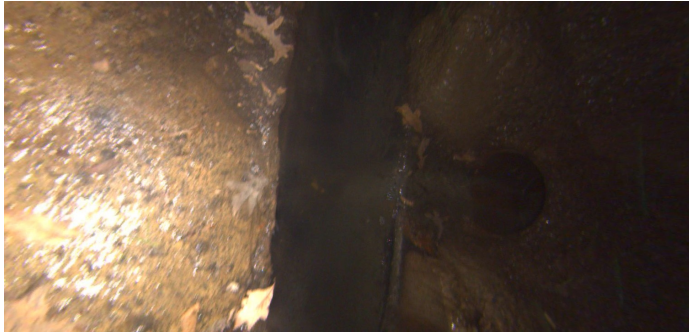
Code: **MGO**
Description: **General Observation**

Distance (ft): **17.1**
Structural Grade: **0**
O&M Grade: **0**
Clock Start/From:
Clock To:
1st Value:
2nd Value:
Value Percent:
Step: **NO**
Remarks: **END SURVEY**

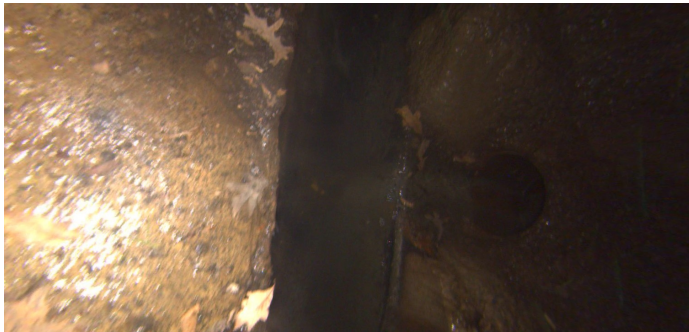
Code: **SAV**
Description: **Surface Aggregate Visible**

Distance (ft): **17.1**
Structural Grade: **3**
O&M Grade: **0**
Clock Start/From: **12**
Clock To: **12**
1st Value:
2nd Value:
Value Percent:
Step: **NO**
Remarks:
