Manhole Inspection Report

Date:	04/26/2018	Weather:		Coding:	RZMACP
MH#:	M-606-068	Owner:	NA	Len. Surveyed:	9.6
P.O.#:		Surveyor:	Jen Costello	Rim to Invert:	10.1
Customer:		Cert. #:	U-907-5518	Wall Material:	Concrete (reinforced)

Street:	189' North of 8th St. East of Glendal	Project:	Hobart, IN
City:	Hobart, IN	GPS Northing:	2902352.843
Location:		GPS Easting:	2902352.843
Drain Area:	Southwest	GPS Accuracy:	Sub-Meter
Cover Shape:	Circular	Evidence of Surcharge:	No
Cover Size:	22.5	Potential for Runoff:	None
Comments:

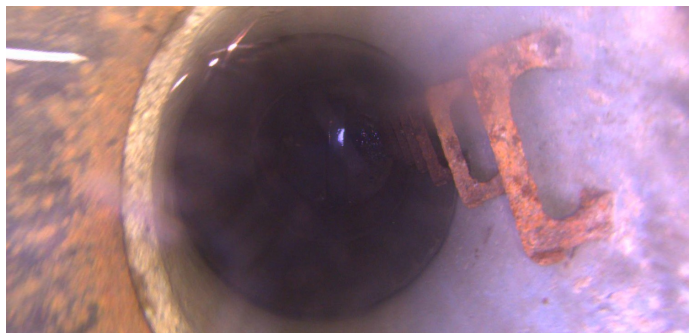
Code: **MGO**
Description: **General Observation**

Distance (ft): **.0**
Structural Grade: **0**
O&M Grade: **0**
Clock Start/From:
Clock To:
1st Value:
2nd Value:
Value Percent:
Step: **NO**
Remarks: **ACCESS MH**

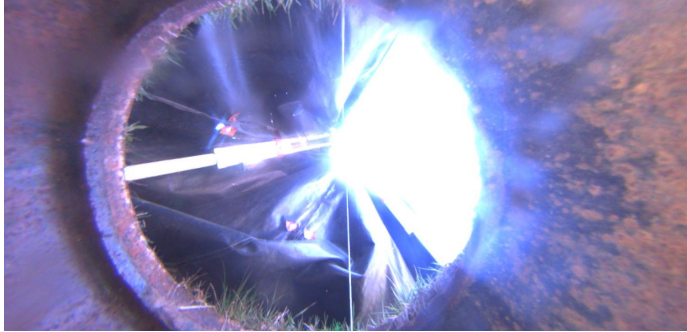
Code:	MGO
Description:	General Observation
Distance (ft):	1.4
Structural Grade:	0
O&M Grade:	0
Clock Start/From:	
Clock To:	
1st Value:	
2nd Value:	
Value Percent:	
Step:	NO
Remarks:	UNDERSIDE OF FRAME

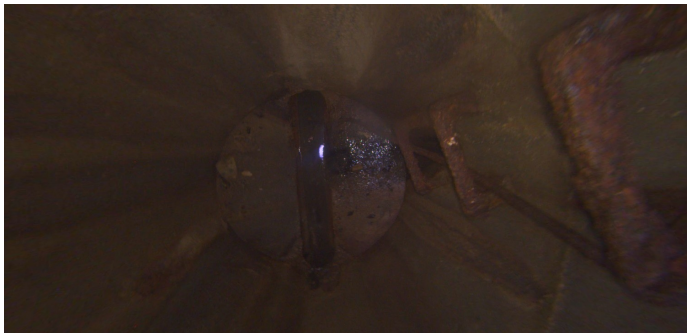
Code:	IW
Description:	Infil Weeper
Distance (ft):	5.9
Structural Grade:	0
O&M Grade:	2
Clock Start/From:	6
Clock To:	12
1st Value:	
2nd Value:	
Value Percent:	
Step:	NO
Remarks:

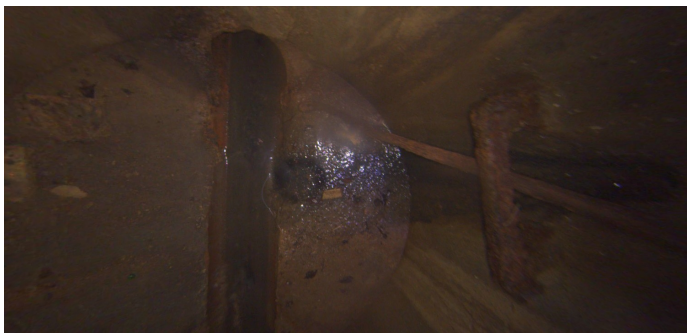
Code:	IW
Description:	Infil Weeper
Distance (ft):	7.9
Structural Grade:	0
O&M Grade:	2
Clock Start/From:	3
Clock To:	
1st Value:	
2nd Value:	
Value Percent:	
Step:	NO
Remarks:

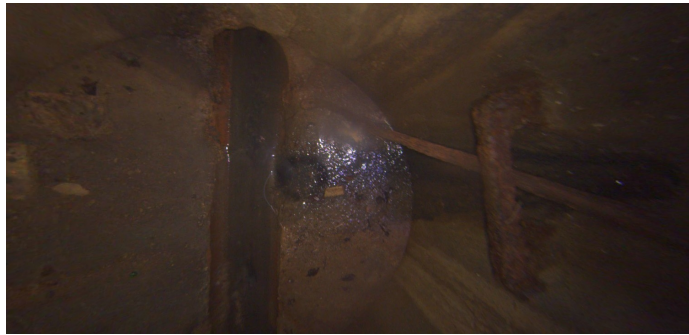
Code: **OBZ**
Description: **Obstacle Other**

Distance (ft): **7.9**
Structural Grade: **0**
O&M Grade: **2**
Clock Start/From: **3**
Clock To:
1st Value:
2nd Value:
Value Percent: **5.000**
Step: **YES**
Remarks: **STICK**

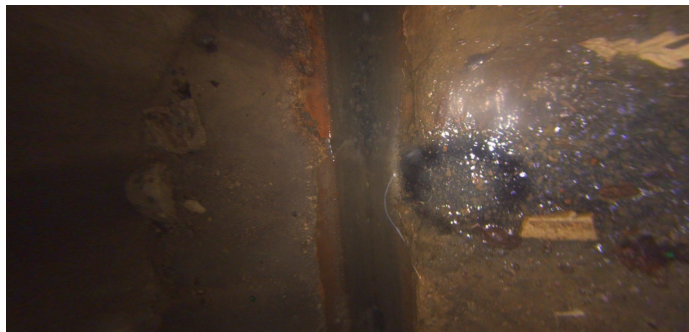
Code: **OBR**
Description: **Obstacle Rocks**

Distance (ft): **9.1**
Structural Grade: **0**
O&M Grade: **2**
Clock Start/From: **9**
Clock To:
1st Value:
2nd Value:
Value Percent: **5.000**
Step: **NO**
Remarks:

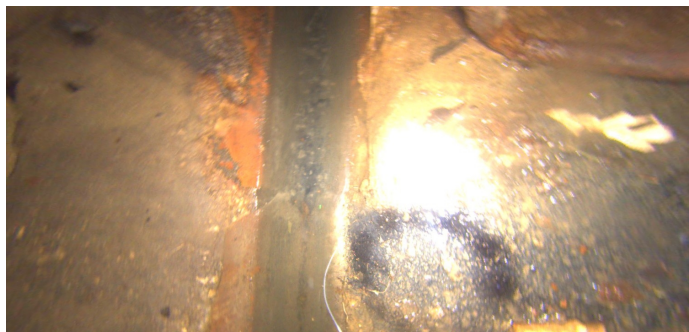
Code: **MGO**
Description: **General Observation**

Distance (ft): **9.6**
Structural Grade: **0**
O&M Grade: **0**
Clock Start/From:
Clock To:
1st Value:
2nd Value:
Value Percent:
Step: **NO**
Remarks: **END SURVEY**
