Manhole Inspection Report

Date:	04/26/2018	Weather:		Coding:	RZMACP
MH#:	M-606-070	Owner:	NA	Len. Surveyed:	7.9
P.O.#:		Surveyor:	Jen Costello	Rim to Invert:	8.2
Customer:		Cert. #:	U-907-5518	Wall Material:	Concrete (reinforced)

Street:	57' South of 7th St. East of Glendale	Project:	Hobart, IN
City:	Hobart, IN	GPS Northing:	2902348.725
Location:		GPS Easting:	2902348.725
Drain Area:	Southwest	GPS Accuracy:	Sub-Meter
Cover Shape:	Circular	Evidence of Surcharge:	No
Cover Size:	22.5	Potential for Runoff:	None
Comments:

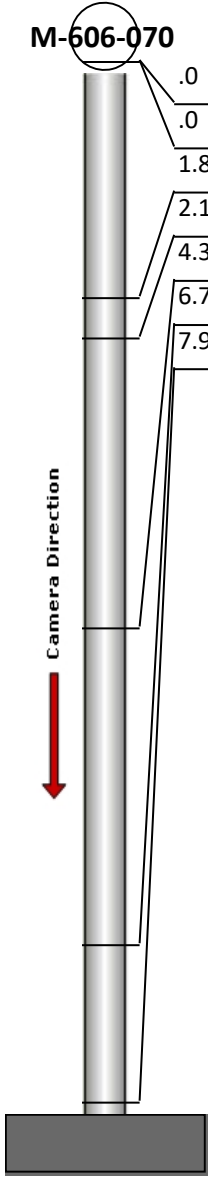
Position	Code	Observation	Video (sec)	Grade

.0	MGO	General Observation	10	NA
	.0	DAE	Deposits Attached Encrustation	21	M 2
	1.8	MGO	General Observation	38	NA
	2.1	SRV	Surface Reinforcement Visible	52	S 5
	4.3	IS	Infil Stain	68	NA
	6.7	DSF	Deposits Settled Fine	84	M 2
	7.9	MGO	General Observation	98	NA

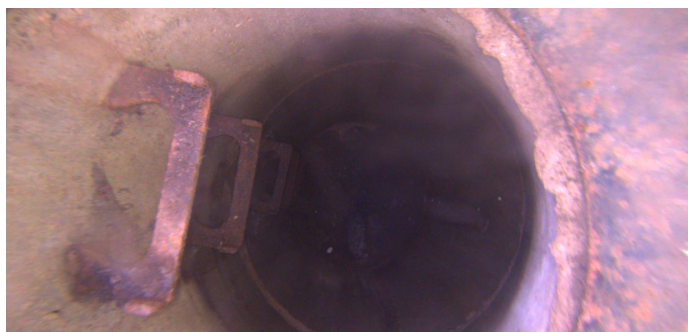
Code: **MGO**
Description: **General Observation**

Distance (ft): **.0**
Structural Grade: **0**
O&M Grade: **0**
Clock Start/From:
Clock To:
1st Value:
2nd Value:
Value Percent:
Step: **NO**
Remarks: **access MH**

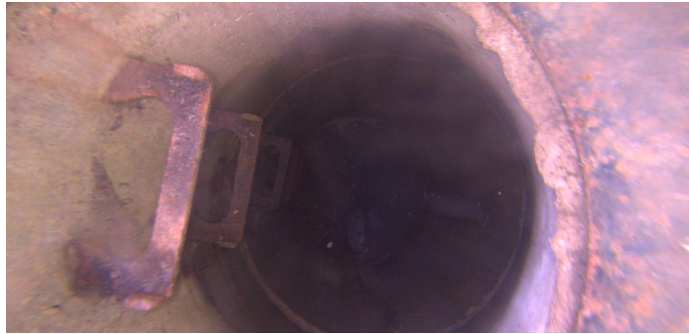
Code:	DAE
Description:	Deposits Attached Encrustation
Distance (ft):	.0
Structural Grade:	0
O&M Grade:	2
Clock Start/From:	1
Clock To:	4
1st Value:	
2nd Value:	
Value Percent:	5.000
Step:	NO
Remarks:

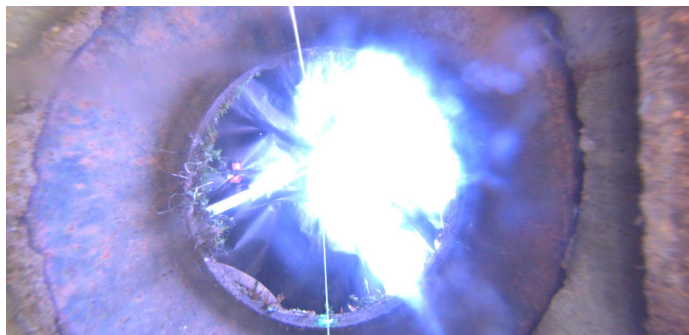
Code:	MGO
Description:	General Observation
Distance (ft):	1.8
Structural Grade:	0
O&M Grade:	0
Clock Start/From:	
Clock To:	
1st Value:	
2nd Value:	
Value Percent:	
Step:	NO
Remarks:	UNDERSIDE OF FRAME

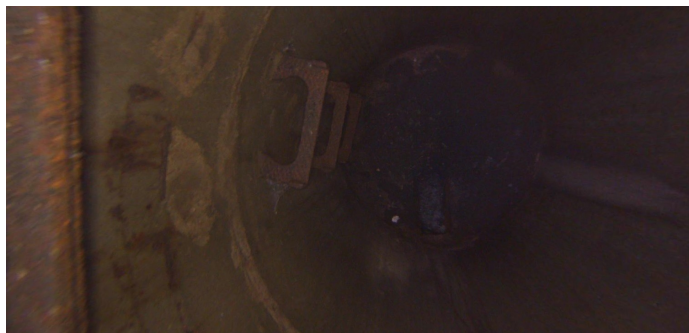
Code:	SRV
Description:	Surface Reinforcement Visible
Distance (ft):	2.1
Structural Grade:	5
O&M Grade:	0
Clock Start/From:	8
Clock To:	10
1st Value:	
2nd Value:	
Value Percent:	
Step:	NO
Remarks:

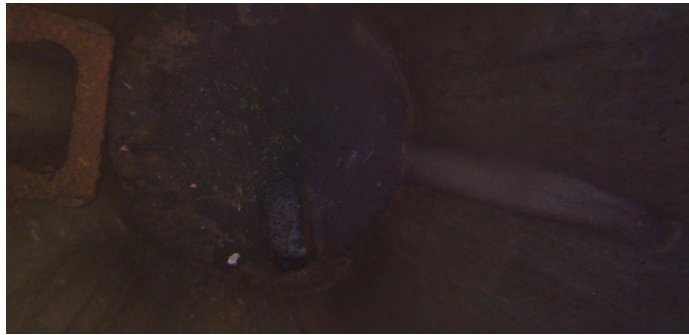
Code: **IS**
Description: **Infil Stain**

Distance (ft): **4.3**
Structural Grade: **0**
O&M Grade: **0**
Clock Start/From: **3**
Clock To:
1st Value:
2nd Value:
Value Percent:
Step: **NO**
Remarks:

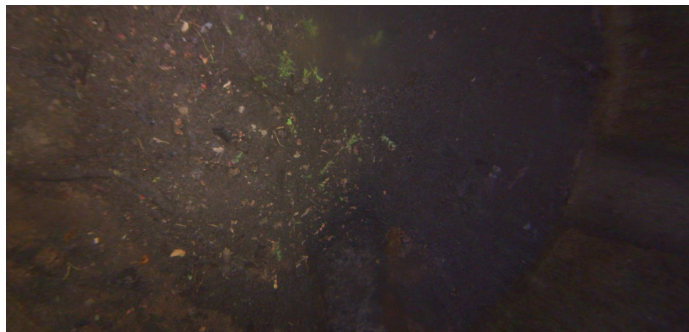
Code: **DSF**
Description: **Deposits Settled Fine**

Distance (ft): **6.7**
Structural Grade: **0**
O&M Grade: **2**
Clock Start/From: **12**
Clock To: **12**
1st Value:
2nd Value:
Value Percent: **5.000**
Step: **NO**
Remarks:

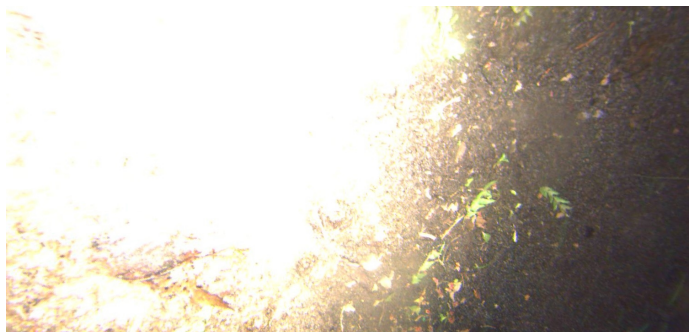
Code: **MGO**
Description: **General Observation**

Distance (ft): **7.9**
Structural Grade: **0**
O&M Grade: **0**
Clock Start/From:
Clock To:
1st Value:
2nd Value:
Value Percent:
Step: **NO**
Remarks: **END SURVEY**
