Manhole Inspection Report

Date:	09/29/2022	Weather:		Coding:	RZMACP
MH#:	M-606-071	Owner:	NA	Len. Surveyed:	9.9
P.O.#:		Surveyor:	Jen Costello	Rim to Invert:	11.0
Customer:		Cert. #:	U-907-5518	Wall Material:	Concrete (cast in place)

Street:	190' North of 8th St. East of Wiscons	Project:	Hobart, IN
City:	Hobart, IN	GPS Northing:	2286702.677
Location:	Alley	GPS Easting:	2902036.943
Drain Area:	Southwest	GPS Accuracy:	Sub-Meter
Cover Shape:	Circular	Evidence of Surcharge:	No
Cover Size:	24.0	Potential for Runoff:	None
Comments:

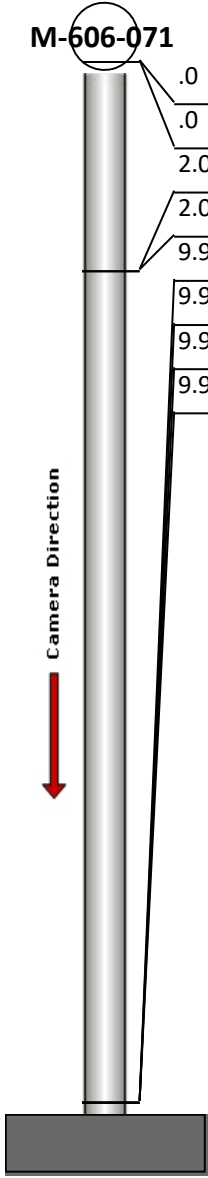
.0	MGO	General Observation	10	NA
	.0	SRI	Surface Roughness Increased	21	S 1
	2.0	IW	Infil Weeper	36	M 2
	2.0	MGO	General Observation	49	NA
	9.9	DSF	Deposits Settled Fine	78	M 2
	9.9	DSF	Deposits Settled Fine	88	M 2
	9.9	SRI	Surface Roughness Increased	98	S 1
	9.9	MGO	General Observation	109	NA

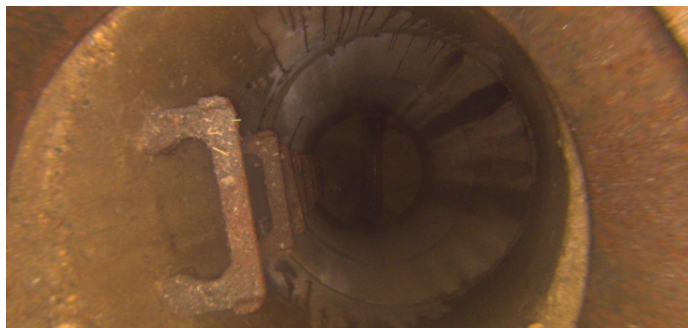
Code: **MGO**
Description: **General Observation**

Distance (ft): **.0**
Structural Grade: **0**
O&M Grade: **0**
Clock Start/From:
Clock To:
1st Value:
2nd Value:
Value Percent:
Step: **NO**
Remarks: **access mh**

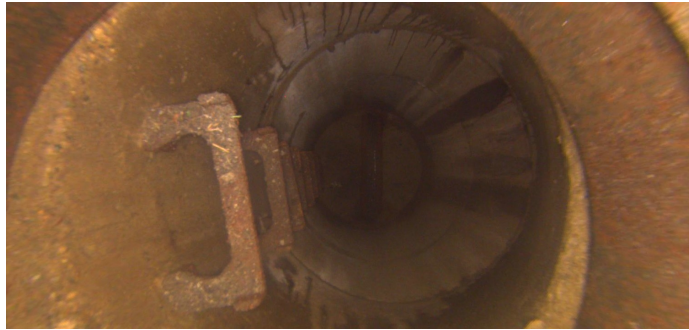
Code: **SRI**
Description: **Surface Roughness Increased**

Distance (ft): **.0**
Structural Grade: **1**
O&M Grade: **0**
Clock Start/From: **12**
Clock To: **12**
1st Value:
2nd Value:
Value Percent:
Step: **NO**
Remarks:

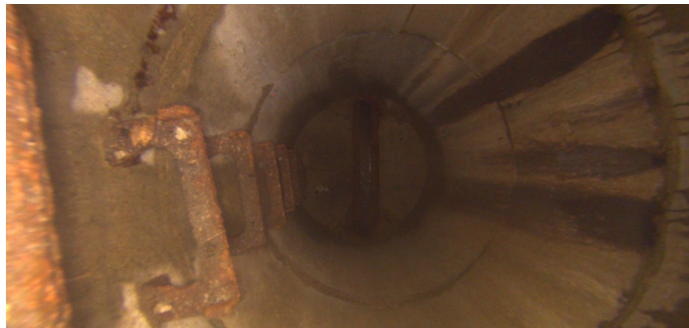
Code: **IW**
Description: **Infil Weeper**

Distance (ft): **2.0**
Structural Grade: **0**
O&M Grade: **2**
Clock Start/From: **2**
Clock To: **4**
1st Value:
2nd Value:
Value Percent:
Step: **NO**
Remarks:

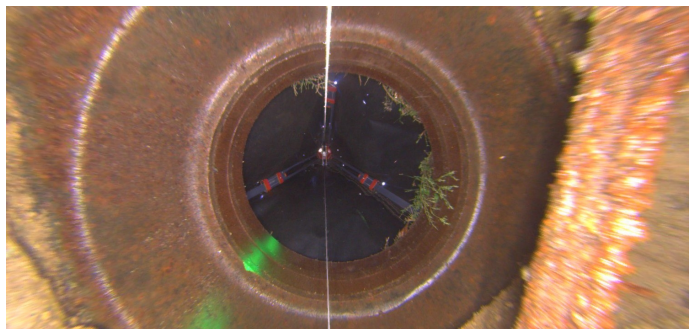
Code: **MGO**
Description: **General Observation**

Distance (ft): **2.0**
Structural Grade: **0**
O&M Grade: **0**
Clock Start/From:
Clock To:
1st Value:
2nd Value:
Value Percent:
Step: **NO**
Remarks: **underside of frame**

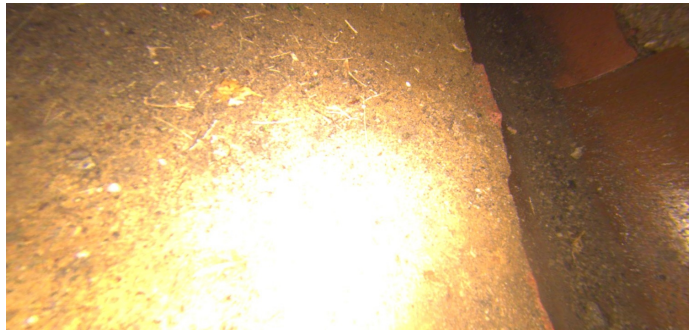
Code: **DSF**
Description: **Deposits Settled Fine**

Distance (ft): **9.9**
Structural Grade: **0**
O&M Grade: **2**
Clock Start/From: **12**
Clock To: **12**
1st Value:
2nd Value:
Value Percent: **5.000**
Step: **NO**
Remarks:

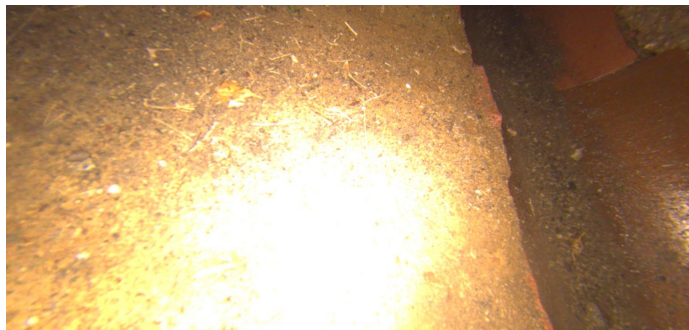
Code: **DSF**
Description: **Deposits Settled Fine**

Distance (ft): **9.9**
Structural Grade: **0**
O&M Grade: **2**
Clock Start/From: **5**
Clock To: **7**
1st Value:
2nd Value:
Value Percent: **5.000**
Step: **NO**
Remarks:

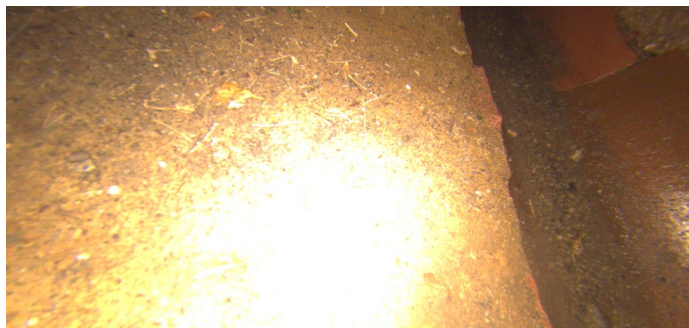
Code: **SRI**
Description: **Surface Roughness Increased**

Distance (ft): **9.9**
Structural Grade: **1**
O&M Grade: **0**
Clock Start/From: **12**
Clock To: **12**
1st Value:
2nd Value:
Value Percent:
Step: **NO**
Remarks:

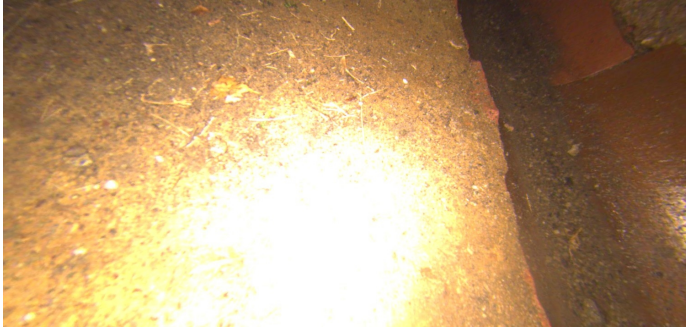
Code:	MGO
Description:	General Observation
Distance (ft):	9.9
Structural Grade:	0
O&M Grade:	0
Clock Start/From:	
Clock To:	
1st Value:	
2nd Value:	
Value Percent:	
Step:	NO
Remarks:	end of survey
