Manhole Inspection Report

Date:	09/29/2022	Weather:		Coding:	RZMACP
MH#:	M-606-072	Owner:	NA	Len. Surveyed:	8.7
P.O.#:		Surveyor:	Jen Costello	Rim to Invert:	10.0
Customer:		Cert. #:	U-907-5518	Wall Material:	Concrete (cast in place)

Street:	256' South of 7th St. East of Wiscons	Project:	Hobart, IN
City:	Hobart, IN	GPS Northing:	2286911.765
Location:	Alley	GPS Easting:	2902044.288
Drain Area:	Southwest	GPS Accuracy:	Sub-Meter
Cover Shape:	Circular	Evidence of Surcharge:	No
Cover Size:	24.0	Potential for Runoff:	None
Comments:

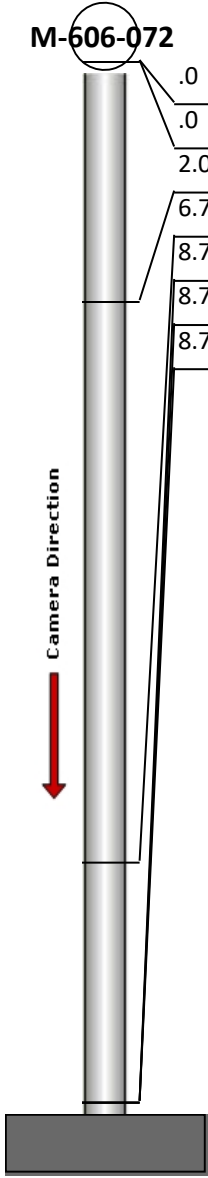
.0	MGO	General Observation	10	NA
	.0	SRI	Surface Roughness Increased	21	S 1
	2.0	MGO	General Observation	39	NA
	6.7	IW	Infil Weeper	62	M 2
	8.7	DSGV	Deposits Settled Gravel	78	M 2
	8.7	MGO	General Observation	89	NA
	8.7	SRI	Surface Roughness Increased	100	S 1

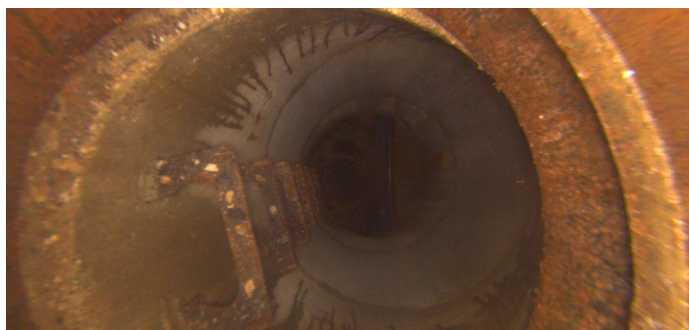
Code: **MGO**
Description: **General Observation**

Distance (ft): **.0**
Structural Grade: **0**
O&M Grade: **0**
Clock Start/From:
Clock To:
1st Value:
2nd Value:
Value Percent:
Step: **NO**
Remarks: **access mh**

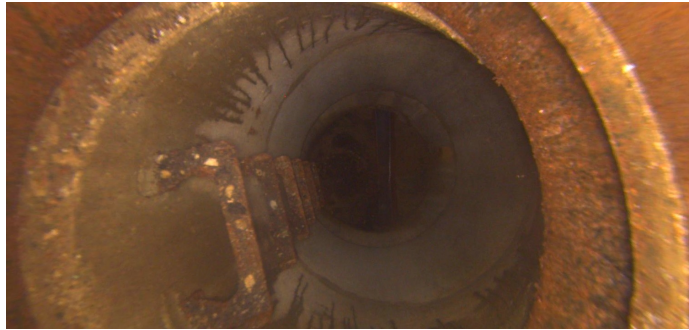
Code: **SRI**
Description: **Surface Roughness Increased**

Distance (ft): **.0**
Structural Grade: **1**
O&M Grade: **0**
Clock Start/From: **12**
Clock To: **12**
1st Value:
2nd Value:
Value Percent:
Step: **NO**
Remarks:

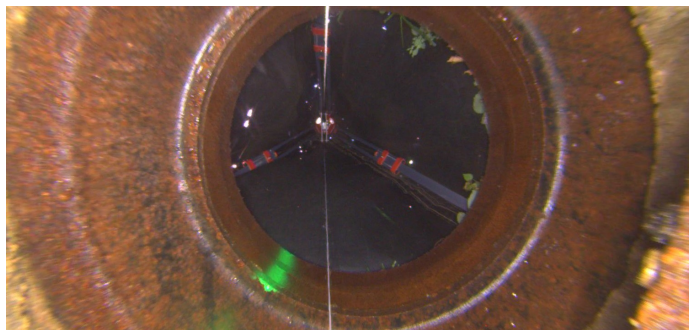
Code: **MGO**
Description: **General Observation**

Distance (ft): **2.0**
Structural Grade: **0**
O&M Grade: **0**
Clock Start/From:
Clock To:
1st Value:
2nd Value:
Value Percent:
Step: **NO**
Remarks: **underside of frame**

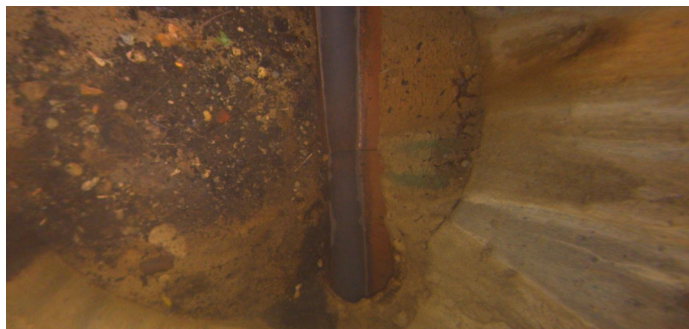
Code: **IW**
Description: **Infil Weeper**

Distance (ft): **6.7**
Structural Grade: **0**
O&M Grade: **2**
Clock Start/From: **8**
Clock To: **4**
1st Value:
2nd Value:
Value Percent:
Step: **NO**
Remarks:

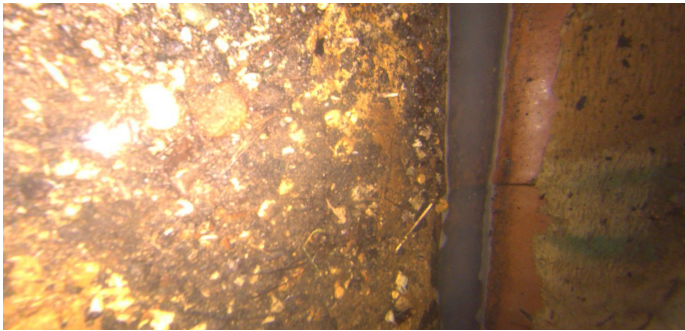
Code:	DSGV
Description:	Deposits Settled Gravel

Distance (ft):	8.7
Structural Grade:	0
O&M Grade:	2
Clock Start/From:	12
Clock To:	12
1st Value:	
2nd Value:	
Value Percent:	5.000
Step:	NO
Remarks:

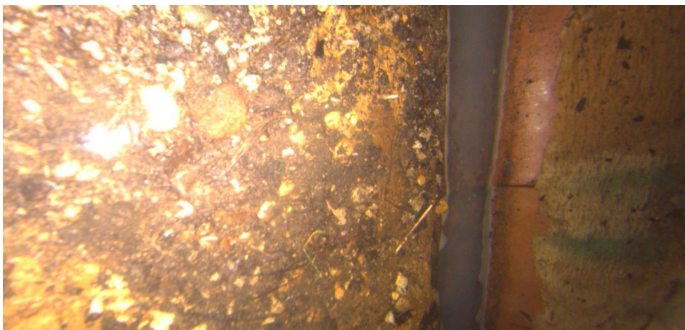
Code:	MGO
Description:	General Observation

Distance (ft):	8.7
Structural Grade:	0
O&M Grade:	0
Clock Start/From:	
Clock To:	
1st Value:	
2nd Value:	
Value Percent:	
Step:	NO
Remarks:	end of survey

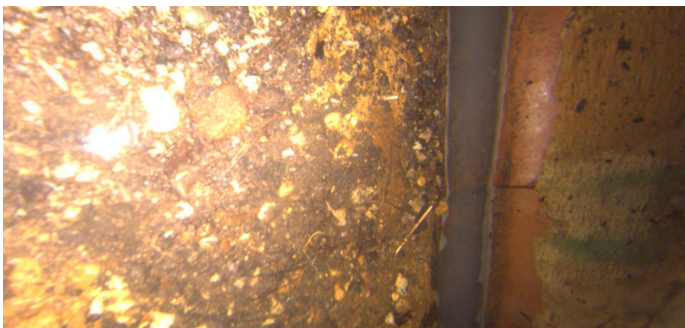
Code:	SRI
Description:	Surface Roughness Increased

Distance (ft):	8.7
Structural Grade:	1
O&M Grade:	0
Clock Start/From:	12
Clock To:	12
1st Value:	
2nd Value:	
Value Percent:	
Step:	NO
Remarks:
