Manhole Inspection Report

Date:	04/26/2018	Weather:		Coding:	RZMACP
MH#:	M-606-073	Owner:	NA	Len. Surveyed:	7.9
P.O.#:		Surveyor:	Jen Costello	Rim to Invert:	8.6
Customer:		Cert. #:	U-907-5518	Wall Material:	Concrete (reinforced)

Street:	74' South of 7th St. East of Wisconsin	Project:	Hobart, IN
City:	Hobart, IN	GPS Northing:	41.52706909
Location:		GPS Easting:	-87.26847839
Drain Area:	Southwest	GPS Accuracy:	Nearest Meter
Cover Shape:	Circular	Evidence of Surcharge:	No
Cover Size:	22.5	Potential for Runoff:	None
Comments:

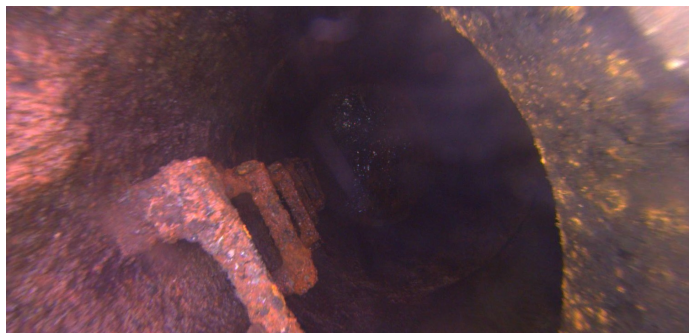
Code: **MGO**
Description: **General Observation**

Distance (ft): **.0**
Structural Grade: **0**
O&M Grade: **0**
Clock Start/From:
Clock To:
1st Value:
2nd Value:
Value Percent:
Step: **NO**
Remarks: **ACCESS MH**

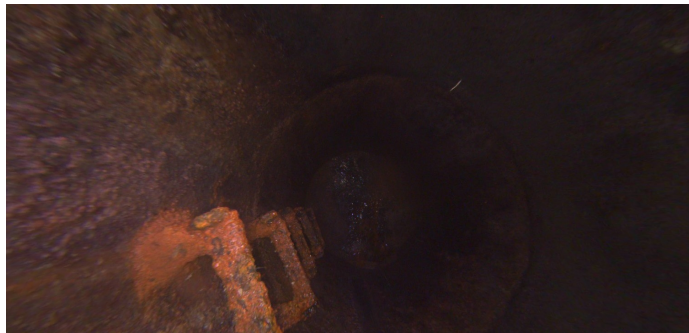
Code:	DAE
Description:	Deposits Attached Encrustation
Distance (ft):	1.3
Structural Grade:	0
O&M Grade:	2
Clock Start/From:	12
Clock To:	12
1st Value:	
2nd Value:	
Value Percent:	5.000
Step:	NO
Remarks:

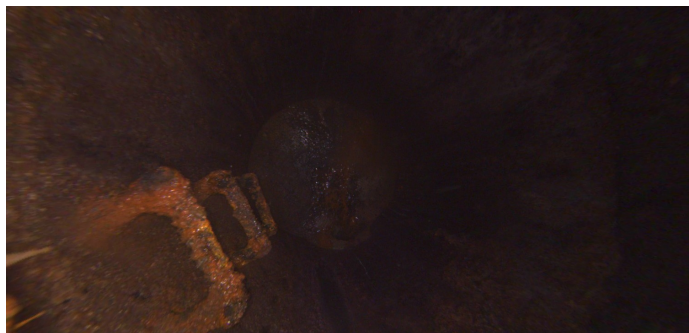
Code:	IS
Description:	Infil Stain
Distance (ft):	2.9
Structural Grade:	0
O&M Grade:	0
Clock Start/From:	12
Clock To:	12
1st Value:	
2nd Value:	
Value Percent:	
Step:	NO
Remarks:

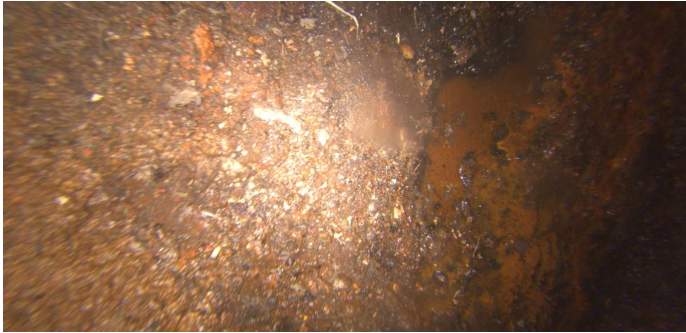
Code:	DAE
Description:	Deposits Attached Encrustation

Distance (ft):	7.9
Structural Grade:	0
O&M Grade:	2
Clock Start/From:	12
Clock To:	12
1st Value:	
2nd Value:	
Value Percent:	5.000
Step:	NO
Remarks:

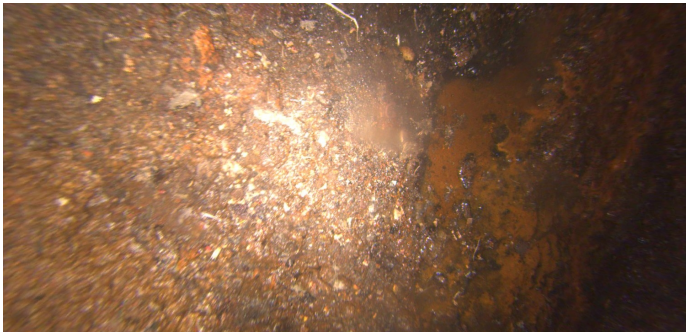
Code:	MGO
Description:	General Observation

Distance (ft):	7.9
Structural Grade:	0
O&M Grade:	0
Clock Start/From:	
Clock To:	
1st Value:	
2nd Value:	
Value Percent:	
Step:	NO
Remarks:	END SURVEY
