Manhole Inspection Report

Date:	04/26/2018	Weather:		Coding:	RZMACP
MH#:	M-606-075	Owner:	NA	Len. Surveyed:	14.2
P.O.#:		Surveyor:	Jen Costello	Rim to Invert:	15.3
Customer:		Cert. #:	U-907-5518	Wall Material:	Concrete (reinforced)

Street:	169' South of Lake Shore Dr. East of	Project:	Hobart, IN
City:	Hobart, IN	GPS Northing:	2903021.647
Location:		GPS Easting:	2903021.647
Drain Area:	Southwest	GPS Accuracy:	Sub-Meter
Cover Shape:	Circular	Evidence of Surcharge:	No
Cover Size:	22.5	Potential for Runoff:	None
Comments:

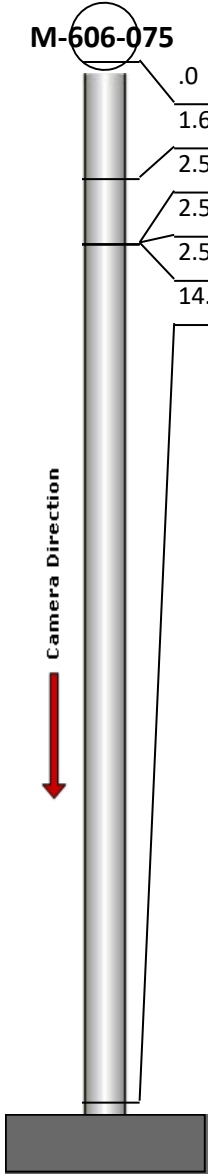
<p>M-606-075</p> <p>Camera Direction</p>	.0	MGO	General Observation	10	NA
	1.6	MGP	General Photo	26	NA
	2.5	RFJ	Roots Fine Joint	42	M 1
	2.5	IW	Infil Weeper	53	M 2
	2.5	OBP	Obstacle External Pipe or Cable	64	M 2
	14.2	MGO	General Observation	99	NA

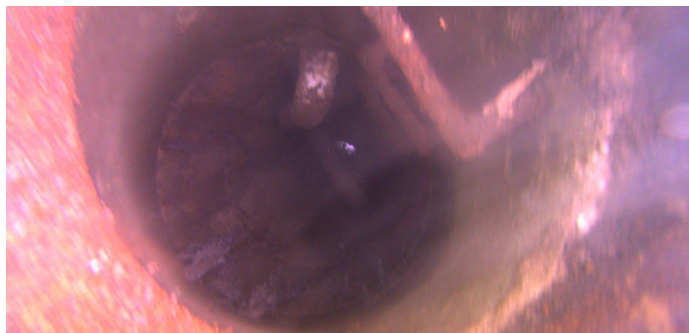
Code: **MGO**
Description: **General Observation**

Distance (ft): **.0**
Structural Grade: **0**
O&M Grade: **0**
Clock Start/From:
Clock To:
1st Value:
2nd Value:
Value Percent:
Step: **NO**
Remarks: **ACCESS MH**

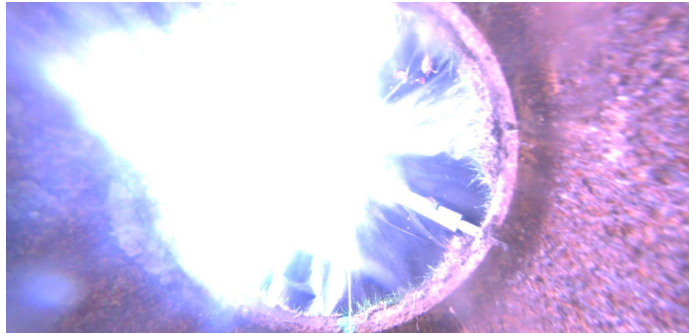
Code:	MGP
Description:	General Photo
Distance (ft):	1.6
Structural Grade:	0
O&M Grade:	0
Clock Start/From:	
Clock To:	
1st Value:	
2nd Value:	
Value Percent:	
Step:	NO
Remarks:	UNDERSIDE OF FRAME

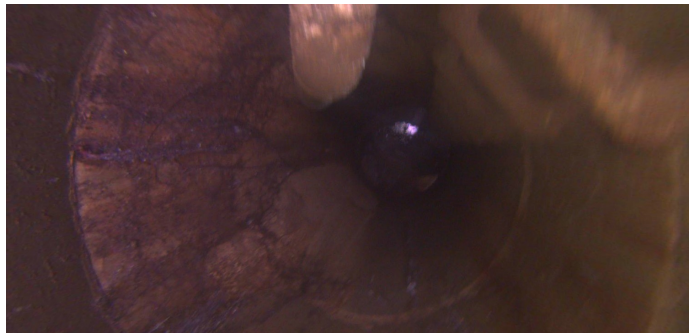
Code:	RFJ
Description:	Roots Fine Joint
Distance (ft):	2.5
Structural Grade:	0
O&M Grade:	1
Clock Start/From:	7
Clock To:	12
1st Value:	
2nd Value:	
Value Percent:	
Step:	NO
Remarks:

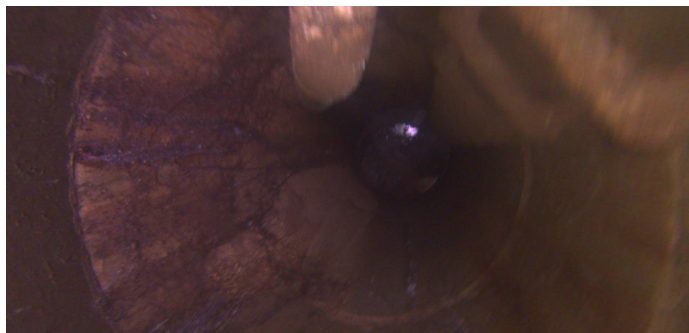
Code:	IW
Description:	Infil Weeper
Distance (ft):	2.5
Structural Grade:	0
O&M Grade:	2
Clock Start/From:	7
Clock To:	12
1st Value:	
2nd Value:	
Value Percent:	
Step:	NO
Remarks:

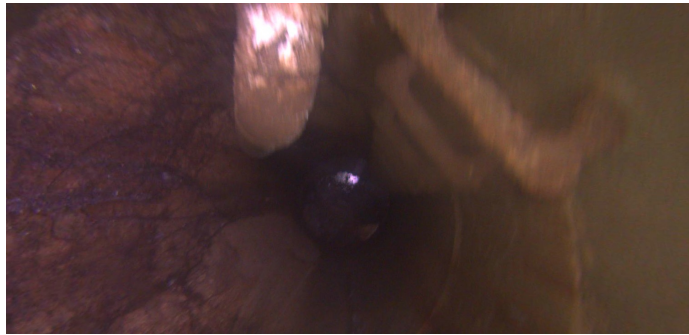
Code:	OBP
Description:	Obstacle External Pipe or Cable
Distance (ft):	2.5
Structural Grade:	0
O&M Grade:	2
Clock Start/From:	12
Clock To:	
1st Value:	
2nd Value:	
Value Percent:	10.000
Step:	NO
Remarks:

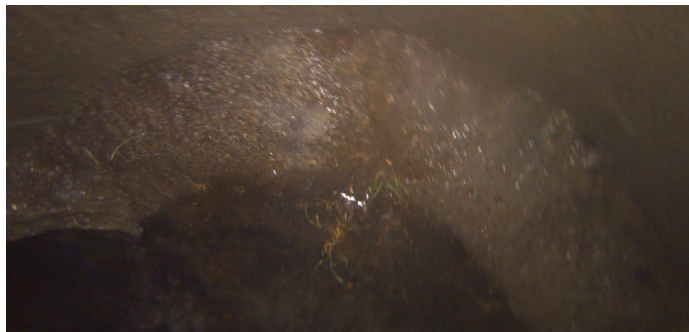
Code:	MGO
Description:	General Observation
Distance (ft):	14.2
Structural Grade:	0
O&M Grade:	0
Clock Start/From:	
Clock To:	
1st Value:	
2nd Value:	
Value Percent:	
Step:	NO
Remarks:	END SURVEY
