Manhole Inspection Report

Date:	04/26/2018	Weather:		Coding:	RZMACP
MH#:	M-606-083	Owner:	NA	Len. Surveyed:	9.4
P.O.#:		Surveyor:	Jen Costello	Rim to Invert:	10.1
Customer:		Cert. #:	U-907-5518	Wall Material:	Concrete (reinforced)

Street:	Lake Shore Dr. 254' East of Hollywo	Project:	Hobart, IN
City:	Hobart, IN	GPS Northing:	2903106.935
Location:		GPS Easting:	2903106.935
Drain Area:	Southwest	GPS Accuracy:	Sub-Meter
Cover Shape:	Circular	Evidence of Surcharge:	No
Cover Size:	22.5	Potential for Runoff:	None
Comments:

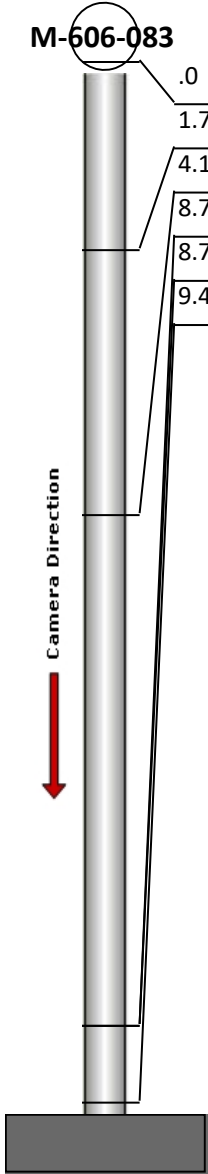
.0	MGO	General Observation	10	NA
	1.7	MGP	General Photo	27	NA
	4.1	FL	Fracture Longitudinal	45	S 3
	8.7	OBR	Obstacle Rocks	66	M 2
	8.7	OBZ	Obstacle Other	77	M 2
	9.4	MGO	General Observation	90	NA

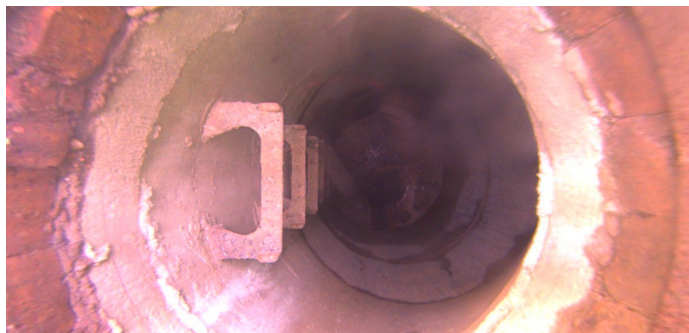
Code: **MGO**
Description: **General Observation**

Distance (ft): **.0**
Structural Grade: **0**
O&M Grade: **0**
Clock Start/From:
Clock To:
1st Value:
2nd Value:
Value Percent:
Step: **NO**
Remarks: **ACCESS MH**

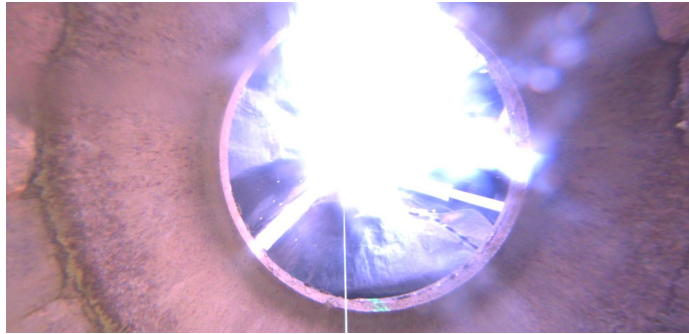
Code:	MGP
Description:	General Photo
Distance (ft):	1.7
Structural Grade:	0
O&M Grade:	0
Clock Start/From:	
Clock To:	
1st Value:	
2nd Value:	
Value Percent:	
Step:	NO
Remarks:	UNDERSIDE OF FRAME

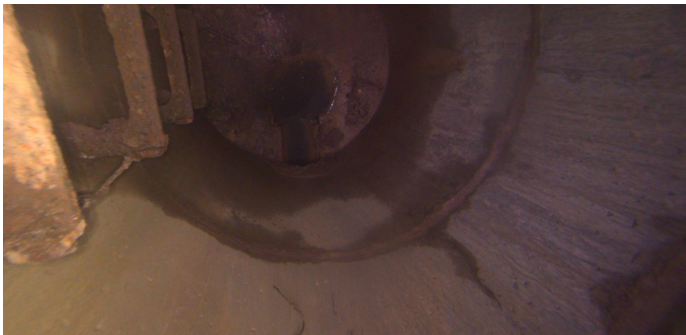
Code:	FL
Description:	Fracture Longitudinal
Distance (ft):	4.1
Structural Grade:	3
O&M Grade:	0
Clock Start/From:	7
Clock To:	
1st Value:	
2nd Value:	
Value Percent:	
Step:	NO
Remarks:

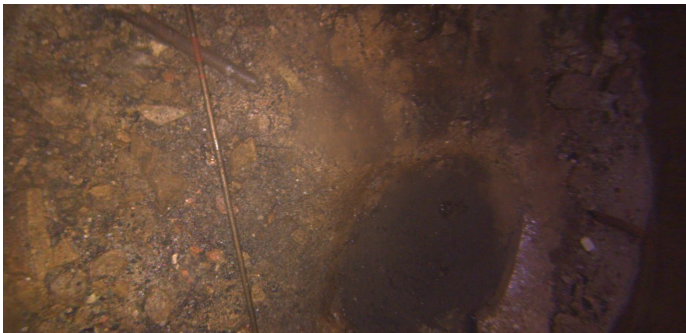
Code:	OBR
Description:	Obstacle Rocks
Distance (ft):	8.7
Structural Grade:	0
O&M Grade:	2
Clock Start/From:	12
Clock To:	12
1st Value:	
2nd Value:	
Value Percent:	5.000
Step:	NO
Remarks:

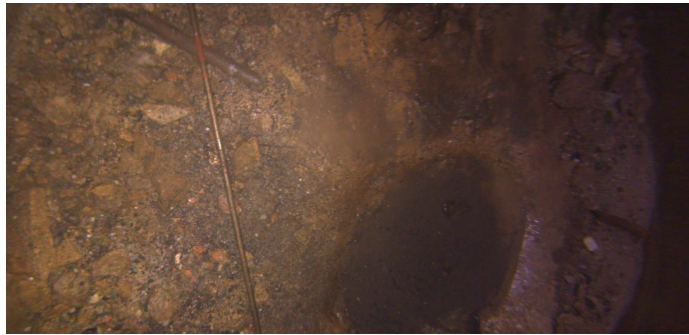
Code: **OBZ**
Description: **Obstacle Other**

Distance (ft): **8.7**
Structural Grade: **0**
O&M Grade: **2**
Clock Start/From: **6**
Clock To: **11**
1st Value:
2nd Value:
Value Percent: **5.000**
Step: **NO**
Remarks: **STICKS**

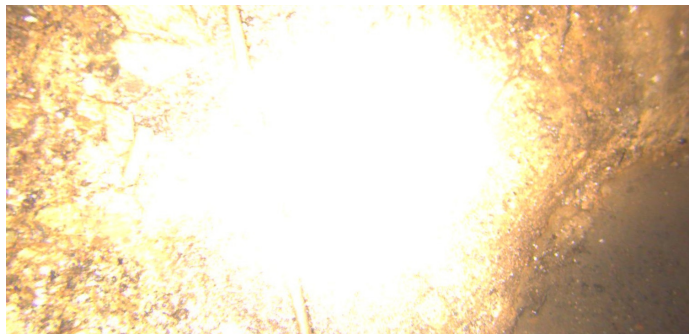
Code: **MGO**
Description: **General Observation**

Distance (ft): **9.4**
Structural Grade: **0**
O&M Grade: **0**
Clock Start/From:
Clock To:
1st Value:
2nd Value:
Value Percent:
Step: **NO**
Remarks: **END SURVEY**
