Manhole Inspection Report

Date:	04/26/2018	Weather:		Coding:	RZMACP
MH#:	M-606-084	Owner:	NA	Len. Surveyed:	12.7
P.O.#:		Surveyor:	Jen Costello	Rim to Invert:	13.6
Customer:		Cert. #:	U-907-5518	Wall Material:	Concrete (reinforced)

Street:	Lake Shore Dr. 171' East of Hollywo	Project:	Hobart, IN
City:	Hobart, IN	GPS Northing:	2902948.15
Location:		GPS Easting:	2902948.15
Drain Area:	Southwest	GPS Accuracy:	Sub-Meter
Cover Shape:	Circular	Evidence of Surcharge:	No
Cover Size:	22.5	Potential for Runoff:	None
Comments:

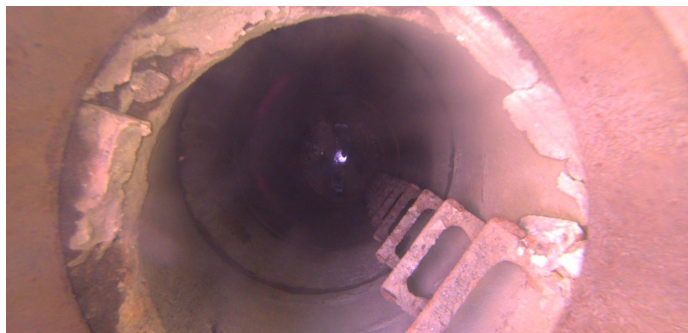
Code: **MGO**
Description: **General Observation**

Distance (ft): **.0**
Structural Grade: **0**
O&M Grade: **0**
Clock Start/From:
Clock To:
1st Value:
2nd Value:
Value Percent:
Step: **NO**
Remarks: **ACCESS MH**

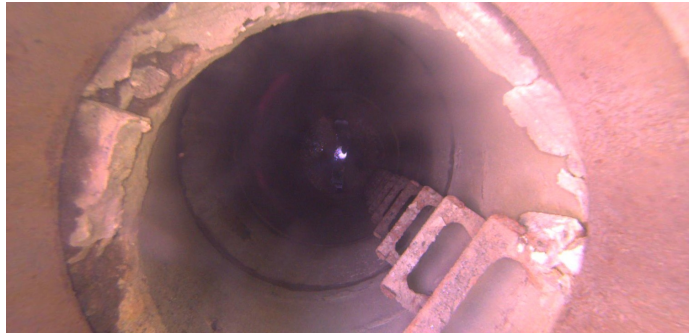
Code: **B**
Description: **Broken**

Distance (ft): **.0**
Structural Grade: **5**
O&M Grade: **0**
Clock Start/From: **9**
Clock To: **3**
1st Value:
2nd Value:
Value Percent:
Step: **NO**
Remarks:

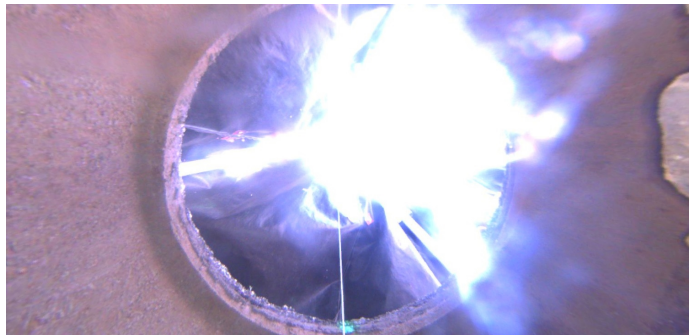
Code: **MGP**
Description: **General Photo**

Distance (ft): **1.6**
Structural Grade: **0**
O&M Grade: **0**
Clock Start/From:
Clock To:
1st Value:
2nd Value:
Value Percent:
Step: **NO**
Remarks: **UNDERSIDE OF FRAME**

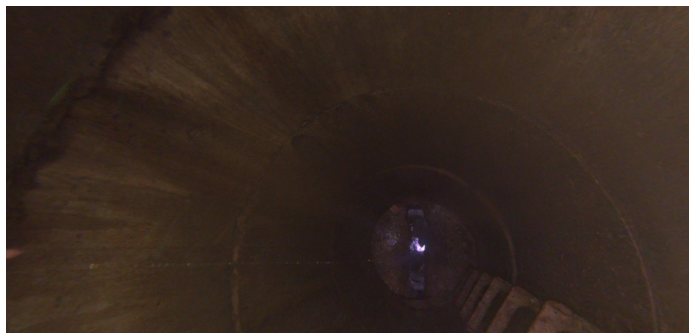
Code: **IW**
Description: **Infil Weeper**

Distance (ft): **3.6**
Structural Grade: **0**
O&M Grade: **2**
Clock Start/From: **9**
Clock To: **11**
1st Value:
2nd Value:
Value Percent:
Step: **NO**
Remarks:

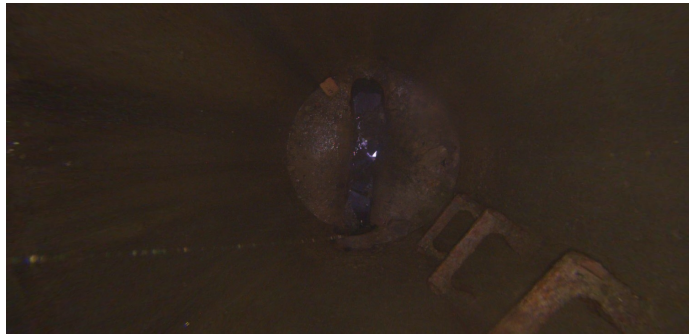
Code: **IW**
Description: **Infil Weeper**

Distance (ft): **8.3**
Structural Grade: **0**
O&M Grade: **2**
Clock Start/From: **8**
Clock To: **12**
1st Value:
2nd Value:
Value Percent:
Step: **NO**
Remarks:

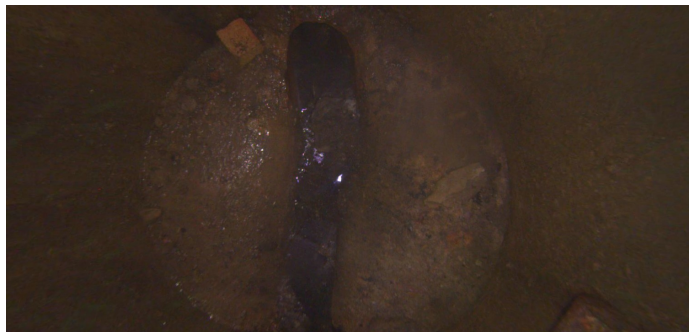
Code: **OBB**
Description: **Obstacle Brick**

Distance (ft): **10.2**
Structural Grade: **0**
O&M Grade: **2**
Clock Start/From: **11**
Clock To:
1st Value:
2nd Value:
Value Percent: **5.000**
Step: **NO**
Remarks:

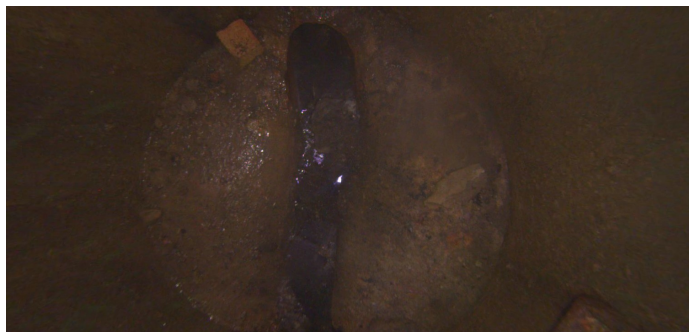
Code: **OBR**
Description: **Obstacle Rocks**

Distance (ft): **10.2**
Structural Grade: **0**
O&M Grade: **2**
Clock Start/From: **3**
Clock To:
1st Value:
2nd Value:
Value Percent: **5.000**
Step: **NO**
Remarks:

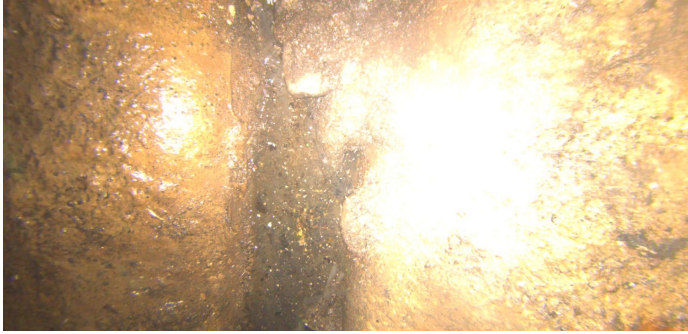
Code:	MGO
Description:	General Observation
Distance (ft):	12.7
Structural Grade:	0
O&M Grade:	0
Clock Start/From:	
Clock To:	
1st Value:	
2nd Value:	
Value Percent:	
Step:	NO
Remarks:	END SURVEY
