# Manhole Inspection Report

Date:	<b>04/26/2018</b>	Weather:		Coding:	<b>RZMACP</b>
MH#:	<b>M-606-087</b>	Owner:	<b>NA</b>	Len. Surveyed:	<b>15.2</b>
P.O.#:		Surveyor:	<b>Jen Costello</b>	Rim to Invert:	<b>16.5</b>
Customer:		Cert. #:	<b>U-907-5518</b>	Wall Material:	<b>Concrete (reinforced)</b>

Street:	<b>Lake Shore Dr. Sunset St. to the Wes</b>	Project:	<b>Hobart, IN</b>
City:	<b>Hobart, IN</b>	GPS Northing:	<b>2902411.998</b>
Location:		GPS Easting:	<b>2902411.998</b>
Drain Area:	<b>Southwest</b>	GPS Accuracy:	<b>Sub-Meter</b>
Cover Shape:	<b>Circular</b>	Evidence of Surcharge:	<b>No</b>
Cover Size:	<b>22.5</b>	Potential for Runoff:	<b>None</b>
Comments:

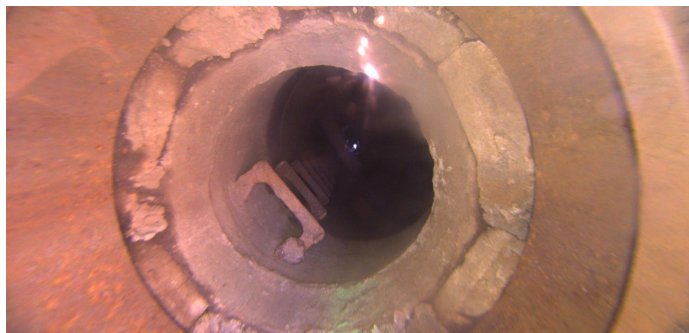
Code: **MGO**  
Description: **General Observation**

Distance (ft): **.0**  
Structural Grade: **0**  
O&M Grade: **0**  
Clock Start/From:  
Clock To:  
1st Value:  
2nd Value:  
Value Percent:  
Step: **NO**  
Remarks: **ACCESS MH**

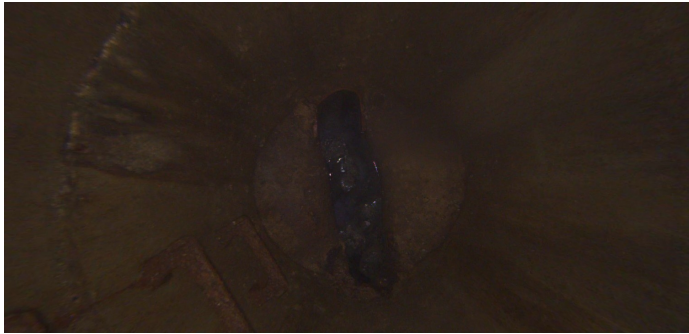
Code: **IW**  
Description: **Infil Weeper**

Distance (ft): **11.7**  
Structural Grade: **0**  
O&M Grade: **2**  
Clock Start/From: **9**  
Clock To: **3**  
1st Value:  
2nd Value:  
Value Percent:  
Step: **NO**  
Remarks:

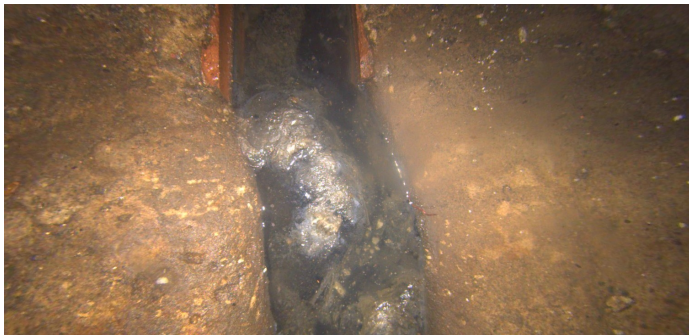
Code: **MGO**  
Description: **General Observation**

Distance (ft): **15.2**  
Structural Grade: **0**  
O&M Grade: **0**  
Clock Start/From:  
Clock To:  
1st Value:  
2nd Value:  
Value Percent:  
Step: **NO**  
Remarks: **END SURVEY**
