Manhole Inspection Report

Date:	04/09/2018	Weather:		Coding:	RZMACP
MH#:	M-607-005	Owner:	NA	Len. Surveyed:	12.2
P.O.#:		Surveyor:	John Kuglmaier	Rim to Invert:	12.7
Customer:		Cert. #:	U-1215-07002349	Wall Material:	Concrete (reinforced)

Street:	West of Lake Park Ave. 348' South of	Project:	Hobart, IN
City:	Hobart, IN	GPS Northing:	2904313.661
Location:		GPS Easting:	2904313.661
Drain Area:	Southwest	GPS Accuracy:	Sub-Meter
Cover Shape:	Circular	Evidence of Surcharge:	Yes
Cover Size:	22.5	Potential for Runoff:	None
Comments:

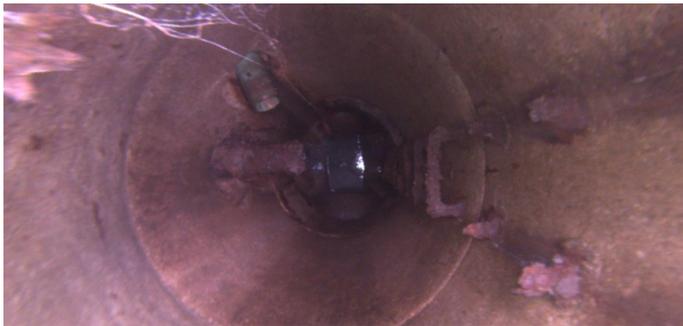
Code: **MGP**
Description: **General Photo**

Distance (ft): **.0**
Structural Grade: **0**
O&M Grade: **0**
Clock Start/From:
Clock To:
1st Value:
2nd Value:
Value Percent:
Step: **NO**
Remarks:

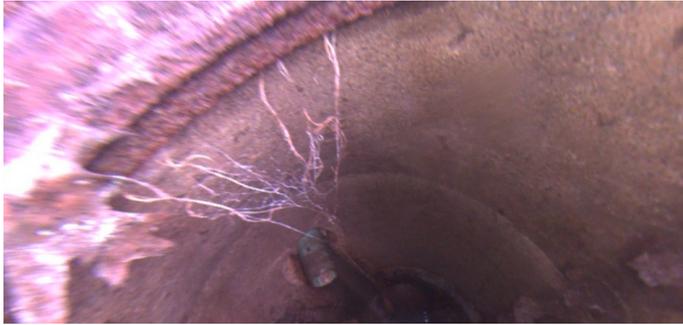
Code: **RFJ**
Description: **Roots Fine Joint**

Distance (ft): **.0**
Structural Grade: **0**
O&M Grade: **1**
Clock Start/From: **10**
Clock To:
1st Value:
2nd Value:
Value Percent:
Step: **NO**
Remarks:

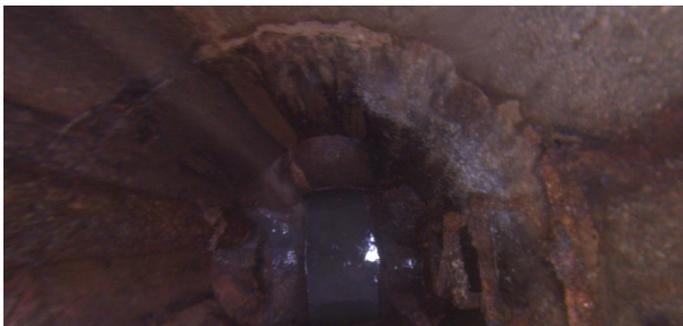
Code: **DAGS**
Description: **Deposits Attached Grease**

Distance (ft): **6.3**
Structural Grade: **0**
O&M Grade: **2**
Clock Start/From: **11**
Clock To: **4**
1st Value:
2nd Value:
Value Percent: **5.000**
Step: **NO**
Remarks:

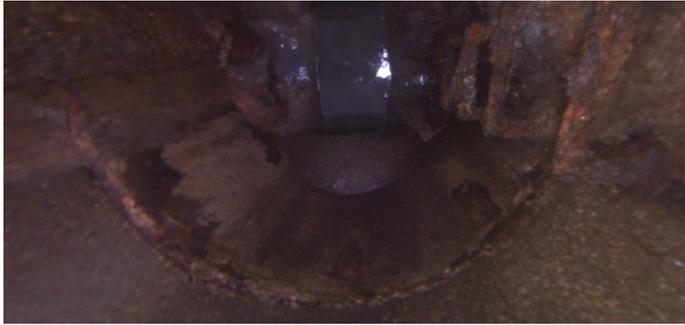
Code: **IS**
Description: **Infil Stain**

Distance (ft): **6.3**
Structural Grade: **0**
O&M Grade: **0**
Clock Start/From: **4**
Clock To: **8**
1st Value:
2nd Value:
Value Percent:
Step: **NO**
Remarks:

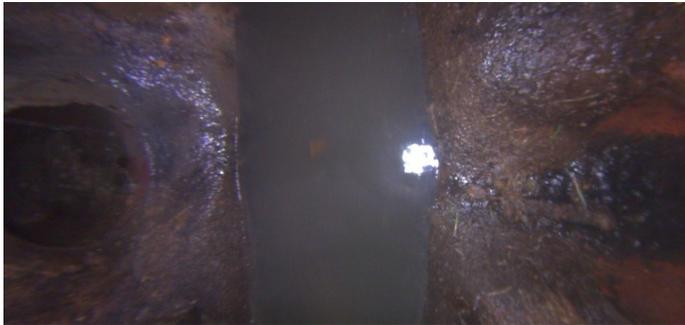
Code: **MGO**
Description: **General Observation**

Distance (ft): **10.7**
Structural Grade: **0**
O&M Grade: **0**
Clock Start/From:
Clock To:
1st Value:
2nd Value:
Value Percent:
Step: **NO**
Remarks: **Ins. Comp.**
