Manhole Inspection Report

Date:	09/24/2022	Weather:		Coding:	RZMACP
MH#:	M-607-019	Owner:	NA	Len. Surveyed:	9.5
P.O.#:		Surveyor:	Jen Costello	Rim to Invert:	12.0
Customer:		Cert. #:	U-907-5518	Wall Material:	Concrete (cast in place)

Street:	Ash St. and 10th St.	Project:	Hobart, IN
City:	Hobart, IN	GPS Northing:	2285177.692
Location:	Local Rural Streets	GPS Easting:	2903194.318
Drain Area:	Southwest	GPS Accuracy:	Sub-Meter
Cover Shape:	Circular	Evidence of Surcharge:	No
Cover Size:	24.0	Potential for Runoff:	None
Comments:	PARTIAL DECENT DUE TO SPLATTER FROM DC

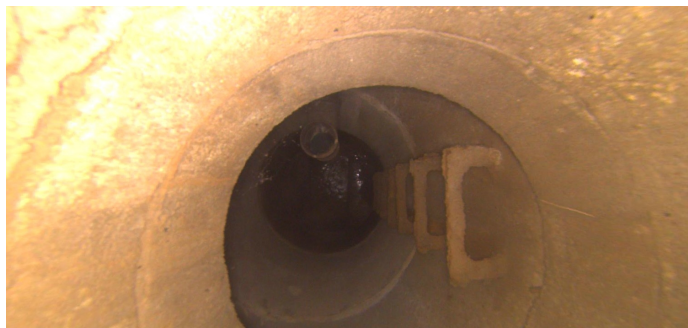
Code: **MGO**
Description: **General Observation**

Distance (ft): **.0**
Structural Grade: **0**
O&M Grade: **0**
Clock Start/From:
Clock To:
1st Value:
2nd Value:
Value Percent:
Step: **NO**
Remarks: **access mh**

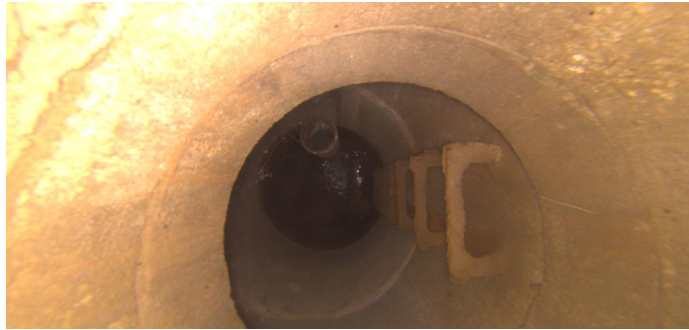
Code:	SRI
Description:	Surface Roughness Increased
Distance (ft):	.0
Structural Grade:	1
O&M Grade:	0
Clock Start/From:	12
Clock To:	12
1st Value:	
2nd Value:	
Value Percent:	
Step:	NO
Remarks:

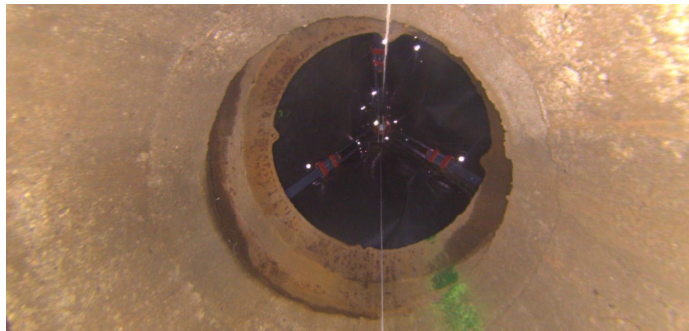
Code:	IW
Description:	Infil Weeper
Distance (ft):	2.5
Structural Grade:	0
O&M Grade:	2
Clock Start/From:	12
Clock To:	12
1st Value:	
2nd Value:	
Value Percent:	
Step:	NO
Remarks:

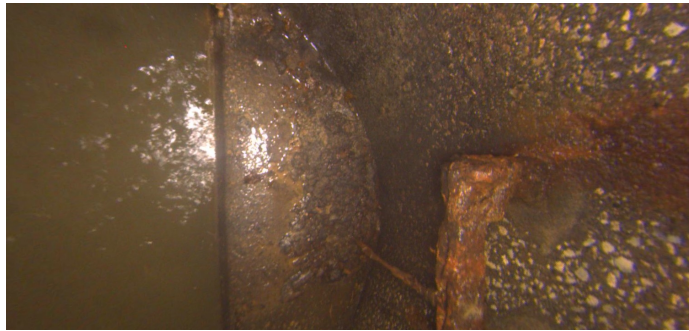
Code: **SAP**
Description: **Surface Aggregate Projecting**

Distance (ft): **9.5**
Structural Grade: **3**
O&M Grade: **0**
Clock Start/From: **12**
Clock To: **12**
1st Value:
2nd Value:
Value Percent:
Step: **NO**
Remarks:

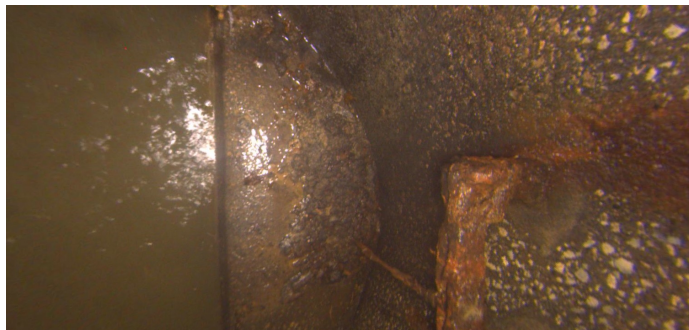
Code: **SRI**
Description: **Surface Roughness Increased**

Distance (ft): **9.5**
Structural Grade: **1**
O&M Grade: **0**
Clock Start/From: **12**
Clock To: **12**
1st Value:
2nd Value:
Value Percent:
Step: **NO**
Remarks:

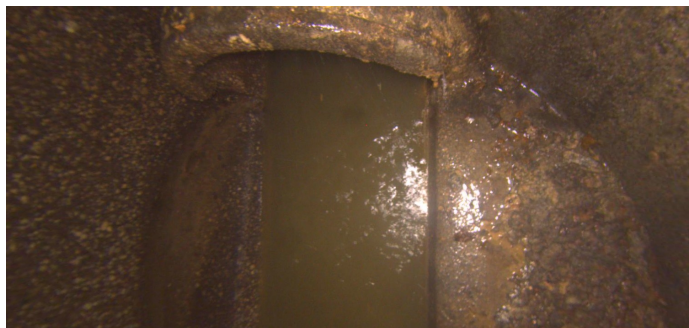
Code: **MGO**
Description: **General Observation**

Distance (ft): **9.5**
Structural Grade: **0**
O&M Grade: **0**
Clock Start/From:
Clock To:
1st Value:
2nd Value:
Value Percent:
Step: **NO**
Remarks: **end of survey**
