Manhole Inspection Report

Date:	04/09/2018	Weather:		Coding:	RZMACP
MH#:	M-607-023	Owner:	NA	Len. Surveyed:	11.6
P.O.#:		Surveyor:	John Kuglmaier	Rim to Invert:	12.7
Customer:		Cert. #:	U-1215-07002349	Wall Material:	Concrete (reinforced)

Street:	Polly Ln. 330' West of Lake Park Ave.	Project:	Hobart, IN
City:	Hobart, IN	GPS Northing:	2904307.899
Location:		GPS Easting:	2904307.899
Drain Area:	Southwest	GPS Accuracy:	Sub-Meter
Cover Shape:	Circular	Evidence of Surcharge:	Yes
Cover Size:	22.5	Potential for Runoff:	None
Comments:

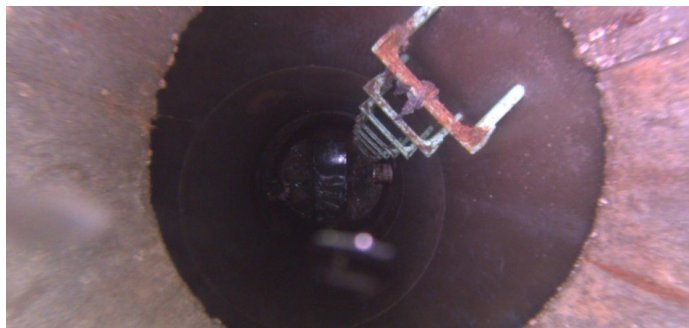
Code: **MGP**
Description: **General Photo**

Distance (ft): **.0**
Structural Grade: **0**
O&M Grade: **0**
Clock Start/From:
Clock To:
1st Value:
2nd Value:
Value Percent:
Step: **NO**
Remarks:

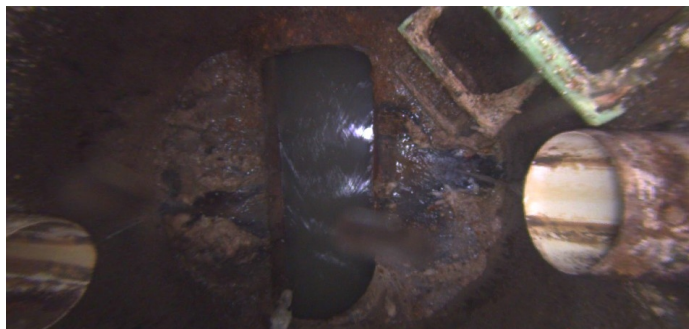
Code: **DAZ**
Description: **Deposits Attached Other**

Distance (ft): **8.3**
Structural Grade: **0**
O&M Grade: **2**
Clock Start/From: **12**
Clock To: **12**
1st Value:
2nd Value:
Value Percent: **10.000**
Step: **NO**
Remarks: **Mixed materials**

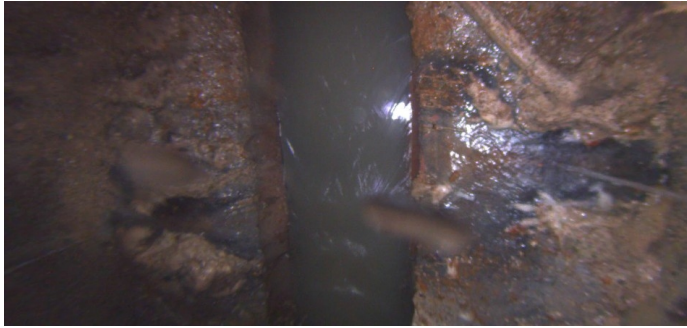
Code:	MGO
Description:	General Observation
Distance (ft):	9.6
Structural Grade:	0
O&M Grade:	0
Clock Start/From:	
Clock To:	
1st Value:	
2nd Value:	
Value Percent:	
Step:	NO
Remarks:	Ins. Comp.
