Manhole Inspection Report

Date:	04/05/2018	Weather:		Coding:	RZMACP
MH#:	M-607-033	Owner:	NA	Len. Surveyed:	6.2
P.O.#:		Surveyor:	John Kuglmaier	Rim to Invert:	6.7
Customer:		Cert. #:	U-1215-07002349	Wall Material:	Concrete (reinforced)

Street:	14th St. and Wisconsin St.	Project:	Hobart, IN
City:	Hobart, IN	GPS Northing:	0.0
Location:		GPS Easting:	0.0
Drain Area:	Southwest	GPS Accuracy:	Nearest Meter
Cover Shape:	Circular	Evidence of Surcharge:	Yes
Cover Size:	22.5	Potential for Runoff:	None
Comments:

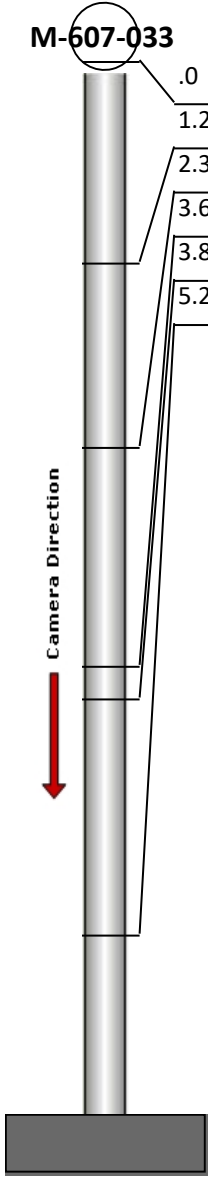
.0	MGP	General Photo	10	NA
	1.2	IS	Infil Stain	24	NA
	2.3	MGP	General Photo	40	NA
	3.6	DAZ	Deposits Attached Other	57	M 2
	3.8	IS	Infil Stain	69	NA
	5.2	MGO	General Observation	84	NA

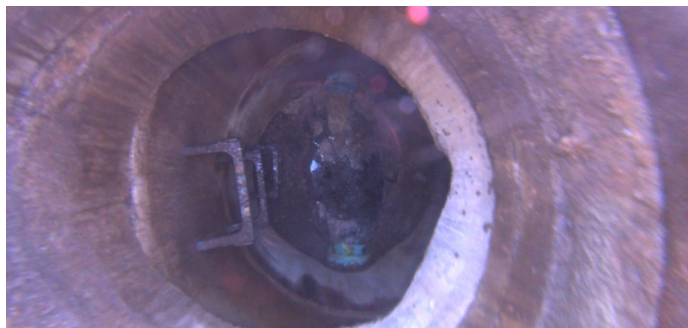
Code: **MGP**
Description: **General Photo**

Distance (ft): **.0**
Structural Grade: **0**
O&M Grade: **0**
Clock Start/From:
Clock To:
1st Value:
2nd Value:
Value Percent:
Step: **NO**
Remarks:

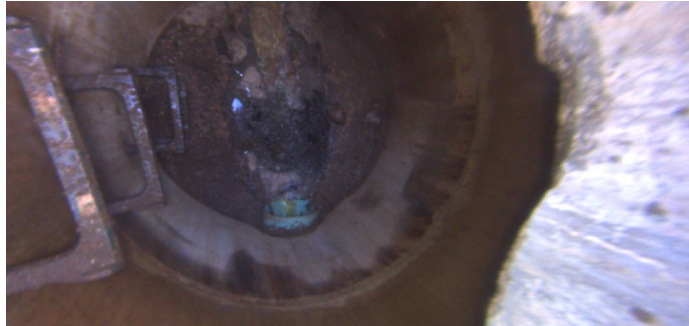
Code: **IS**
Description: **Infil Stain**

Distance (ft): **1.2**
Structural Grade: **0**
O&M Grade: **0**
Clock Start/From: **3**
Clock To: **8**
1st Value:
2nd Value:
Value Percent:
Step: **NO**
Remarks:

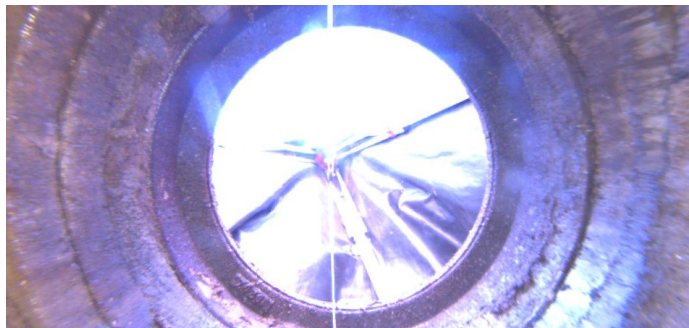
Code: **MGP**
Description: **General Photo**

Distance (ft): **2.3**
Structural Grade: **0**
O&M Grade: **0**
Clock Start/From:
Clock To:
1st Value:
2nd Value:
Value Percent:
Step: **NO**
Remarks:

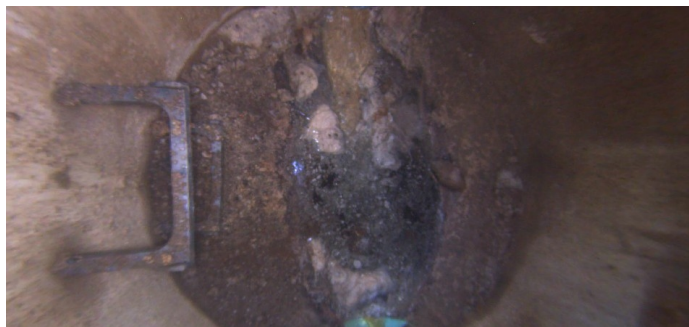
Code: **DAZ**
Description: **Deposits Attached Other**

Distance (ft): **3.6**
Structural Grade: **0**
O&M Grade: **2**
Clock Start/From: **12**
Clock To: **12**
1st Value:
2nd Value:
Value Percent: **10.000**
Step: **NO**
Remarks: **Mixed materials**

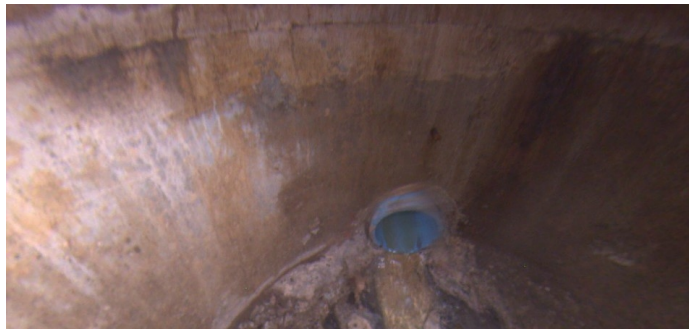
Code: **IS**
Description: **Infil Stain**

Distance (ft): **3.8**
Structural Grade: **0**
O&M Grade: **0**
Clock Start/From: **1**
Clock To:
1st Value:
2nd Value:
Value Percent:
Step: **NO**
Remarks:

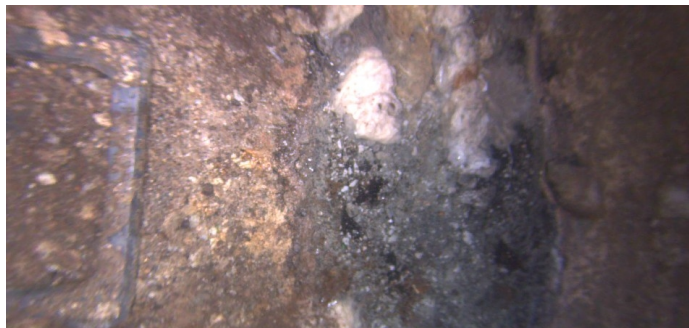
Code: **MGO**
Description: **General Observation**

Distance (ft): **5.2**
Structural Grade: **0**
O&M Grade: **0**
Clock Start/From:
Clock To:
1st Value:
2nd Value:
Value Percent:
Step: **NO**
Remarks: **Ins. Comp.**
