Manhole Inspection Report

Date:	04/04/2018	Weather:		Coding:	RZMACP
MH#:	M-607-037	Owner:	NA	Len. Surveyed:	6.8
P.O.#:		Surveyor:	John Kuglmaier	Rim to Invert:	7.4
Customer:		Cert. #:	U-1215-07002349	Wall Material:	Concrete (reinforced)

Street:	Diane Ct. and Medlee Dr.	Project:	Hobart, IN
City:	Hobart, IN	GPS Northing:	0.0
Location:		GPS Easting:	0.0
Drain Area:	Southwest	GPS Accuracy:	Nearest Meter
Cover Shape:	Circular	Evidence of Surcharge:	No
Cover Size:	22.5	Potential for Runoff:	None
Comments:

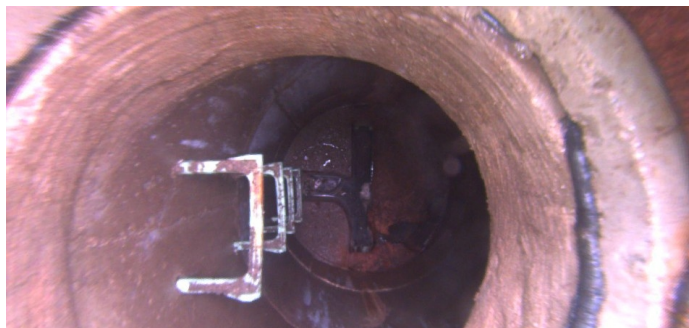
Code: **MGP**
Description: **General Photo**

Distance (ft): **.0**
Structural Grade: **0**
O&M Grade: **0**
Clock Start/From:
Clock To:
1st Value:
2nd Value:
Value Percent:
Step: **NO**
Remarks:

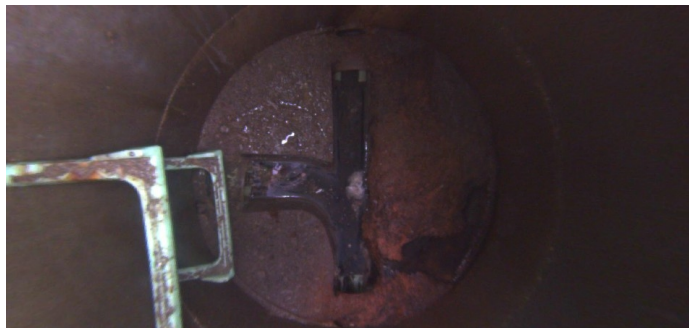
Code: **DAZ**
Description: **Deposits Attached Other**

Distance (ft): **3.2**
Structural Grade: **0**
O&M Grade: **2**
Clock Start/From: **12**
Clock To: **12**
1st Value:
2nd Value:
Value Percent: **10.000**
Step: **NO**
Remarks: **Mixed materials**

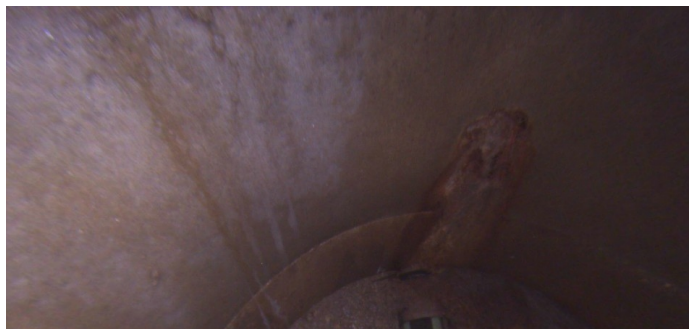
Code: **IS**
Description: **Infil Stain**

Distance (ft): **3.5**
Structural Grade: **0**
O&M Grade: **0**
Clock Start/From: **1**
Clock To:
1st Value:
2nd Value:
Value Percent:
Step: **NO**
Remarks:

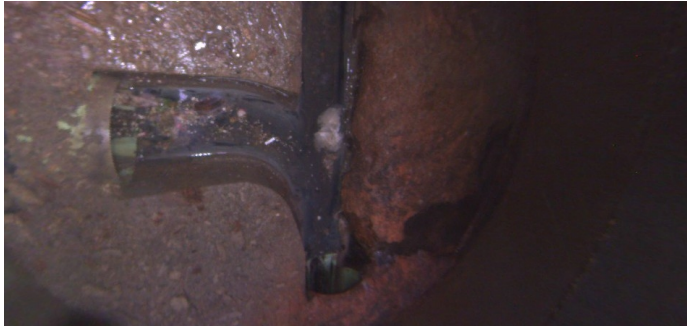
Code:	IS
Description:	Infil Stain
Distance (ft):	5.0
Structural Grade:	0
O&M Grade:	0
Clock Start/From:	4
Clock To:	
1st Value:	
2nd Value:	
Value Percent:	
Step:	NO
Remarks:

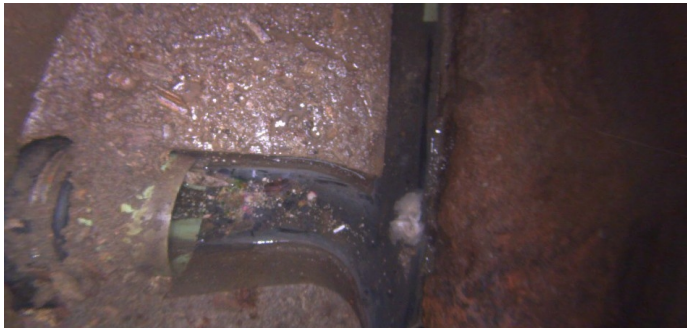
Code:	MGO
Description:	General Observation
Distance (ft):	5.4
Structural Grade:	0
O&M Grade:	0
Clock Start/From:	
Clock To:	
1st Value:	
2nd Value:	
Value Percent:	
Step:	NO
Remarks:	Ins. Comp.
