# Manhole Inspection Report

Date:	<b>04/04/2018</b>	Weather:		Coding:	<b>RZMACP</b>
MH#:	<b>M-607-045</b>	Owner:	<b>NA</b>	Len. Surveyed:	<b>6.7</b>
P.O.#:		Surveyor:	<b>John Kuglmaier</b>	Rim to Invert:	<b>7.2</b>
Customer:		Cert. #:	<b>U-1215-07002349</b>	Wall Material:	<b>Concrete (reinforced)</b>

Street:	<b>Fatima Ln. 322' West of Medlee Dr.</b>	Project:	<b>Hobart, IN</b>
City:	<b>Hobart, IN</b>	GPS Northing:	<b>0.0</b>
Location:		GPS Easting:	<b>0.0</b>
Drain Area:	<b>Southwest</b>	GPS Accuracy:	<b>Nearest Meter</b>
Cover Shape:	<b>Circular</b>	Evidence of Surcharge:	<b>No</b>
Cover Size:	<b>22.5</b>	Potential for Runoff:	<b>None</b>
Comments:

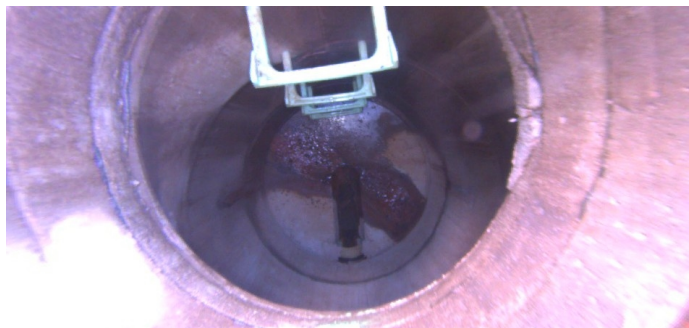
Code: **MGP**  
Description: **General Photo**

Distance (ft): **.0**  
Structural Grade: **0**  
O&M Grade: **0**  
Clock Start/From:  
Clock To:  
1st Value:  
2nd Value:  
Value Percent:  
Step: **NO**  
Remarks:

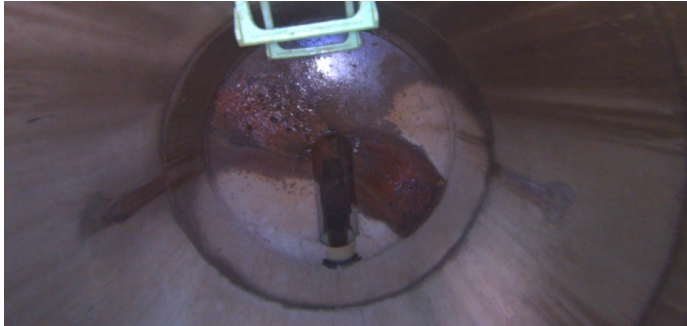
Code: **IS**  
Description: **Infil Stain**

Distance (ft): **2.4**  
Structural Grade: **0**  
O&M Grade: **0**  
Clock Start/From: **8**  
Clock To:  
1st Value:  
2nd Value:  
Value Percent:  
Step: **NO**  
Remarks:

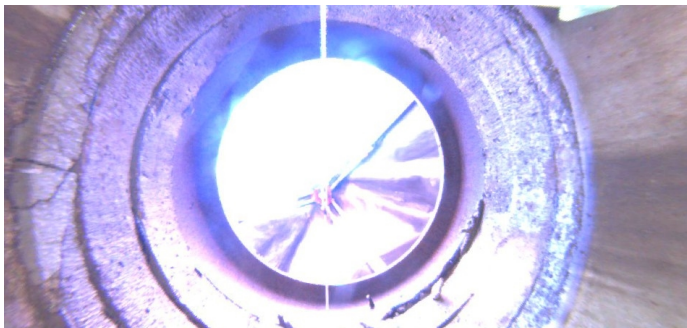
Code: **MGP**  
Description: **General Photo**

Distance (ft): **2.7**  
Structural Grade: **0**  
O&M Grade: **0**  
Clock Start/From:  
Clock To:  
1st Value:  
2nd Value:  
Value Percent:  
Step: **NO**  
Remarks:

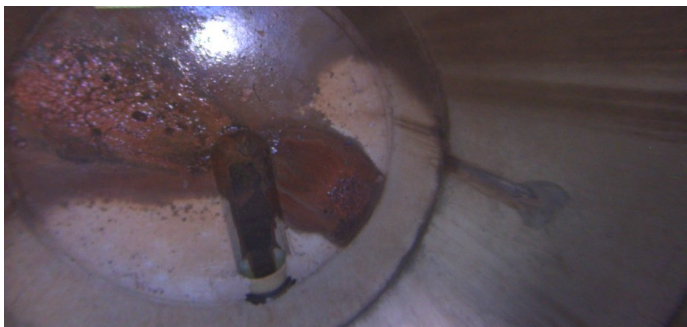
Code: **IS**  
Description: **Infil Stain**

Distance (ft): **3.5**  
Structural Grade: **0**  
O&M Grade: **0**  
Clock Start/From: **4**  
Clock To:  
1st Value:  
2nd Value:  
Value Percent:  
Step: **NO**  
Remarks:

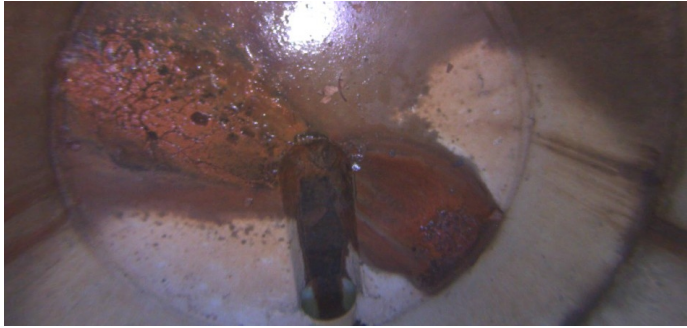
Code: **IS**  
Description: **Infil Stain**

Distance (ft): **4.6**  
Structural Grade: **0**  
O&M Grade: **0**  
Clock Start/From: **4**  
Clock To: **5**  
1st Value:  
2nd Value:  
Value Percent:  
Step: **NO**  
Remarks:

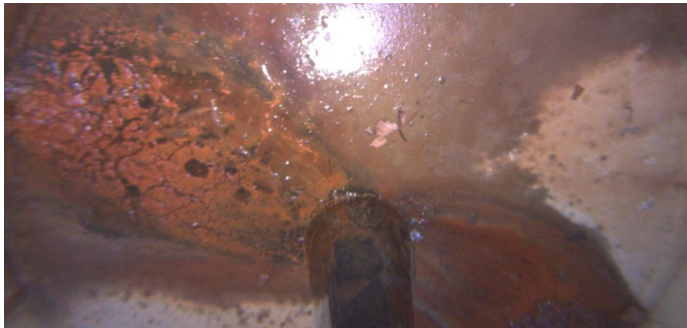
Code: **MGO**  
Description: **General Observation**

Distance (ft): **5.6**  
Structural Grade: **0**  
O&M Grade: **0**  
Clock Start/From:  
Clock To:  
1st Value:  
2nd Value:  
Value Percent:  
Step: **NO**  
Remarks: **Ins. Comp.**
