Manhole Inspection Report

Date:	04/04/2018	Weather:		Coding:	RZMACP
MH#:	M-607-046	Owner:	NA	Len. Surveyed:	6.5
P.O.#:		Surveyor:	John Kuglmaier	Rim to Invert:	7.0
Customer:		Cert. #:	U-1215-07002349	Wall Material:	Concrete (reinforced)

Street:	Medlee Dr and Fatima Ln.	Project:	Hobart, IN
City:	Hobart, IN	GPS Northing:	0.0
Location:		GPS Easting:	0.0
Drain Area:	Southwest	GPS Accuracy:	Nearest Meter
Cover Shape:	Circular	Evidence of Surcharge:	No
Cover Size:	22.5	Potential for Runoff:	None
Comments:

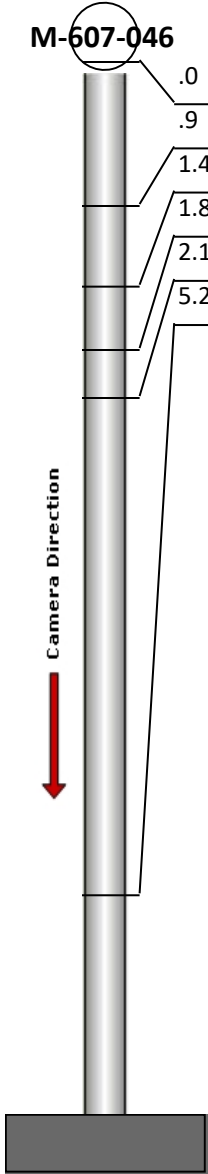
.0	MGP	General Photo	10	NA
	.9	IS	Infil Stain	23	NA
	1.4	IS	Infil Stain	36	NA
	1.8	IS	Infil Stain	49	NA
	2.1	MGP	General Photo	63	NA
	5.2	MGO	General Observation	83	NA

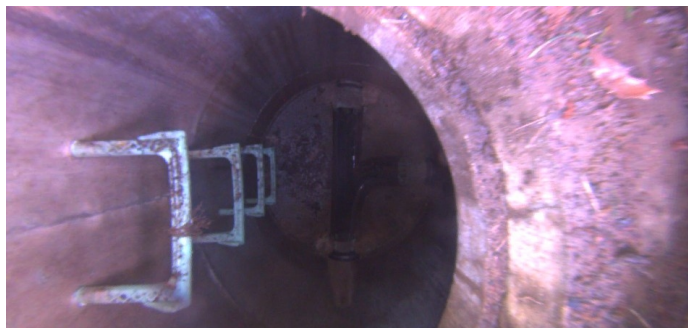
Code: **MGP**
Description: **General Photo**

Distance (ft): **.0**
Structural Grade: **0**
O&M Grade: **0**
Clock Start/From:
Clock To:
1st Value:
2nd Value:
Value Percent:
Step: **NO**
Remarks:

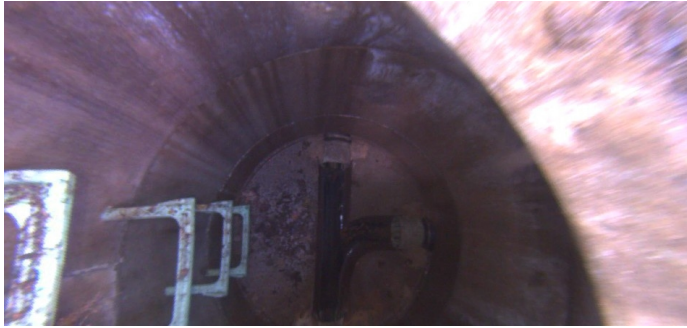
Code: **IS**
Description: **Infil Stain**

Distance (ft): **.9**
Structural Grade: **0**
O&M Grade: **0**
Clock Start/From: **10**
Clock To: **12**
1st Value:
2nd Value:
Value Percent:
Step: **NO**
Remarks:

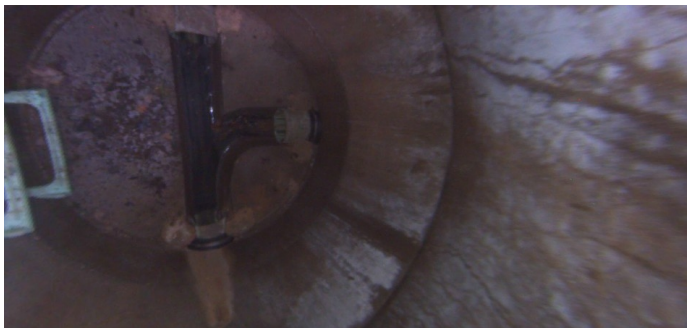
Code: **IS**
Description: **Infil Stain**

Distance (ft): **1.4**
Structural Grade: **0**
O&M Grade: **0**
Clock Start/From: **4**
Clock To:
1st Value:
2nd Value:
Value Percent:
Step: **NO**
Remarks:

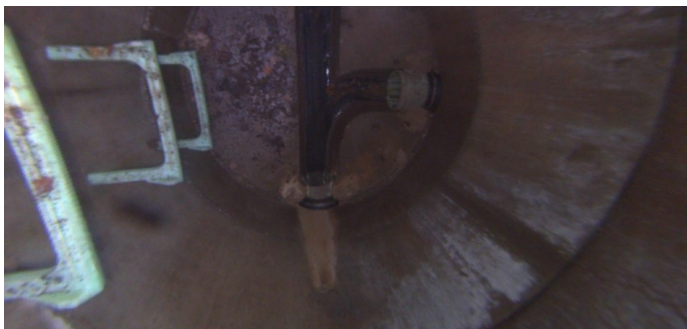
Code: **IS**
Description: **Infil Stain**

Distance (ft): **1.8**
Structural Grade: **0**
O&M Grade: **0**
Clock Start/From: **6**
Clock To:
1st Value:
2nd Value:
Value Percent:
Step: **NO**
Remarks:

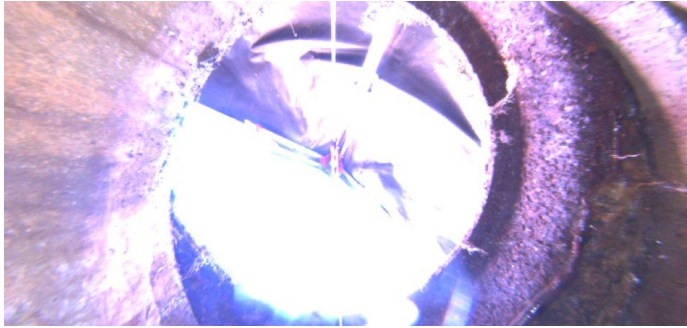
Code: **MGP**
Description: **General Photo**

Distance (ft): **2.1**
Structural Grade: **0**
O&M Grade: **0**
Clock Start/From:
Clock To:
1st Value:
2nd Value:
Value Percent:
Step: **NO**
Remarks:

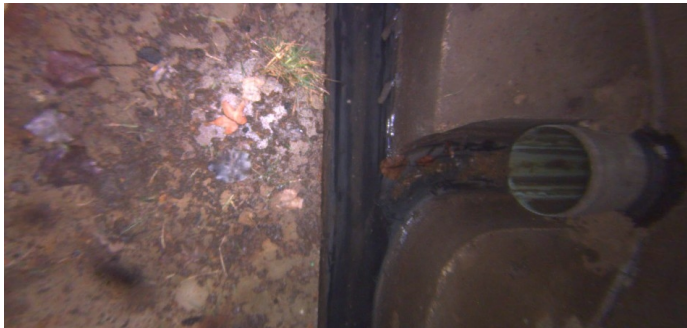
Code: **MGO**
Description: **General Observation**

Distance (ft): **5.2**
Structural Grade: **0**
O&M Grade: **0**
Clock Start/From:
Clock To:
1st Value:
2nd Value:
Value Percent:
Step: **NO**
Remarks: **Ins. Comp.**
