Manhole Inspection Report

Date:	04/04/2018	Weather:		Coding:	RZMACP
MH#:	M-607-047	Owner:	NA	Len. Surveyed:	7.2
P.O.#:		Surveyor:	John Kuglmaier	Rim to Invert:	8.6
Customer:		Cert. #:	U-1215-07002349	Wall Material:	Concrete (reinforced)

Street:	Medlee Dr. 206' North of Fatima Ln.	Project:	Hobart, IN
City:	Hobart, IN	GPS Northing:	0.0
Location:		GPS Easting:	0.0
Drain Area:	Southwest	GPS Accuracy:	Nearest Meter
Cover Shape:	Circular	Evidence of Surcharge:	No
Cover Size:	22.5	Potential for Runoff:	None
Comments:

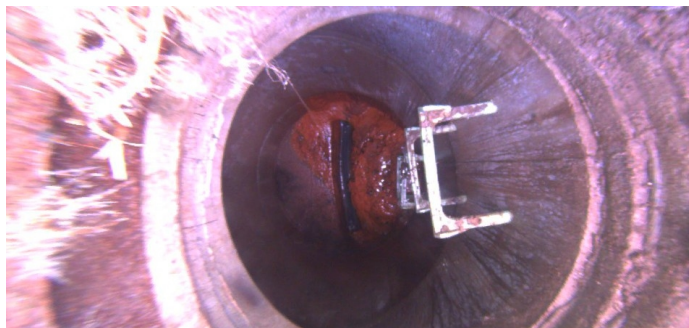
Code: **MGP**
Description: **General Photo**

Distance (ft): **.0**
Structural Grade: **0**
O&M Grade: **0**
Clock Start/From:
Clock To:
1st Value:
2nd Value:
Value Percent:
Step: **NO**
Remarks:

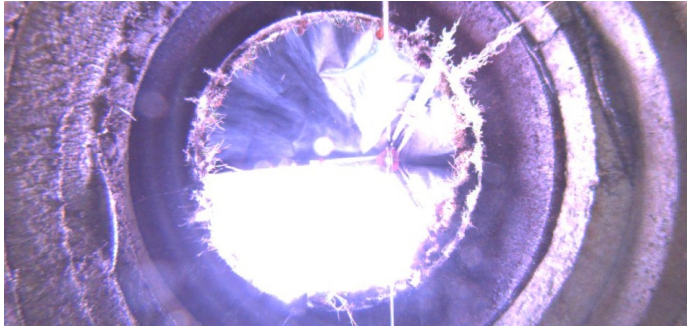
Code:	MGP
Description:	General Photo
Distance (ft):	2.2
Structural Grade:	0
O&M Grade:	0
Clock Start/From:	
Clock To:	
1st Value:	
2nd Value:	
Value Percent:	
Step:	NO
Remarks:

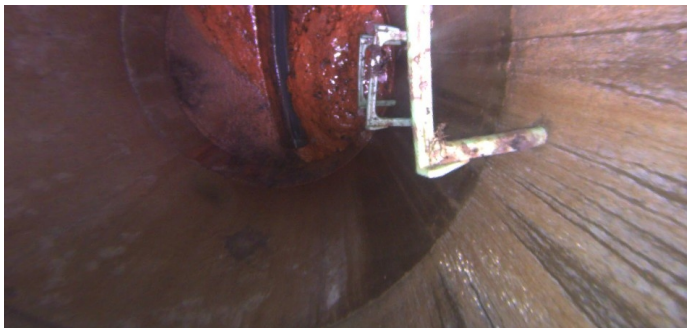
Code:	IS
Description:	Infil Stain
Distance (ft):	2.4
Structural Grade:	0
O&M Grade:	0
Clock Start/From:	4
Clock To:	5
1st Value:	
2nd Value:	
Value Percent:	
Step:	NO
Remarks:

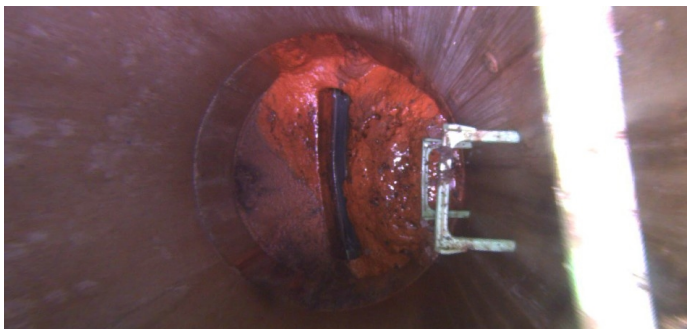
Code:	IS
Description:	Infil Stain
Distance (ft):	3.1
Structural Grade:	0
O&M Grade:	0
Clock Start/From:	12
Clock To:	12
1st Value:	
2nd Value:	
Value Percent:	
Step:	NO
Remarks:

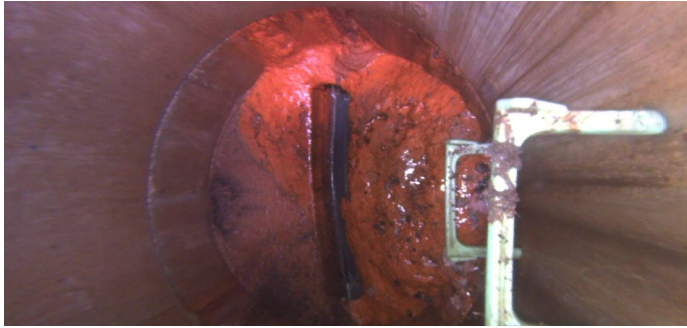
Code:	DAE
Description:	Deposits Attached Encrustation
Distance (ft):	4.1
Structural Grade:	0
O&M Grade:	3
Clock Start/From:	11
Clock To:	6
1st Value:	
2nd Value:	
Value Percent:	15.000
Step:	NO
Remarks:

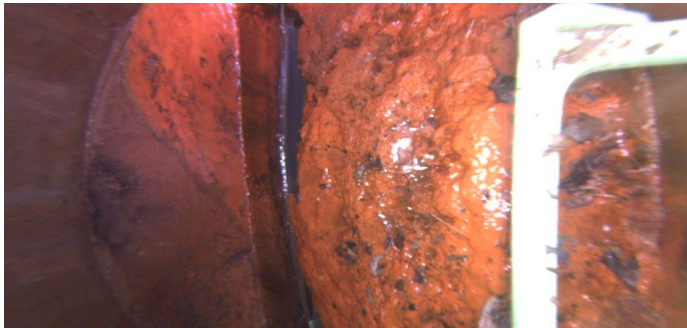
Code:	MGO
Description:	General Observation
Distance (ft):	5.8
Structural Grade:	0
O&M Grade:	0
Clock Start/From:	
Clock To:	
1st Value:	
2nd Value:	
Value Percent:	
Step:	NO
Remarks:	Ins. Comp.
