# Manhole Inspection Report

| MH#: | M-607-056 | Owner: | NA | Len. Surveyed: | 5.4 |

| Street: | Wisconsin St. 332' South of Fatima L | Project: | Hobart, IN |

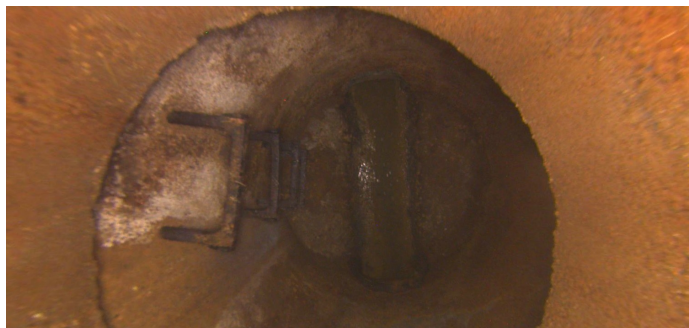
Code: **MGO**  
Description: **General Observation**

Distance (ft): **.0**  
Structural Grade: **0**  
O&M Grade: **0**  
Clock Start/From:  
Clock To:  
1st Value:  
2nd Value:  
Value Percent:  
Step: **NO**  
Remarks: **access mh**

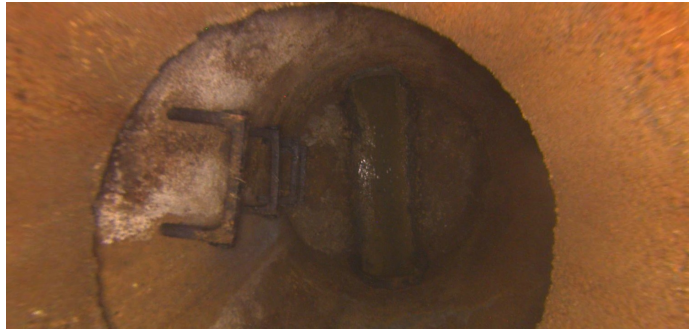
Code: **SRI**  
Description: **Surface Roughness Increased**

Distance (ft): **.0**  
Structural Grade: **1**  
O&M Grade: **0**  
Clock Start/From: **12**  
Clock To: **12**  
1st Value:  
2nd Value:  
Value Percent:  
Step: **NO**  
Remarks:

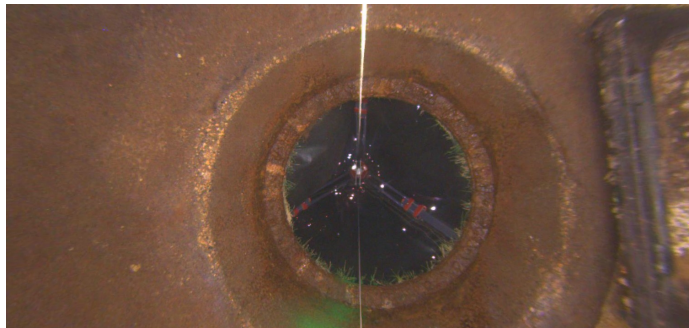
Code: **MGO**  
Description: **General Observation**

Distance (ft): **2.9**  
Structural Grade: **0**  
O&M Grade: **0**  
Clock Start/From:  
Clock To:  
1st Value:  
2nd Value:  
Value Percent:  
Step: **NO**  
Remarks: **underside of frame**

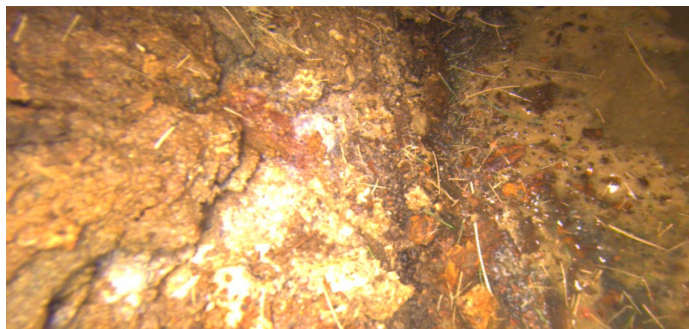
Code: **SAM**  
Description: **Surface Aggregate Missing**

Distance (ft): **5.3**  
Structural Grade: **4**  
O&M Grade: **0**  
Clock Start/From: **3**  
Clock To: **9**  
1st Value:  
2nd Value:  
Value Percent:  
Step: **NO**  
Remarks:

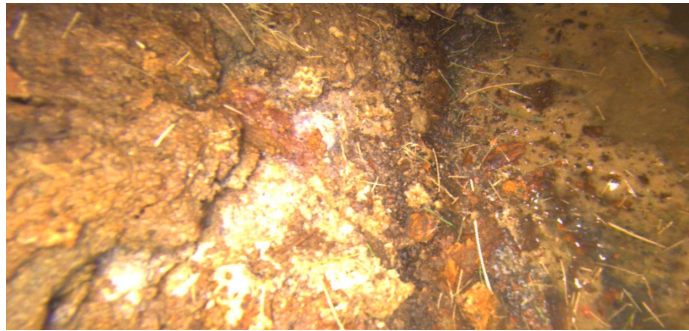
Code: **SRI**  
Description: **Surface Roughness Increased**

Distance (ft): **5.3**  
Structural Grade: **1**  
O&M Grade: **0**  
Clock Start/From: **12**  
Clock To: **12**  
1st Value:  
2nd Value:  
Value Percent:  
Step: **NO**  
Remarks:

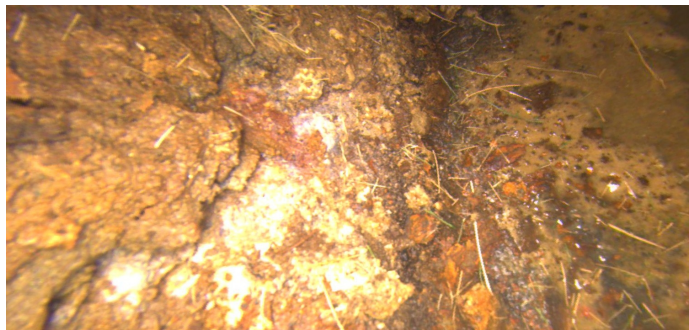
Code: **MGO**  
Description: **General Observation**

Distance (ft): **5.3**  
Structural Grade: **0**  
O&M Grade: **0**  
Clock Start/From:  
Clock To:  
1st Value:  
2nd Value:  
Value Percent:  
Step: **NO**  
Remarks: **end of survey**
