# Manhole Inspection Report

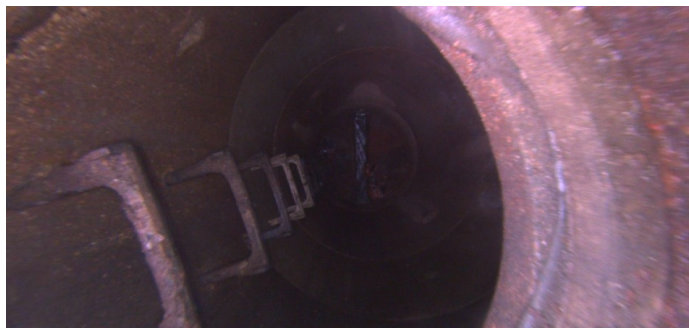
Code: **MGP**  
Description: **General Photo**

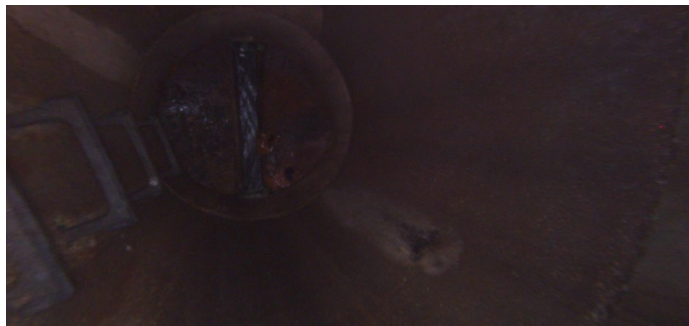
Code: **IS**  
Description: **Infil Stain**

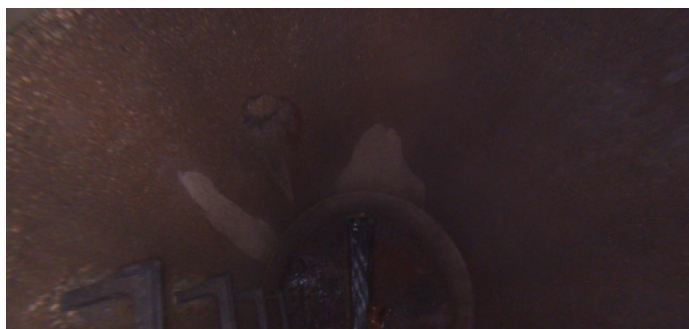
Code: **IS**  
Description: **Infil Stain**

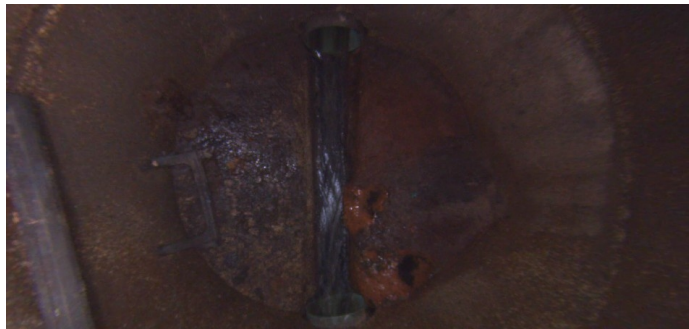
Code: **DSF**  
Description: **Deposits Settled Fine**

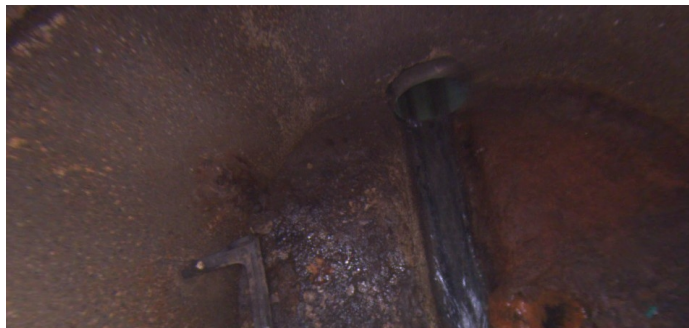
Code: **IS**  
Description: **Infil Stain**
