Manhole Inspection Report

Date:	04/06/2018	Weather:		Coding:	RZMACP
MH#:	M-607-066	Owner:	NA	Len. Surveyed:	12.8
P.O.#:		Surveyor:	John Kuglmaier	Rim to Invert:	13.1
Customer:		Cert. #:	U-1215-07002349	Wall Material:	Concrete (reinforced)

Street:	14th St. 637' West of Hwy 51.	Project:	Hobart, IN
City:	Hobart, IN	GPS Northing:	0.0
Location:		GPS Easting:	0.0
Drain Area:	Southwest	GPS Accuracy:	Nearest Meter
Cover Shape:	Circular	Evidence of Surcharge:	Yes
Cover Size:	22.5	Potential for Runoff:	None
Comments:

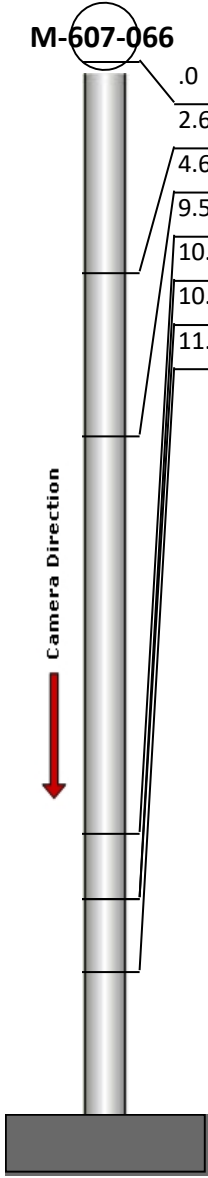
.0	MGP	General Photo	10	NA
	2.6	MGP	General Photo	29	NA
	4.6	IS	Infil Stain	47	NA
	9.5	DAZ	Deposits Attached Other	68	M 2
	10.3	IS	Infil Stain	81	NA
	10.3	IS	Infil Stain	93	NA
	11.2	MGO	General Observation	107	NA

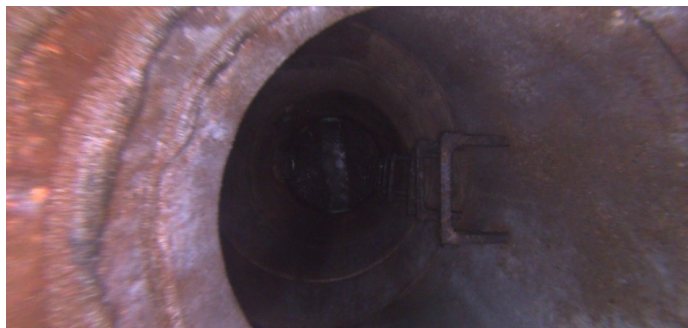
Code: **MGP**
Description: **General Photo**

Distance (ft): **.0**
Structural Grade: **0**
O&M Grade: **0**
Clock Start/From:
Clock To:
1st Value:
2nd Value:
Value Percent:
Step: **NO**
Remarks:

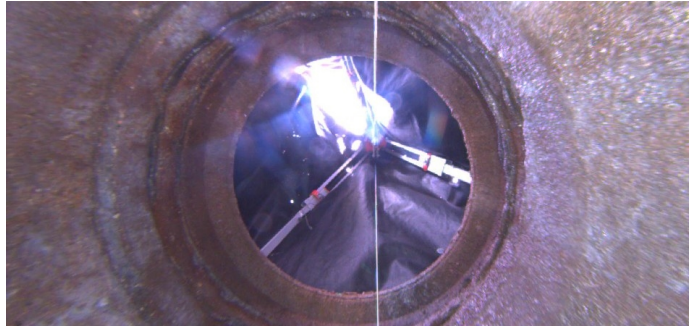
Code: **MGP**
Description: **General Photo**

Distance (ft): **2.6**
Structural Grade: **0**
O&M Grade: **0**
Clock Start/From:
Clock To:
1st Value:
2nd Value:
Value Percent:
Step: **NO**
Remarks:

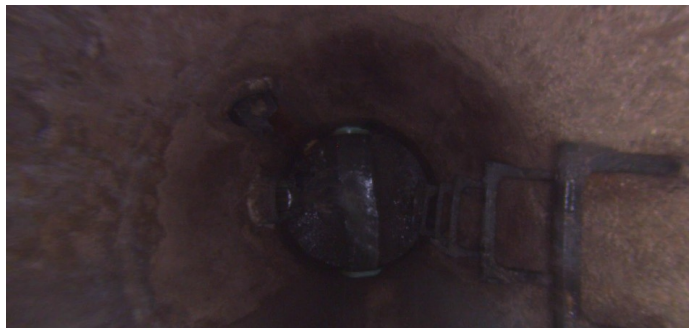
Code: **IS**
Description: **Infil Stain**

Distance (ft): **4.6**
Structural Grade: **0**
O&M Grade: **0**
Clock Start/From: **11**
Clock To: **7**
1st Value:
2nd Value:
Value Percent:
Step: **NO**
Remarks:

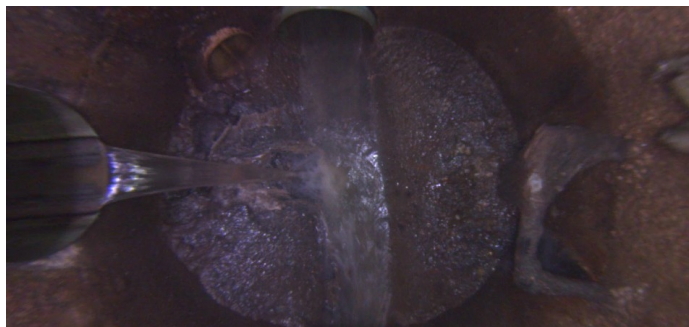
Code: **DAZ**
Description: **Deposits Attached Other**

Distance (ft): **9.5**
Structural Grade: **0**
O&M Grade: **2**
Clock Start/From: **12**
Clock To: **12**
1st Value:
2nd Value:
Value Percent: **5.000**
Step: **NO**
Remarks: **Mixed materials**

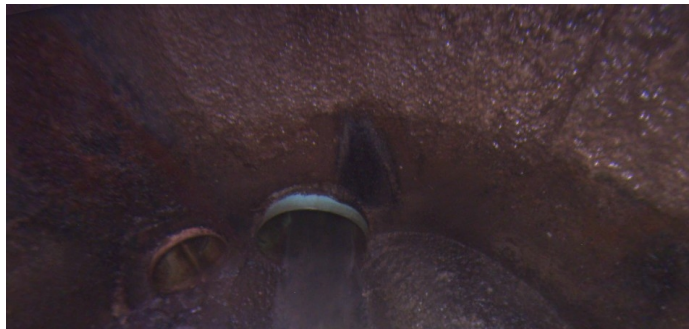
Code: **IS**
Description: **Infil Stain**

Distance (ft): **10.3**
Structural Grade: **0**
O&M Grade: **0**
Clock Start/From: **1**
Clock To:
1st Value:
2nd Value:
Value Percent:
Step: **NO**
Remarks:

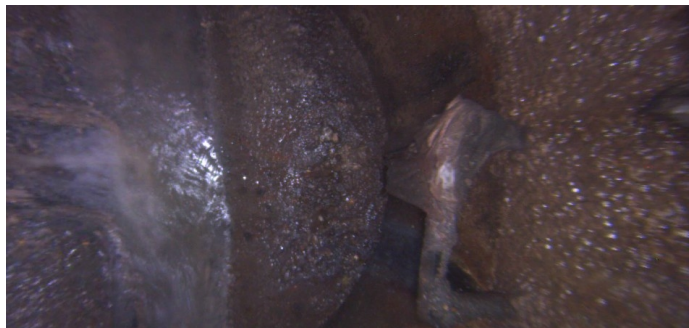
Code: **IS**
Description: **Infil Stain**

Distance (ft): **10.3**
Structural Grade: **0**
O&M Grade: **0**
Clock Start/From: **2**
Clock To: **4**
1st Value:
2nd Value:
Value Percent:
Step: **NO**
Remarks:

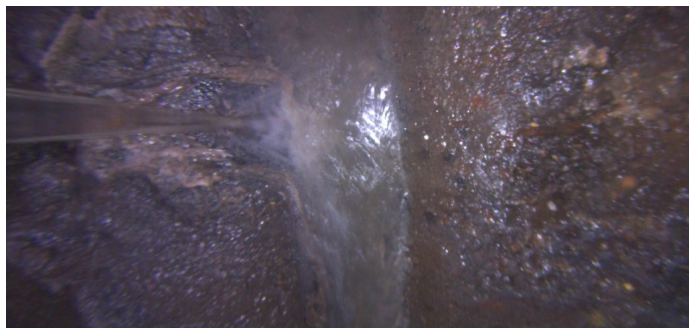
Code: **MGO**
Description: **General Observation**

Distance (ft): **11.2**
Structural Grade: **0**
O&M Grade: **0**
Clock Start/From:
Clock To:
1st Value:
2nd Value:
Value Percent:
Step: **NO**
Remarks: **Ins. Comp.**
