Manhole Inspection Report

Date:	04/06/2018	Weather:		Coding:	RZMACP
MH#:	M-607-067	Owner:	NA	Len. Surveyed:	11.2
P.O.#:		Surveyor:	John Kuglmaier	Rim to Invert:	11.9
Customer:		Cert. #:	U-1215-07002349	Wall Material:	Concrete (reinforced)

Street:	On the North Side of 14th St. 267' Ea	Project:	Hobart, IN
City:	Hobart, IN	GPS Northing:	0.0
Location:		GPS Easting:	0.0
Drain Area:	Southwest	GPS Accuracy:	Nearest Meter
Cover Shape:	Circular	Evidence of Surcharge:	No
Cover Size:	22.5	Potential for Runoff:	None
Comments:

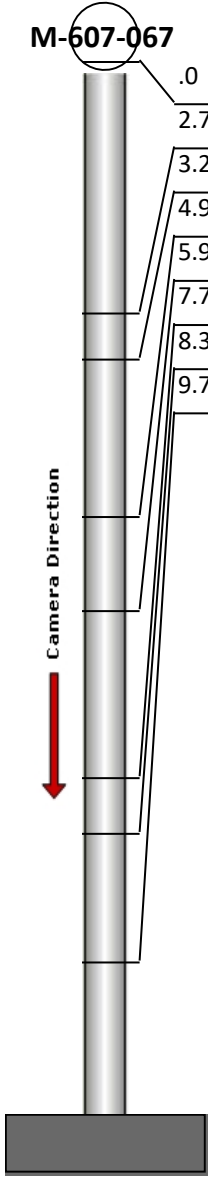
.0	MGP	General Photo	10	NA
	2.7	MGP	General Photo	29	NA
	3.2	IS	Infil Stain	44	NA
	4.9	IS	Infil Stain	59	NA
	5.9	IS	Infil Stain	73	NA
	7.7	IS	Infil Stain	88	NA
	8.3	DSF	Deposits Settled Fine	100	M 3
	9.7	MGO	General Observation	115	NA

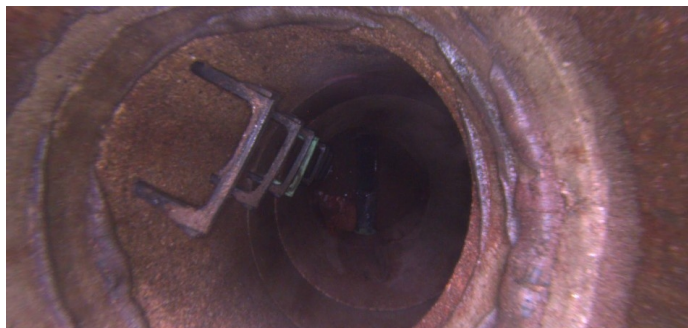
Code: **MGP**
Description: **General Photo**

Distance (ft): **.0**
Structural Grade: **0**
O&M Grade: **0**
Clock Start/From:
Clock To:
1st Value:
2nd Value:
Value Percent:
Step: **NO**
Remarks:

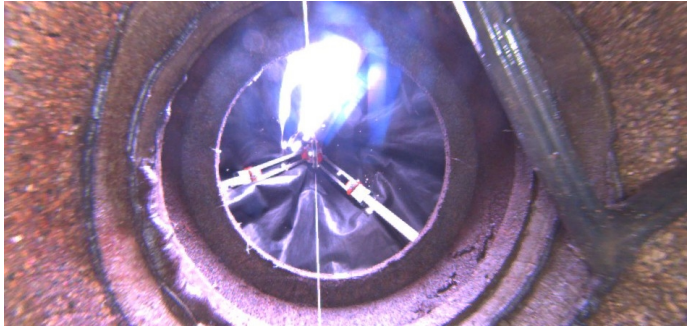
Code: **MGP**
Description: **General Photo**

Distance (ft): **2.7**
Structural Grade: **0**
O&M Grade: **0**
Clock Start/From:
Clock To:
1st Value:
2nd Value:
Value Percent:
Step: **NO**
Remarks:

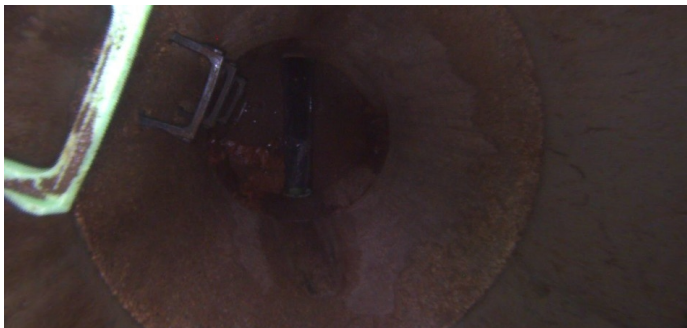
Code: **IS**
Description: **Infil Stain**

Distance (ft): **3.2**
Structural Grade: **0**
O&M Grade: **0**
Clock Start/From: **6**
Clock To:
1st Value:
2nd Value:
Value Percent:
Step: **NO**
Remarks:

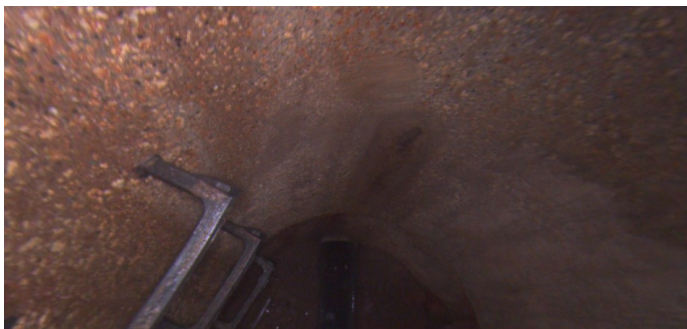
Code: **IS**
Description: **Infil Stain**

Distance (ft): **4.9**
Structural Grade: **0**
O&M Grade: **0**
Clock Start/From: **12**
Clock To:
1st Value:
2nd Value:
Value Percent:
Step: **NO**
Remarks:

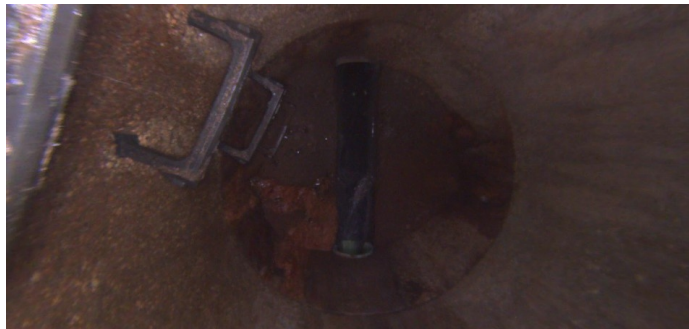
Code: **IS**
Description: **Infil Stain**

Distance (ft): **5.9**
Structural Grade: **0**
O&M Grade: **0**
Clock Start/From: **6**
Clock To: **12**
1st Value:
2nd Value:
Value Percent:
Step: **NO**
Remarks:

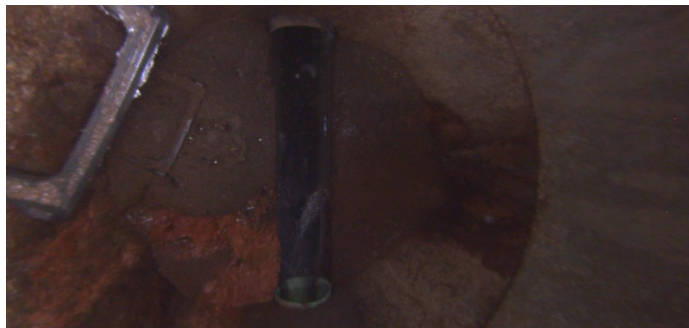
Code: **IS**
Description: **Infil Stain**

Distance (ft): **7.7**
Structural Grade: **0**
O&M Grade: **0**
Clock Start/From: **3**
Clock To: **4**
1st Value:
2nd Value:
Value Percent:
Step: **NO**
Remarks:

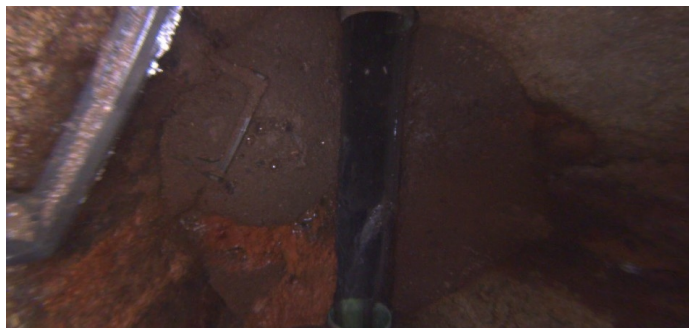
Code: **DSF**
Description: **Deposits Settled Fine**

Distance (ft): **8.3**
Structural Grade: **0**
O&M Grade: **3**
Clock Start/From: **12**
Clock To: **12**
1st Value:
2nd Value:
Value Percent: **15.000**
Step: **NO**
Remarks:

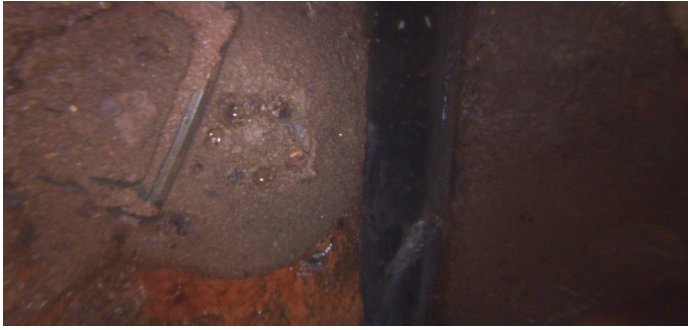
Code:	MGO
Description:	General Observation
Distance (ft):	9.7
Structural Grade:	0
O&M Grade:	0
Clock Start/From:	
Clock To:	
1st Value:	
2nd Value:	
Value Percent:	
Step:	NO
Remarks:	Ins. Comp.
