Manhole Inspection Report

Date:	04/25/2018	Weather:		Coding:	RZMACP
MH#:	M-607-076	Owner:	NA	Len. Surveyed:	6.4
P.O.#:		Surveyor:	John Kuglmaier	Rim to Invert:	6.3
Customer:	8.7	Cert. #:	U-1215-07002349	Wall Material:	Concrete (reinforced)

Street:	Laura Ct. 246' North of Laura Ln.	Project:	Hobart, IN
City:	Hobart, IN	GPS Northing:	0.0
Location:		GPS Easting:	0.0
Drain Area:	Southwest	GPS Accuracy:	Nearest Meter
Cover Shape:	Circular	Evidence of Surcharge:	Yes
Cover Size:	22.5	Potential for Runoff:	None
Comments:

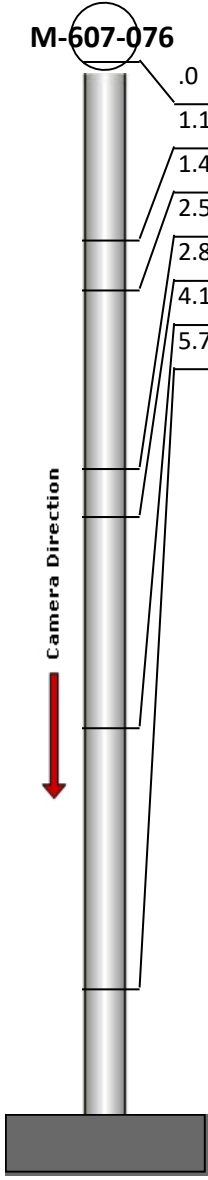
.0	MGP	General Photo	10	NA
	1.1	IS	Infil Stain	24	NA
	1.4	IS	Infil Stain	37	NA
	2.5	IS	Infil Stain	51	NA
	2.8	MGP	General Photo	65	NA
	4.1	MGO	General Observation	81	NA
	5.7	MGO	General Observation	96	NA

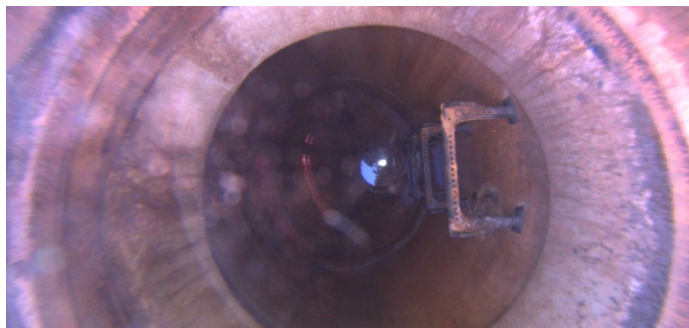
Code: **MGP**
 Description: **General Photo**

Distance (ft): **.0**
 Structural Grade: **0**
 O&M Grade: **0**
 Clock Start/From:
 Clock To:
 1st Value:
 2nd Value:
 Value Percent:
 Step: **NO**
 Remarks:

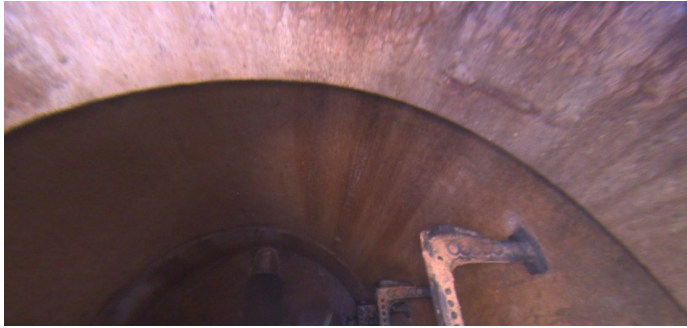
Code: **IS**
Description: **Infil Stain**

Distance (ft): **1.1**
Structural Grade: **0**
O&M Grade: **0**
Clock Start/From: **1**
Clock To: **2**
1st Value:
2nd Value:
Value Percent:
Step: **NO**
Remarks:

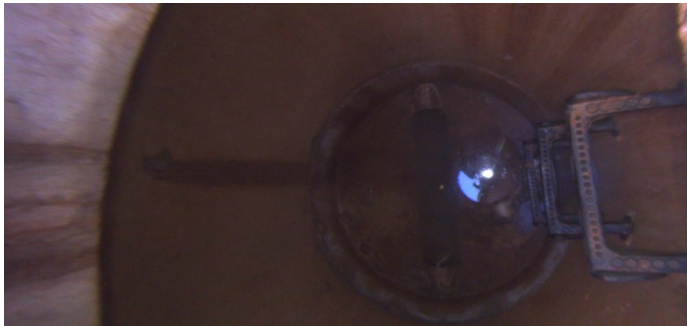
Code: **IS**
Description: **Infil Stain**

Distance (ft): **1.4**
Structural Grade: **0**
O&M Grade: **0**
Clock Start/From: **10**
Clock To:
1st Value:
2nd Value:
Value Percent:
Step: **NO**
Remarks:

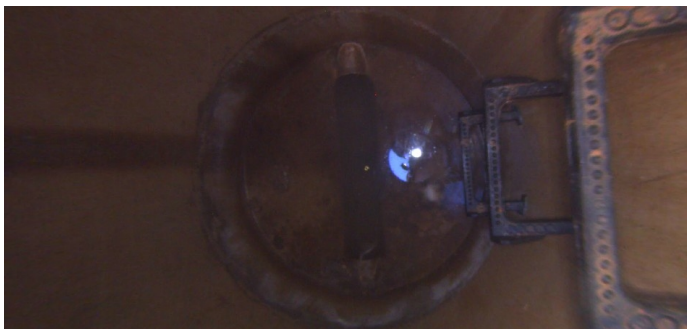
Code: **IS**
Description: **Infil Stain**

Distance (ft): **2.5**
Structural Grade: **0**
O&M Grade: **0**
Clock Start/From: **12**
Clock To: **12**
1st Value:
2nd Value:
Value Percent:
Step: **NO**
Remarks:

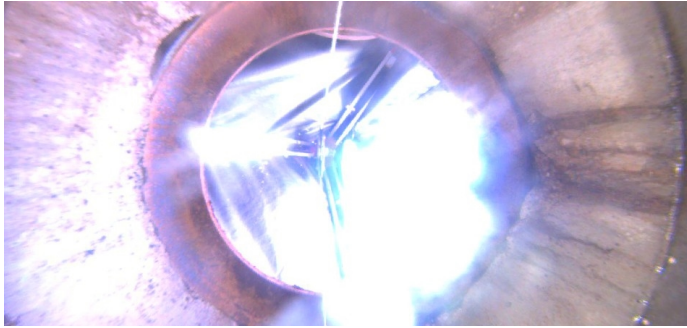
Code: **MGP**
Description: **General Photo**

Distance (ft): **2.8**
Structural Grade: **0**
O&M Grade: **0**
Clock Start/From:
Clock To:
1st Value:
2nd Value:
Value Percent:
Step: **NO**
Remarks:

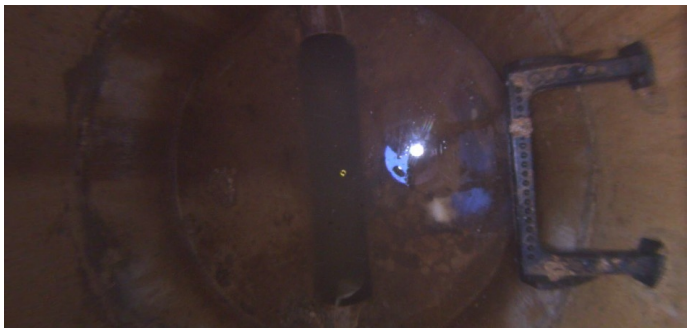
Code: **MGO**
Description: **General Observation**

Distance (ft): **4.1**
Structural Grade: **0**
O&M Grade: **0**
Clock Start/From:
Clock To:
1st Value:
2nd Value:
Value Percent:
Step: **NO**
Remarks: **Surcharge**

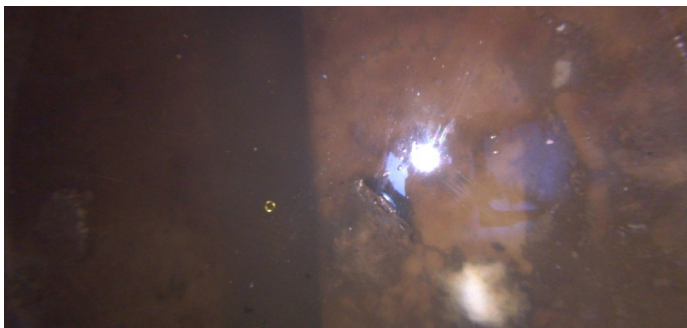
Code: **MGO**
Description: **General Observation**

Distance (ft): **5.7**
Structural Grade: **0**
O&M Grade: **0**
Clock Start/From:
Clock To:
1st Value:
2nd Value:
Value Percent:
Step: **NO**
Remarks: **Ins. Comp.**
