Manhole Inspection Report

Date:	04/08/2018	Weather:		Coding:	RZMACP
MH#:	M-608-011	Owner:	NA	Len. Surveyed:	6.6
P.O.#:		Surveyor:	John Kuglmaier	Rim to Invert:	7.1
Customer:		Cert. #:	U-1215-07002349	Wall Material:	Concrete (reinforced)

Street:	On West 61st St. 258' North of 61st	Project:	Hobart, IN
City:	Hobart, IN	GPS Northing:	2903421.878
Location:		GPS Easting:	2903421.878
Drain Area:	Southwest	GPS Accuracy:	Sub-Meter
Cover Shape:	Circular	Evidence of Surcharge:	No
Cover Size:	22.5	Potential for Runoff:	None
Comments:

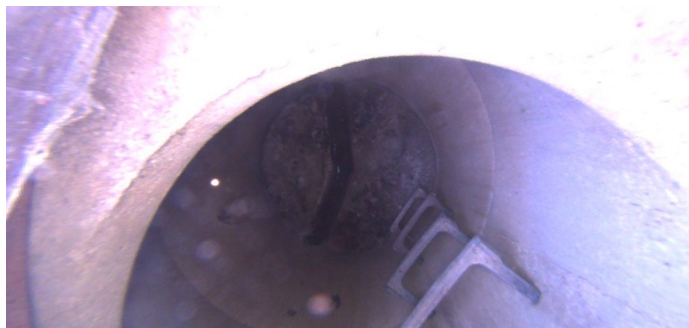
Code: **MGP**
Description: **General Photo**

Distance (ft): **.0**
Structural Grade: **0**
O&M Grade: **0**
Clock Start/From:
Clock To:
1st Value:
2nd Value:
Value Percent:
Step: **NO**
Remarks:

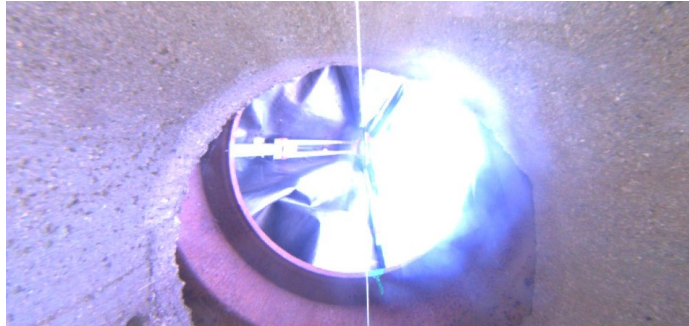
Code: **MGP**
Description: **General Photo**

Distance (ft): **2.3**
Structural Grade: **0**
O&M Grade: **0**
Clock Start/From:
Clock To:
1st Value:
2nd Value:
Value Percent:
Step: **NO**
Remarks:

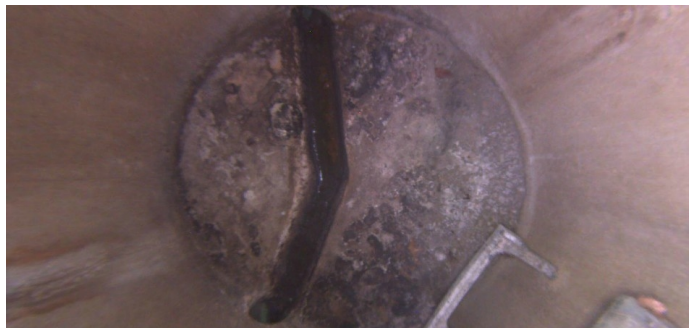
Code: **DAZ**
Description: **Deposits Attached Other**

Distance (ft): **3.4**
Structural Grade: **0**
O&M Grade: **2**
Clock Start/From: **12**
Clock To: **12**
1st Value:
2nd Value:
Value Percent: **5.000**
Step: **NO**
Remarks: **Mixed materials**

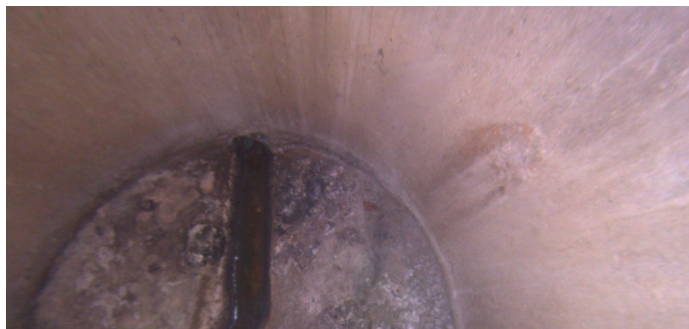
Code: **IS**
Description: **Infil Stain**

Distance (ft): **3.4**
Structural Grade: **0**
O&M Grade: **0**
Clock Start/From: **2**
Clock To:
1st Value:
2nd Value:
Value Percent:
Step: **NO**
Remarks:

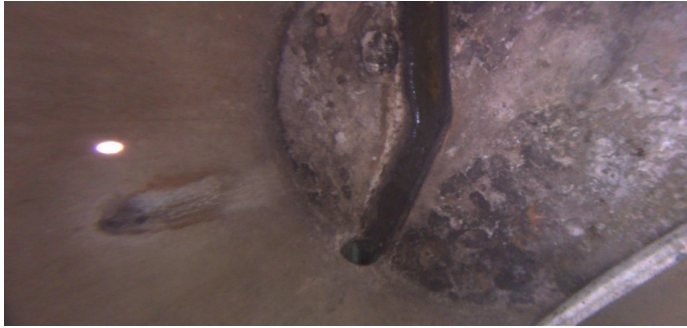
Code: **IS**
Description: **Infil Stain**

Distance (ft): **3.8**
Structural Grade: **0**
O&M Grade: **0**
Clock Start/From: **7**
Clock To:
1st Value:
2nd Value:
Value Percent:
Step: **NO**
Remarks:

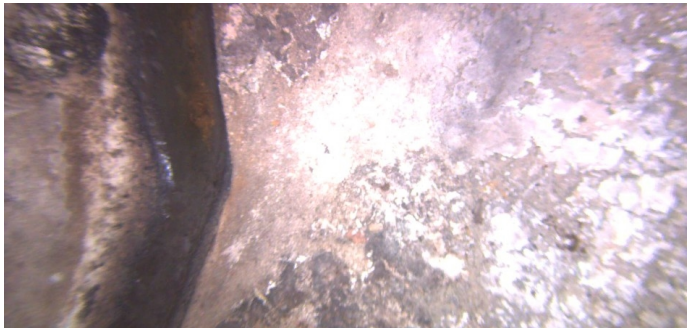
Code: **MGO**
Description: **General Observation**

Distance (ft): **5.5**
Structural Grade: **0**
O&M Grade: **0**
Clock Start/From:
Clock To:
1st Value:
2nd Value:
Value Percent:
Step: **NO**
Remarks: **Ins. Comp.**
