Manhole Inspection Report

Date:	04/08/2018	Weather:		Coding:	RZMACP
MH#:	M-608-015	Owner:	NA	Len. Surveyed:	9.4
P.O.#:		Surveyor:	John Kuglmaier	Rim to Invert:	9.9
Customer:		Cert. #:	U-1215-07002349	Wall Material:	Concrete (reinforced)

Street:	On West 61st St. 124' North of 15th	Project:	Hobart, IN
City:	Hobart, IN	GPS Northing:	2903318.999
Location:		GPS Easting:	2903318.999
Drain Area:	Southwest	GPS Accuracy:	Sub-Meter
Cover Shape:	Circular	Evidence of Surcharge:	Yes
Cover Size:	22.5	Potential for Runoff:	None
Comments:	IN A BUSH

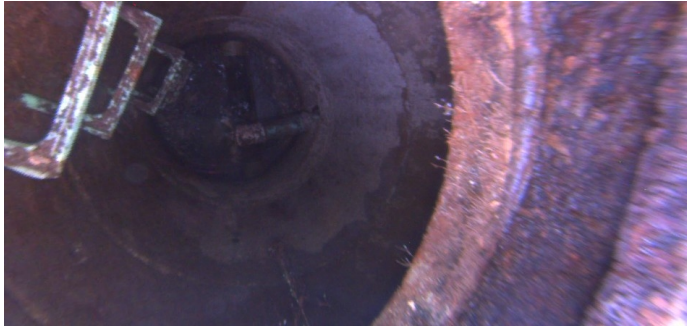
Code:	MGP
Description:	General Photo

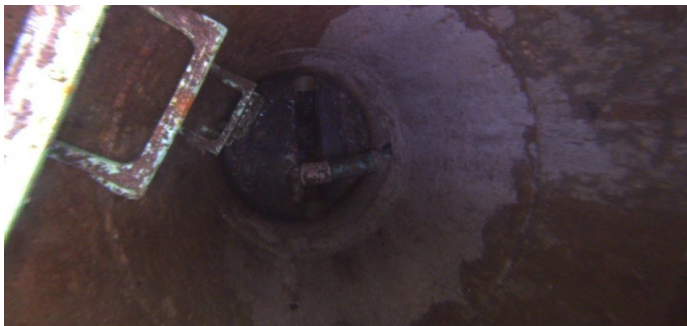
Code: **RFJ**
Description: **Roots Fine Joint**

Distance (ft): **.0**
Structural Grade: **0**
O&M Grade: **1**
Clock Start/From: **4**
Clock To:
1st Value:
2nd Value:
Value Percent:
Step: **NO**
Remarks:

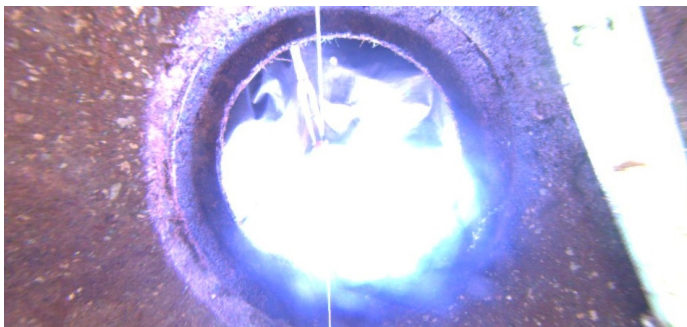
Code: **DAGS**
Description: **Deposits Attached Grease**

Distance (ft): **1.1**
Structural Grade: **0**
O&M Grade: **2**
Clock Start/From: **1**
Clock To: **8**
1st Value:
2nd Value:
Value Percent: **5.000**
Step: **NO**
Remarks:

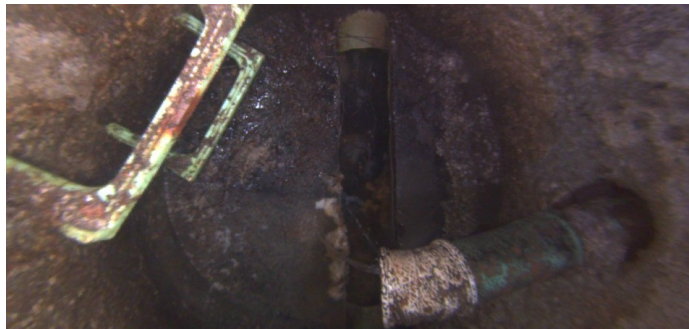
Code: **MGP**
Description: **General Photo**

Distance (ft): **2.4**
Structural Grade: **0**
O&M Grade: **0**
Clock Start/From:
Clock To:
1st Value:
2nd Value:
Value Percent:
Step: **NO**
Remarks:

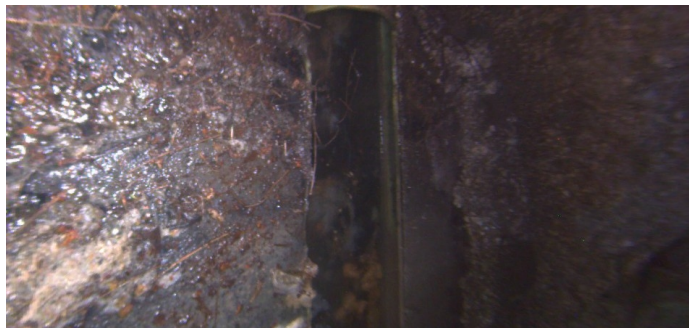
Code:	DAZ
Description:	Deposits Attached Other
Distance (ft):	6.3
Structural Grade:	0
O&M Grade:	2
Clock Start/From:	12
Clock To:	12
1st Value:	
2nd Value:	
Value Percent:	10.000
Step:	NO
Remarks:	Mixed materials
