# Manhole Inspection Report

Date:	04/08/2018	Weather:		Coding:	RZMACP
MH#:	M-608-018	Owner:	NA	Len. Surveyed:	3.9
P.O.#:		Surveyor:	John Kuglmaier	Rim to Invert:	4.2
Customer:		Cert. #:	U-1215-07002349	Wall Material:	Concrete (reinforced)

Street:	395' North of 61st Ave. 447' East of	Project:	Hobart, IN
City:	Hobart, IN	GPS Northing:	2903820.847
Location:		GPS Easting:	2903820.847
Drain Area:	Southwest	GPS Accuracy:	Sub-Meter
Cover Shape:	Circular	Evidence of Surcharge:	Yes
Cover Size:	22.5	Potential for Runoff:	None
Comments:

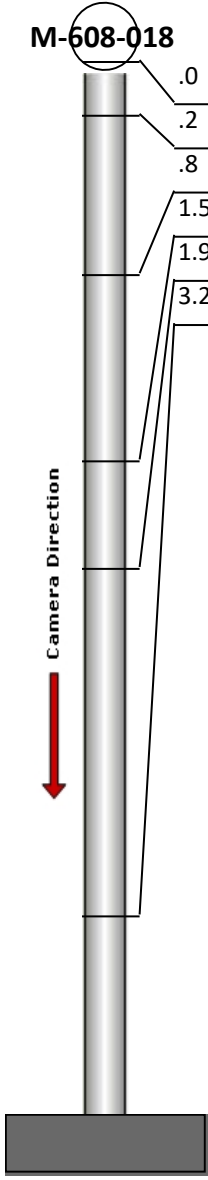
.0	MGP	General Photo	10	NA
	.2	IS	Infil Stain	22	NA
	.8	DAZ	Deposits Attached Other	35	M 3
	1.5	MGO	General Observation	48	NA
	1.9	MGP	General Photo	62	NA
	3.2	MGO	General Observation	79	NA

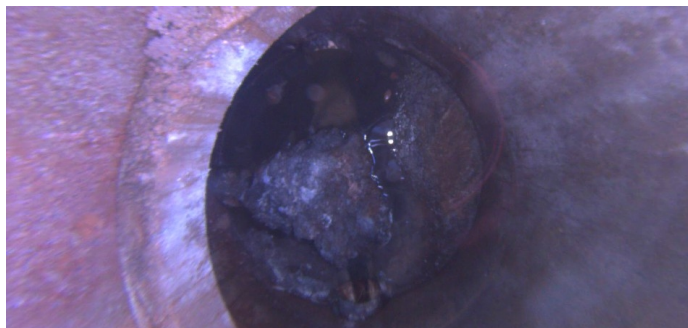
Code: **MGP**  
Description: **General Photo**

Distance (ft): **.0**  
Structural Grade: **0**  
O&M Grade: **0**  
Clock Start/From:  
Clock To:  
1st Value:  
2nd Value:  
Value Percent:  
Step: **NO**  
Remarks:

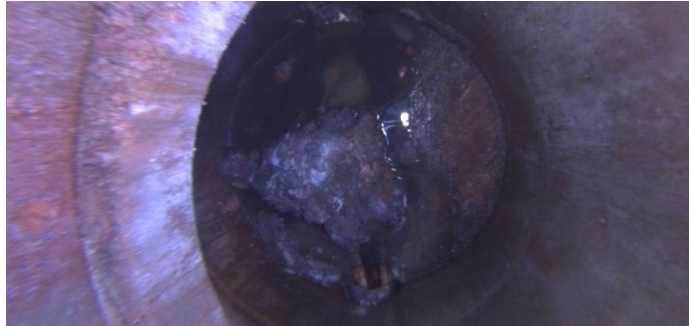
Code: **IS**  
Description: **Infil Stain**

Distance (ft): **.2**  
Structural Grade: **0**  
O&M Grade: **0**  
Clock Start/From: **12**  
Clock To: **12**  
1st Value:  
2nd Value:  
Value Percent:  
Step: **NO**  
Remarks:

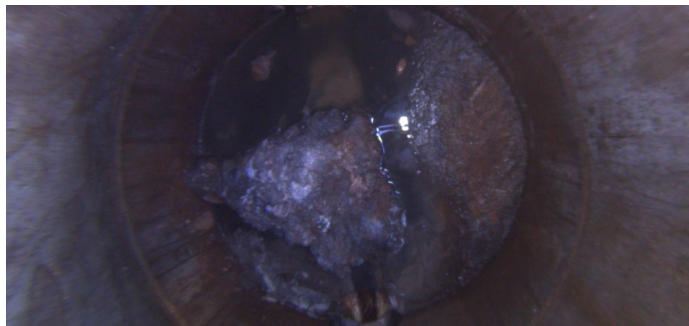
Code: **DAZ**  
Description: **Deposits Attached Other**

Distance (ft): **.8**  
Structural Grade: **0**  
O&M Grade: **3**  
Clock Start/From: **12**  
Clock To: **12**  
1st Value:  
2nd Value:  
Value Percent: **20.000**  
Step: **NO**  
Remarks: **Mixed materials**

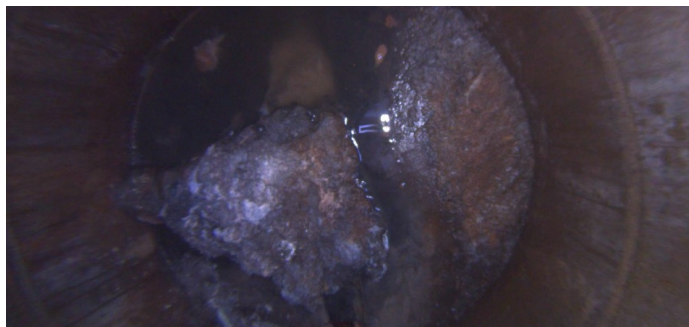
Code: **MGO**  
Description: **General Observation**

Distance (ft): **1.5**  
Structural Grade: **0**  
O&M Grade: **0**  
Clock Start/From:  
Clock To:  
1st Value:  
2nd Value:  
Value Percent:  
Step: **NO**  
Remarks: **Surcharge**

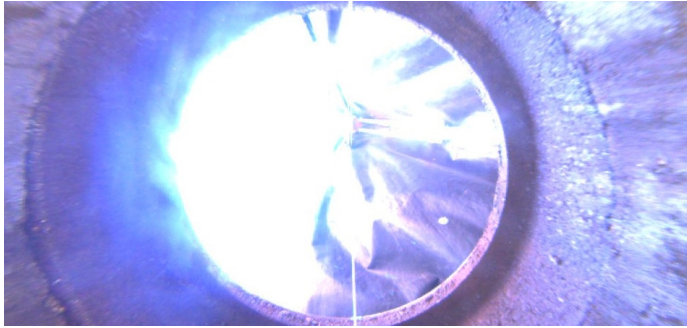
Code: **MGP**  
Description: **General Photo**

Distance (ft): **1.9**  
Structural Grade: **0**  
O&M Grade: **0**  
Clock Start/From:  
Clock To:  
1st Value:  
2nd Value:  
Value Percent:  
Step: **NO**  
Remarks:

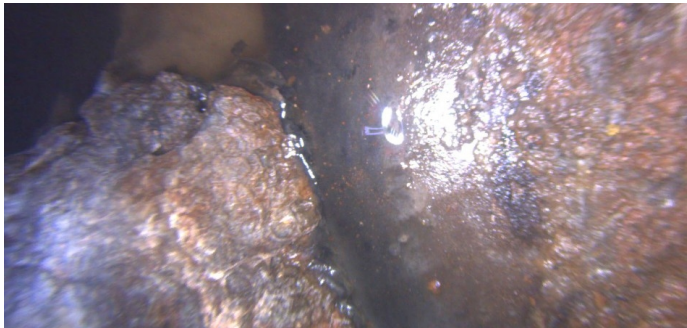
Code: **MGO**  
Description: **General Observation**

Distance (ft): **3.2**  
Structural Grade: **0**  
O&M Grade: **0**  
Clock Start/From:  
Clock To:  
1st Value:  
2nd Value:  
Value Percent:  
Step: **NO**  
Remarks: **Ins. Comp.**
