Manhole Inspection Report

Date:	09/20/2022	Weather:		Coding:	RZMACP
MH#:	M-608-027	Owner:	NA	Len. Surveyed:	10.3
P.O.#:		Surveyor:	Jen Costello	Rim to Invert:	11.6
Customer:		Cert. #:	U-907-5518	Wall Material:	Concrete (cast in place)

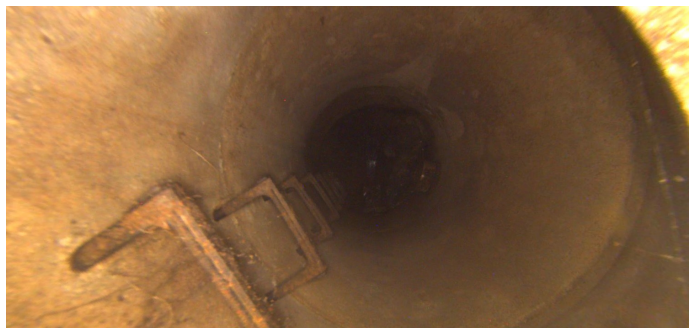
Code: **MGO**
Description: **General Observation**

Distance (ft): **.0**
Structural Grade: **0**
O&M Grade: **0**
Clock Start/From:
Clock To:
1st Value:
2nd Value:
Value Percent:
Step: **NO**
Remarks: **access mh**

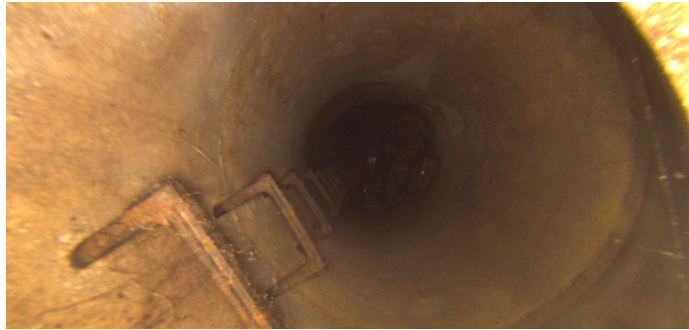
Code: **SRI**
Description: **Surface Roughness Increased**

Distance (ft): **.0**
Structural Grade: **1**
O&M Grade: **0**
Clock Start/From: **12**
Clock To: **12**
1st Value:
2nd Value:
Value Percent:
Step: **NO**
Remarks:

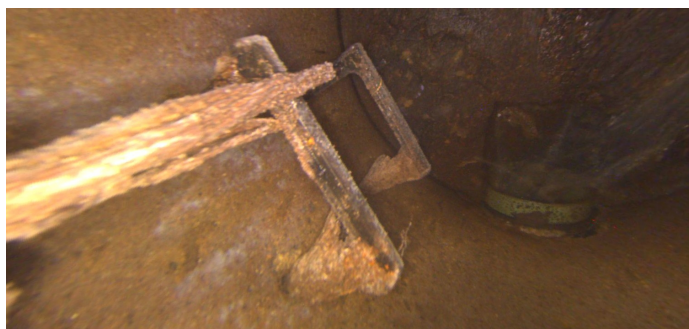
Code: **DAR**
Description: **Deposits Attached Ragging**

Distance (ft): **7.8**
Structural Grade: **0**
O&M Grade: **2**
Clock Start/From: **8**
Clock To: **9**
1st Value:
2nd Value:
Value Percent: **5.000**
Step: **YES**
Remarks:

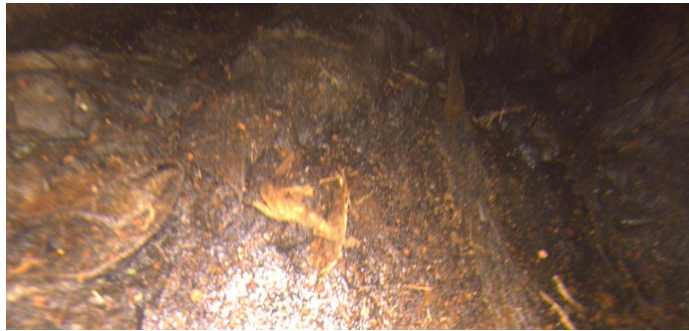
Code: **DSF**
Description: **Deposits Settled Fine**

Distance (ft): **10.0**
Structural Grade: **0**
O&M Grade: **2**
Clock Start/From: **12**
Clock To: **12**
1st Value:
2nd Value:
Value Percent: **5.000**
Step: **NO**
Remarks:

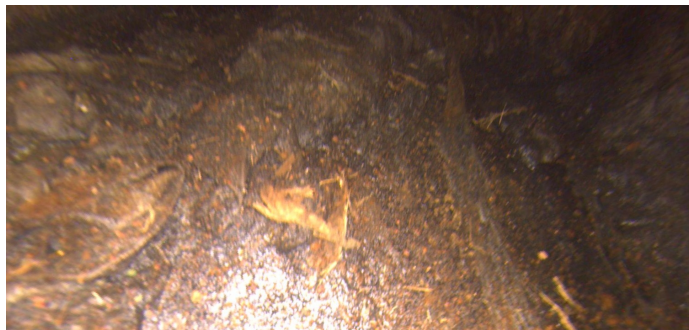
Code: **SRI**
Description: **Surface Roughness Increased**

Distance (ft): **10.0**
Structural Grade: **1**
O&M Grade: **0**
Clock Start/From: **12**
Clock To: **12**
1st Value:
2nd Value:
Value Percent:
Step: **NO**
Remarks:

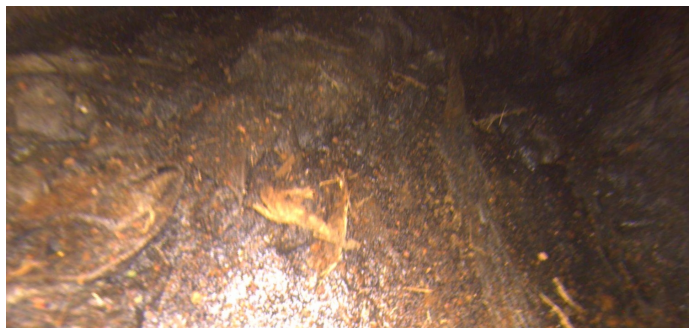
Code: **MGO**
Description: **General Observation**

Distance (ft): **10.0**
Structural Grade: **0**
O&M Grade: **0**
Clock Start/From:
Clock To:
1st Value:
2nd Value:
Value Percent:
Step: **NO**
Remarks: **end of survey**
