# Manhole Inspection Report

Position	Code	Observation	Video (sec)	Grade

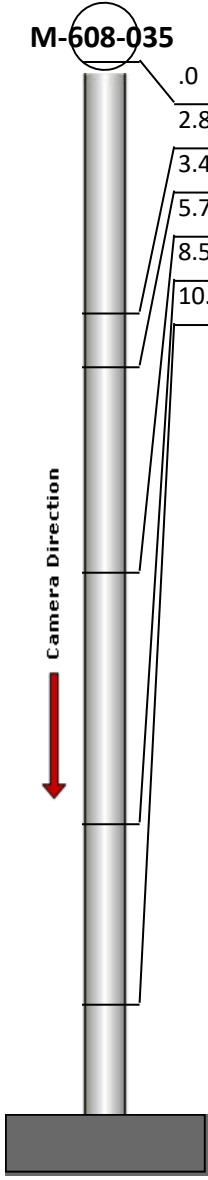
0.0	MGP	General Photo	10	NA
	2.8	MGP	General Photo	29	NA
	3.4	IS	Infil Stain	44	NA
	5.7	IS	Infil Stain	61	NA
	8.5	DSF	Deposits Settled Fine	78	M 2
	10.5	MGO	General Observation	94	NA

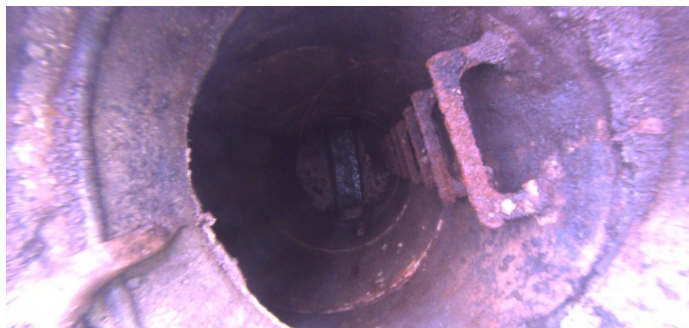
Code: **MGP**  
Description: **General Photo**

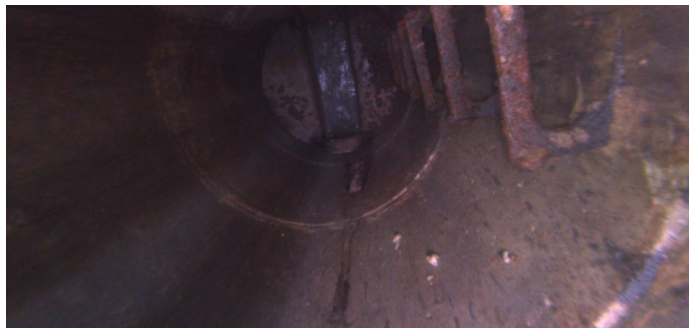
Code: **IS**  
Description: **Infil Stain**

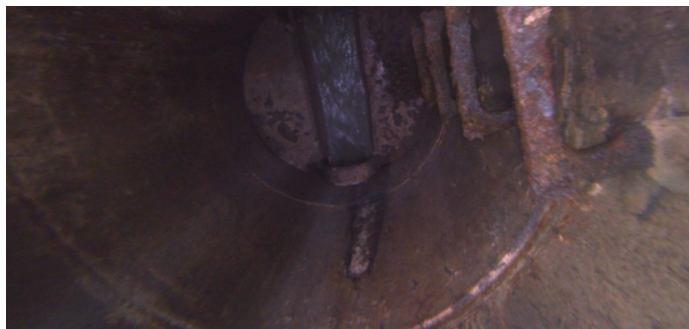
Code: **IS**  
Description: **Infil Stain**

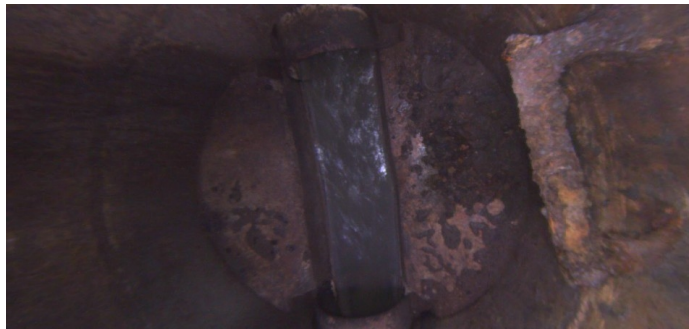
Code:	<b>DSF</b>
Description:	<b>Deposits Settled Fine</b>
Distance (ft):	<b>8.5</b>
Structural Grade:	<b>0</b>
O&M Grade:	<b>2</b>
Clock Start/From:	<b>1</b>
Clock To:	<b>5</b>
1st Value:	
2nd Value:	
Value Percent:	<b>10.000</b>
Step:	<b>NO</b>
Remarks:
