# Manhole Inspection Report

Date:	<b>04/04/2018</b>	Weather:		Coding:	<b>RZMACP</b>
MH#:	<b>M-608-041</b>	Owner:	<b>NA</b>	Len. Surveyed:	<b>7.3</b>
P.O.#:		Surveyor:	<b>John Kuglmaier</b>	Rim to Invert:	<b>8.0</b>
Customer:		Cert. #:	<b>U-1215-07002349</b>	Wall Material:	<b>Concrete (reinforced)</b>

Street:	<b>On Washington St. 361' South of 14t</b>	Project:	<b>Hobart, IN</b>
City:	<b>Hobart, IN</b>	GPS Northing:	<b>0.0</b>
Location:		GPS Easting:	<b>0.0</b>
Drain Area:	<b>Southwest</b>	GPS Accuracy:	<b>Nearest Meter</b>
Cover Shape:	<b>Circular</b>	Evidence of Surcharge:	<b>No</b>
Cover Size:	<b>22.5</b>	Potential for Runoff:	<b>None</b>
Comments:

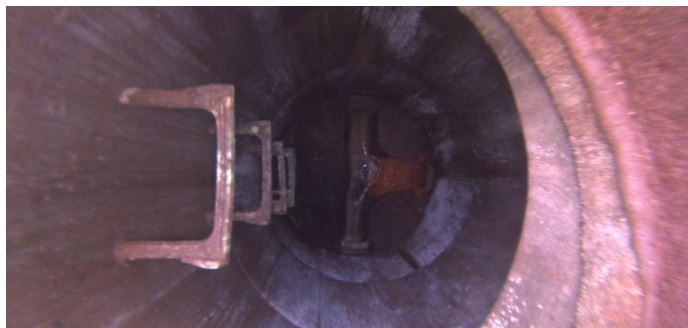
Code: **MGP**

Description: **General Photo**

Distance (ft): **.0**

Structural Grade: **0**

O&M Grade: **0**

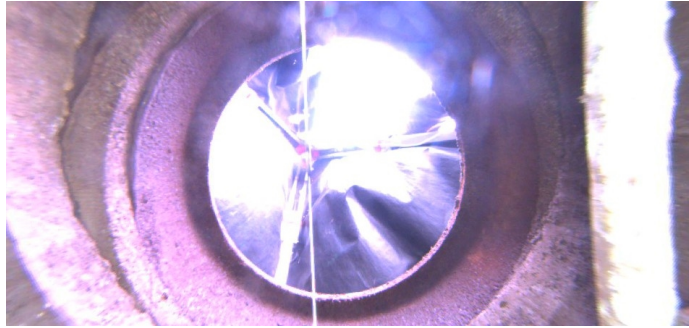
Code:	<b>MGP</b>
Description:	<b>General Photo</b>
Distance (ft):	<b>2.3</b>
Structural Grade:	<b>0</b>
O&M Grade:	<b>0</b>
Clock Start/From:	
Clock To:	
1st Value:	
2nd Value:	
Value Percent:	
Step:	<b>NO</b>
Remarks:

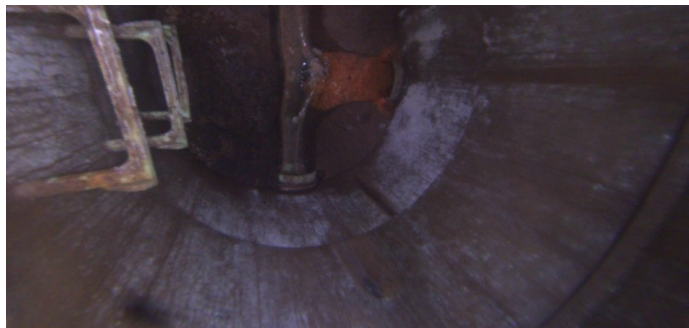
Code:	<b>IS</b>
Description:	<b>Infil Stain</b>
Distance (ft):	<b>2.4</b>
Structural Grade:	<b>0</b>
O&M Grade:	<b>0</b>
Clock Start/From:	<b>6</b>
Clock To:	
1st Value:	
2nd Value:	
Value Percent:	
Step:	<b>NO</b>
Remarks:

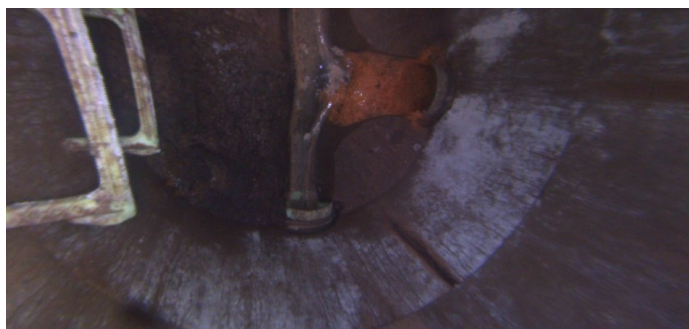
Code:	<b>IS</b>
Description:	<b>Infil Stain</b>
Distance (ft):	<b>3.8</b>
Structural Grade:	<b>0</b>
O&M Grade:	<b>0</b>
Clock Start/From:	<b>5</b>
Clock To:	
1st Value:	
2nd Value:	
Value Percent:	
Step:	<b>NO</b>
Remarks:

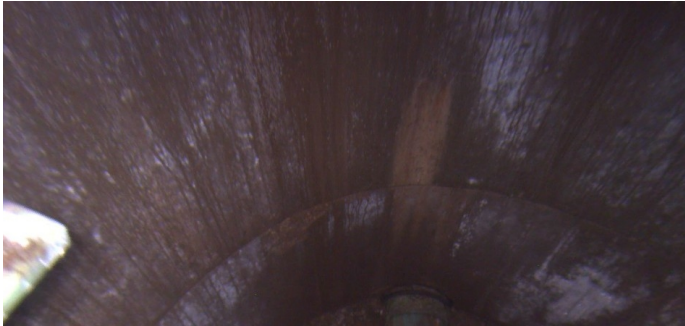
Code: **IS**  
Description: **Infil Stain**

Distance (ft): **3.8**  
Structural Grade: **0**  
O&M Grade: **0**  
Clock Start/From: **12**  
Clock To:  
1st Value:  
2nd Value:  
Value Percent:  
Step: **NO**  
Remarks:

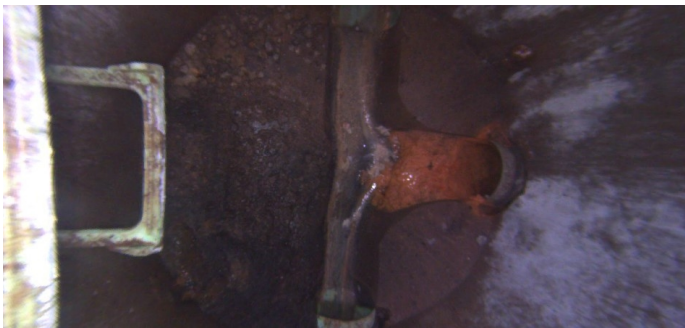
Code: **DAZ**  
Description: **Deposits Attached Other**

Distance (ft): **4.4**  
Structural Grade: **0**  
O&M Grade: **2**  
Clock Start/From: **6**  
Clock To: **12**  
1st Value:  
2nd Value:  
Value Percent: **5.000**  
Step: **NO**  
Remarks: **Mixed materials**

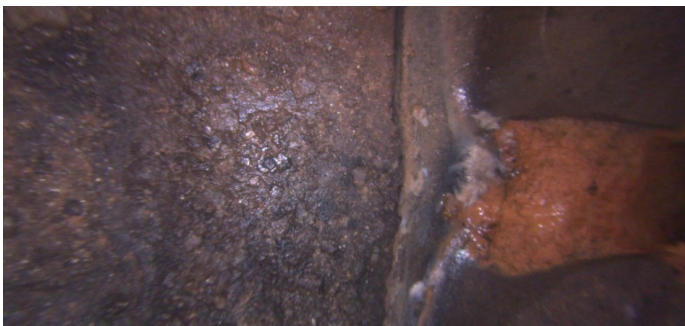
Code: **MGO**  
Description: **General Observation**

Distance (ft): **6.1**  
Structural Grade: **0**  
O&M Grade: **0**  
Clock Start/From:  
Clock To:  
1st Value:  
2nd Value:  
Value Percent:  
Step: **NO**  
Remarks: **Ins. Comp.**
