Manhole Inspection Report

Date:	10/07/2022	Weather:		Coding:	RZMACP
MH#:	M-703-011	Owner:	NA	Len. Surveyed:	3.3
P.O.#:		Surveyor:	Jen Costello	Rim to Invert:	4.9
Customer:		Cert. #:	U-907-5518	Wall Material:	Concrete (cast in place)

Street:	Pheasant Run Dr. at the East End.	Project:	Hobart, IN
City:	Hobart, IN	GPS Northing:	2294194.34
Location:	Other	GPS Easting:	2906912.477
Drain Area:	North	GPS Accuracy:	Sub-Meter
Cover Shape:	Circular	Evidence of Surcharge:	No
Cover Size:	24.0	Potential for Runoff:	None
Comments:

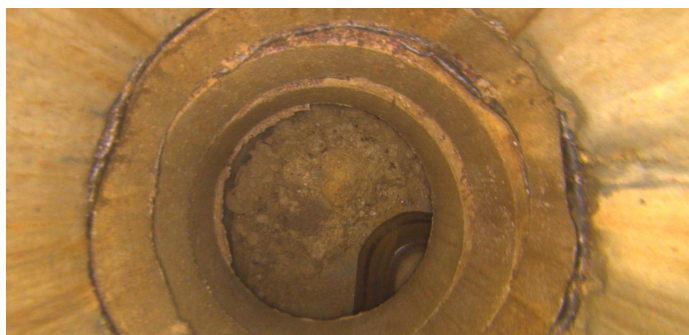
Code: **MGO**
Description: **General Observation**

Distance (ft): **.0**
Structural Grade: **0**
O&M Grade: **0**
Clock Start/From:
Clock To:
1st Value:
2nd Value:
Value Percent:
Step: **NO**
Remarks: **access mh**

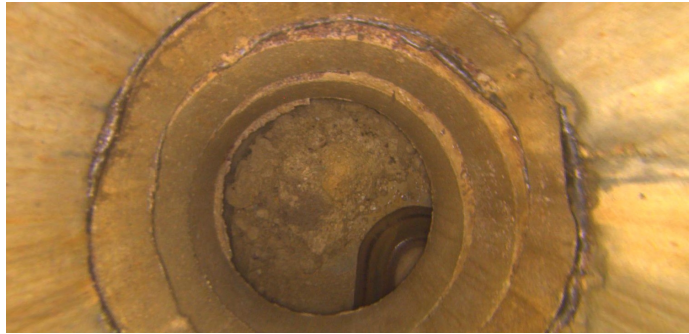
Code: **SRI**
Description: **Surface Roughness Increased**

Distance (ft): **.0**
Structural Grade: **1**
O&M Grade: **0**
Clock Start/From: **12**
Clock To: **12**
1st Value:
2nd Value:
Value Percent:
Step: **NO**
Remarks:

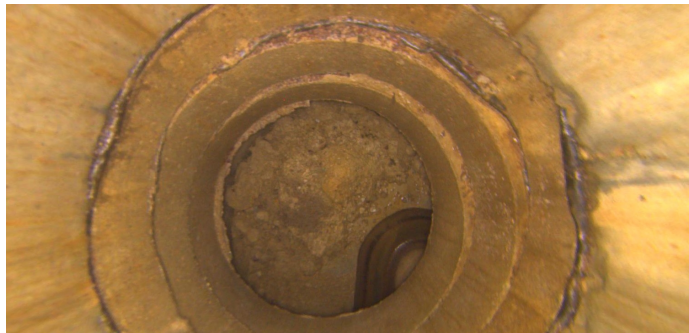
Code: **ISGT**
Description: **Intruding Sealing Grout**

Distance (ft): **.0**
Structural Grade: **0**
O&M Grade: **2**
Clock Start/From: **12**
Clock To: **12**
1st Value:
2nd Value:
Value Percent: **5.000**
Step: **NO**
Remarks:

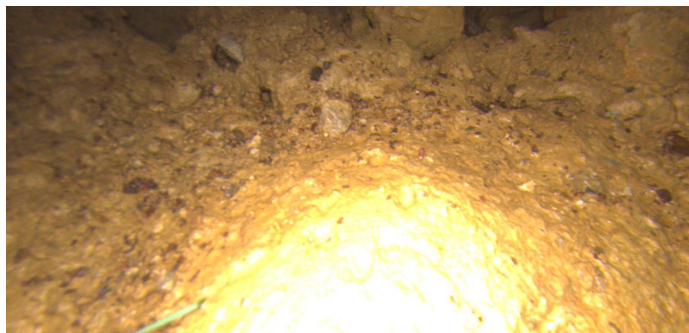
Code: **DSF**
Description: **Deposits Settled Fine**

Distance (ft): **3.3**
Structural Grade: **0**
O&M Grade: **2**
Clock Start/From: **12**
Clock To: **12**
1st Value:
2nd Value:
Value Percent: **10.000**
Step: **NO**
Remarks:

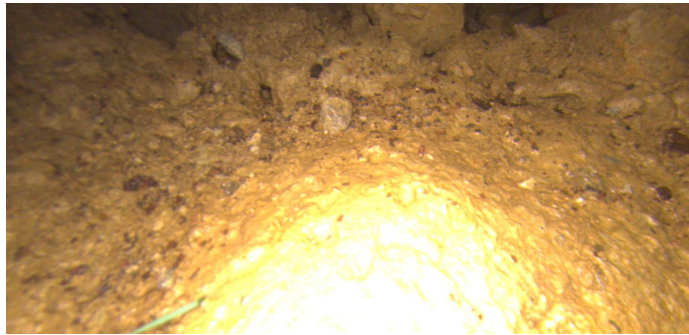
Code: **MGO**
Description: **General Observation**

Distance (ft): **3.3**
Structural Grade: **0**
O&M Grade: **0**
Clock Start/From:
Clock To:
1st Value:
2nd Value:
Value Percent:
Step: **NO**
Remarks: **end of survey**

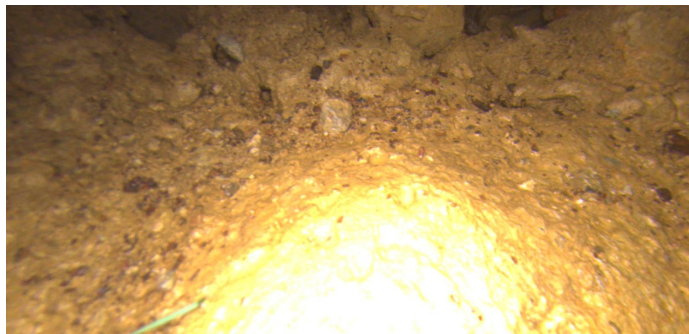
Code: **SRI**
Description: **Surface Roughness Increased**

Distance (ft): **3.3**
Structural Grade: **1**
O&M Grade: **0**
Clock Start/From: **12**
Clock To: **12**
1st Value:
2nd Value:
Value Percent:
Step: **NO**
Remarks:
