Manhole Inspection Report

Date:	03/26/2018	Weather:		Coding:	RZMACP
MH#:	M-703-032	Owner:	NA	Len. Surveyed:	6.7
P.O.#:		Surveyor:	John Kuglmaier	Rim to Invert:	9.0
Customer:		Cert. #:	U-1215-07002349	Wall Material:	Concrete (reinforced)

Street:	Manor Drive (Private) 248' South of	Project:	Hobart, IN
City:	Hobart, IN	GPS Northing:	0.0
Location:		GPS Easting:	0.0
Drain Area:	North	GPS Accuracy:	Nearest Meter
Cover Shape:	Circular	Evidence of Surcharge:	No
Cover Size:	23.0	Potential for Runoff:	None
Comments:

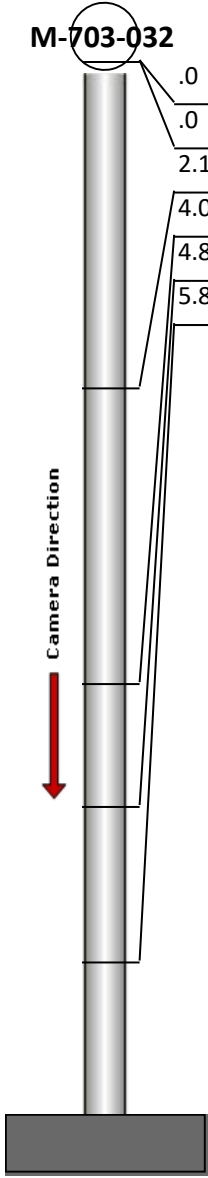
.0	MGP	General Photo	10	NA
	.0	RFJ	Roots Fine Joint	22	M 1
	2.1	MGP	General Photo	40	NA
	4.0	IW	Infil Weeper	57	M 2
	4.8	DSF	Deposits Settled Fine	70	M 2
	5.8	MGO	General Observation	83	NA

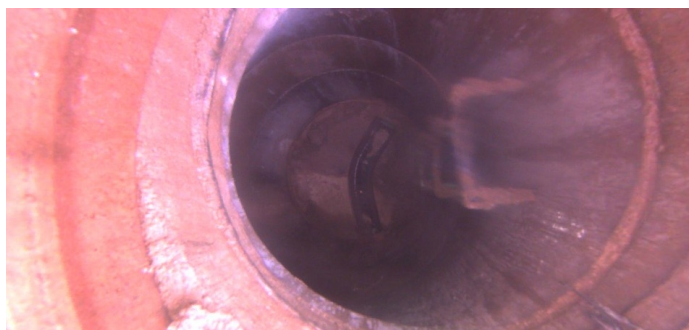
Code: **MGP**
Description: **General Photo**

Distance (ft): **.0**
Structural Grade: **0**
O&M Grade: **0**
Clock Start/From:
Clock To:
1st Value:
2nd Value:
Value Percent:
Step: **NO**
Remarks:

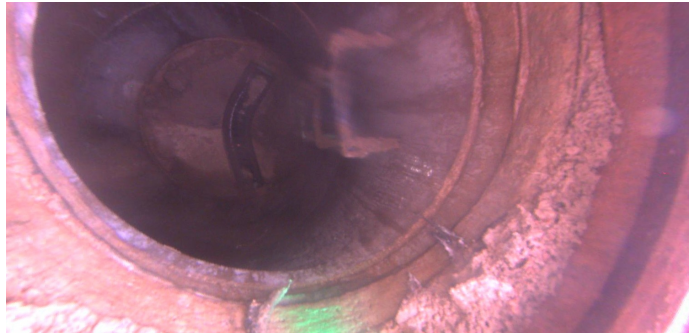
Code:	RFJ
Description:	Roots Fine Joint
Distance (ft):	.0
Structural Grade:	0
O&M Grade:	1
Clock Start/From:	4
Clock To:	6
1st Value:	
2nd Value:	
Value Percent:	
Step:	NO
Remarks:

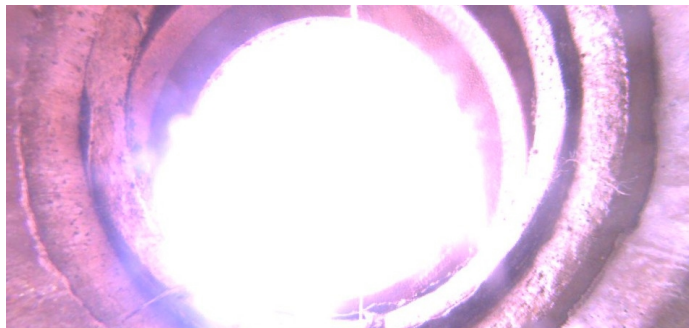
Code:	MGP
Description:	General Photo
Distance (ft):	2.1
Structural Grade:	0
O&M Grade:	0
Clock Start/From:	
Clock To:	
1st Value:	
2nd Value:	
Value Percent:	
Step:	NO
Remarks:

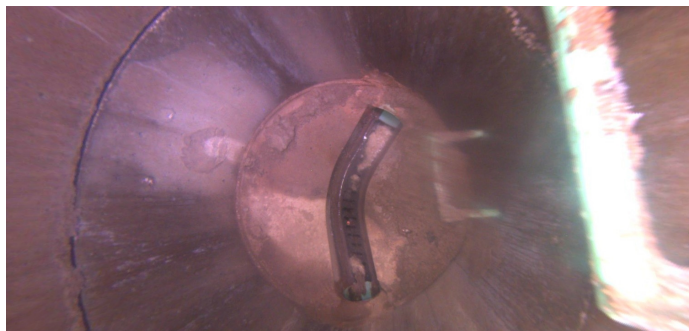
Code:	IW
Description:	Infil Weeper
Distance (ft):	4.0
Structural Grade:	0
O&M Grade:	2
Clock Start/From:	12
Clock To:	12
1st Value:	
2nd Value:	
Value Percent:	
Step:	NO
Remarks:

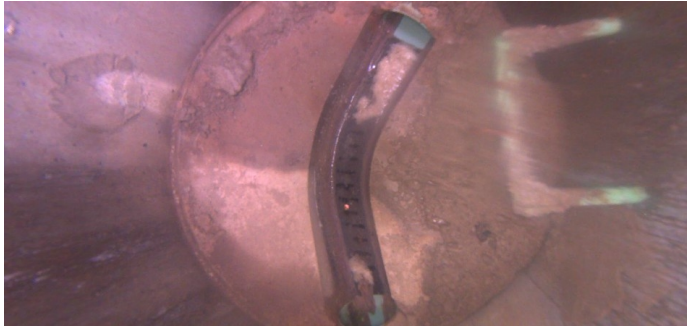
Code:	DSF
Description:	Deposits Settled Fine
Distance (ft):	4.8
Structural Grade:	0
O&M Grade:	2
Clock Start/From:	12
Clock To:	12
1st Value:	
2nd Value:	
Value Percent:	10.000
Step:	NO
Remarks:

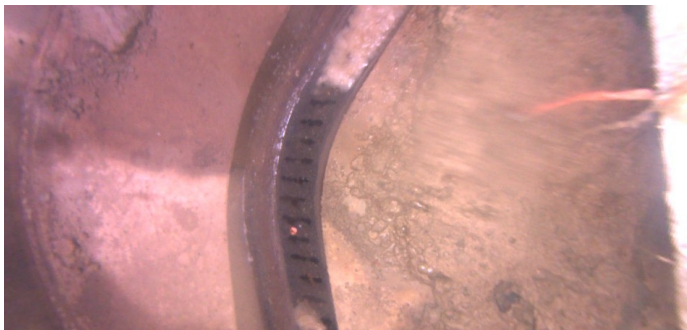
Code:	MGO
Description:	General Observation
Distance (ft):	5.8
Structural Grade:	0
O&M Grade:	0
Clock Start/From:	
Clock To:	
1st Value:	
2nd Value:	
Value Percent:	
Step:	NO
Remarks:	Ins. Comp.
