# Manhole Inspection Report

Street:	<b>Intersection of Hidden Lake Dr. and</b>	Project:	<b>Hobart, IN</b>
City:	<b>Hobart, IN</b>	GPS Northing:	<b>2293589.546</b>
Location:	<b>Other</b>	GPS Easting:	<b>2905034.205</b>
Drain Area:	<b>North</b>	GPS Accuracy:	<b>Sub-Meter</b>
Cover Shape:	<b>Circular</b>	Evidence of Surcharge:	<b>Yes</b>
Cover Size:	<b>24.0</b>	Potential for Runoff:	<b>None</b>
Comments:

**M-703-033**

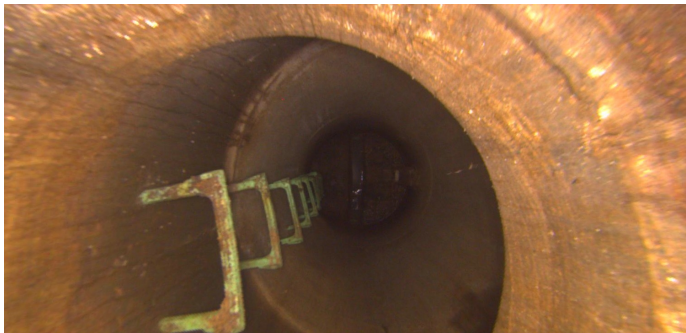
Code:	MGO
Description:	General Observation

Distance (ft):	.0
Structural Grade:	0
O&M Grade:	0
Clock Start/From:	
Clock To:	
1st Value:	
2nd Value:	
Value Percent:	
Step:	NO
Remarks:	ac

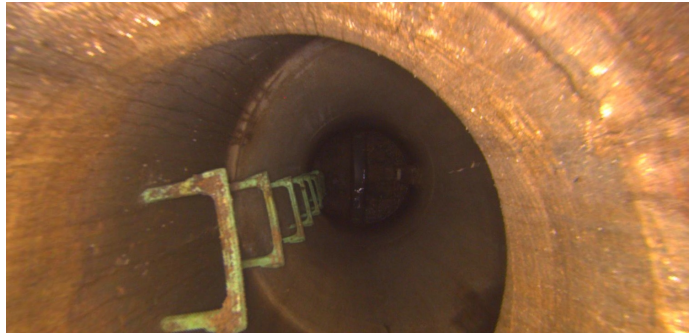
Code: **SRI**  
Description: **Surface Roughness Increased**

Distance (ft): **.0**  
Structural Grade: **1**  
O&M Grade: **0**  
Clock Start/From: **12**  
Clock To: **12**  
1st Value:  
2nd Value:  
Value Percent:  
Step: **NO**  
Remarks:

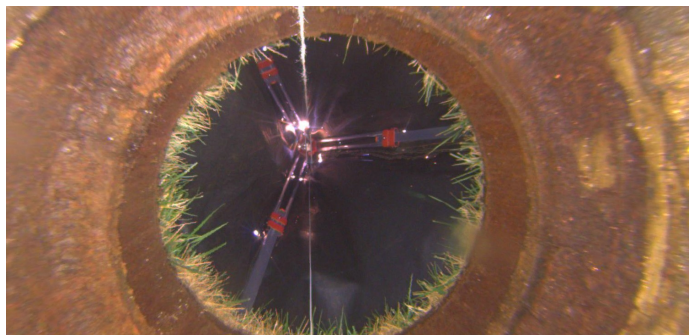
Code: **MGO**  
Description: **General Observation**

Distance (ft): **1.4**  
Structural Grade: **0**  
O&M Grade: **0**  
Clock Start/From:  
Clock To:  
1st Value:  
2nd Value:  
Value Percent:  
Step: **NO**  
Remarks: **underside of frame**

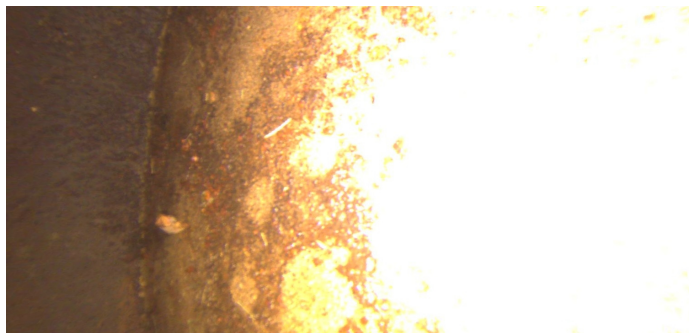
Code: **DSF**  
Description: **Deposits Settled Fine**

Distance (ft): **11.3**  
Structural Grade: **0**  
O&M Grade: **2**  
Clock Start/From: **12**  
Clock To: **12**  
1st Value:  
2nd Value:  
Value Percent: **5.000**  
Step: **NO**  
Remarks:

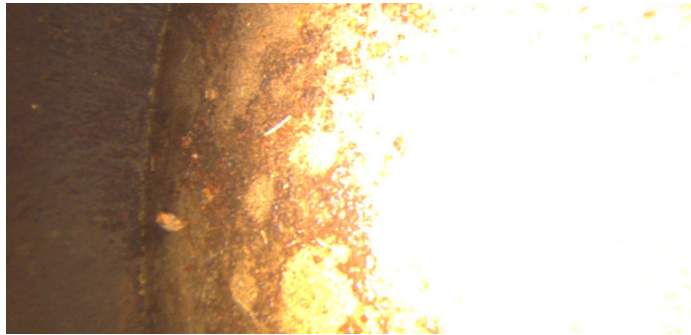
Code: **SRI**  
Description: **Surface Roughness Increased**

Distance (ft): **11.3**  
Structural Grade: **1**  
O&M Grade: **0**  
Clock Start/From: **12**  
Clock To: **12**  
1st Value:  
2nd Value:  
Value Percent:  
Step: **NO**  
Remarks:

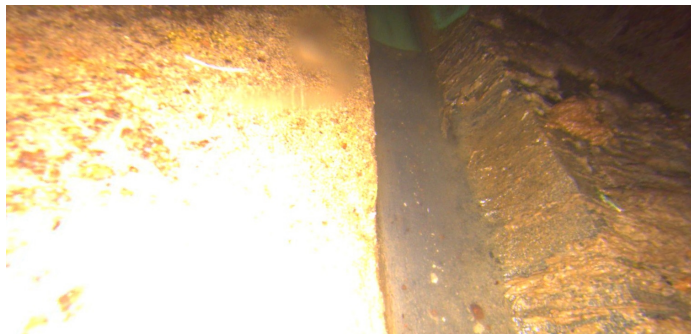
Code: **MGO**  
Description: **General Observation**

Distance (ft): **11.3**  
Structural Grade: **0**  
O&M Grade: **0**  
Clock Start/From:  
Clock To:  
1st Value:  
2nd Value:  
Value Percent:  
Step: **NO**  
Remarks: **end of survey**
