Manhole Inspection Report

Date:	10/10/2022	Weather:		Coding:	RZMACP
MH#:	M-703-041	Owner:	NA	Len. Surveyed:	2.8
P.O.#:		Surveyor:	Jen Costello	Rim to Invert:	4.0
Customer:		Cert. #:	U-907-5518	Wall Material:	Concrete (cast in place)

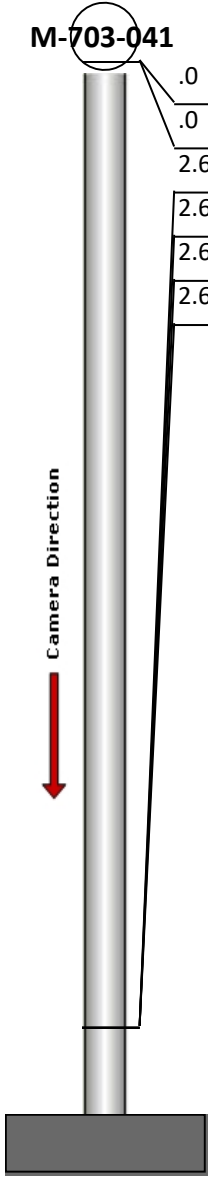
.0	MGO	General Observation	10	NA
	.0	SRI	Surface Roughness Increased	21	S 1
	2.6	DAR	Deposits Attached Ragging	38	M 3
	2.6	DSF	Deposits Settled Fine	50	M 2
	2.6	SRI	Surface Roughness Increased	61	S 1
	2.6	MGO	General Observation	72	NA

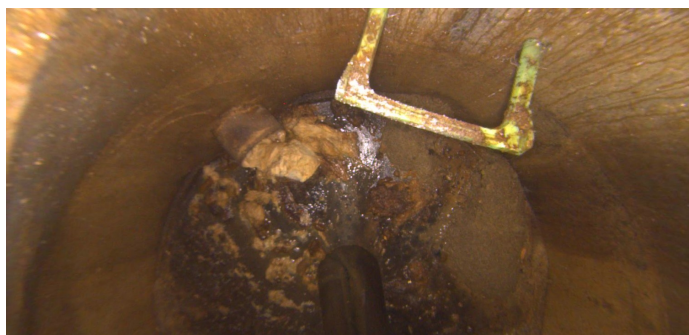
Code: **MGO**
Description: **General Observation**

Distance (ft): **.0**
Structural Grade: **0**
O&M Grade: **0**
Clock Start/From:
Clock To:
1st Value:
2nd Value:
Value Percent:
Step: **NO**
Remarks: **access mh**

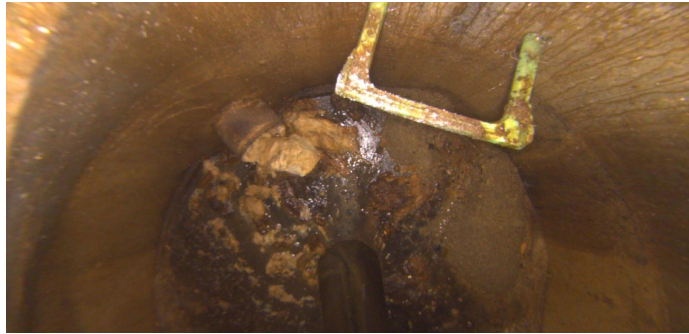
Code:	SRI
Description:	Surface Roughness Increased
Distance (ft):	.0
Structural Grade:	1
O&M Grade:	0
Clock Start/From:	12
Clock To:	12
1st Value:	
2nd Value:	
Value Percent:	
Step:	NO
Remarks:

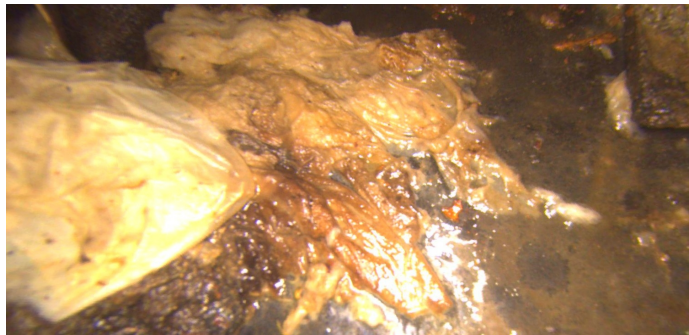
Code:	DAR
Description:	Deposits Attached Ragging
Distance (ft):	2.6
Structural Grade:	0
O&M Grade:	3
Clock Start/From:	10
Clock To:	12
1st Value:	
2nd Value:	
Value Percent:	20.000
Step:	NO
Remarks:

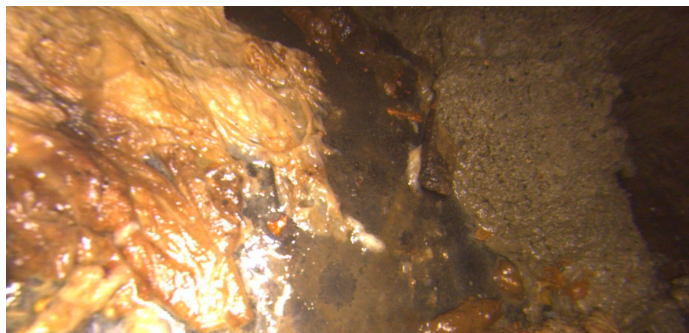
Code:	DSF
Description:	Deposits Settled Fine
Distance (ft):	2.6
Structural Grade:	0
O&M Grade:	2
Clock Start/From:	12
Clock To:	6
1st Value:	
2nd Value:	
Value Percent:	10.000
Step:	NO
Remarks:

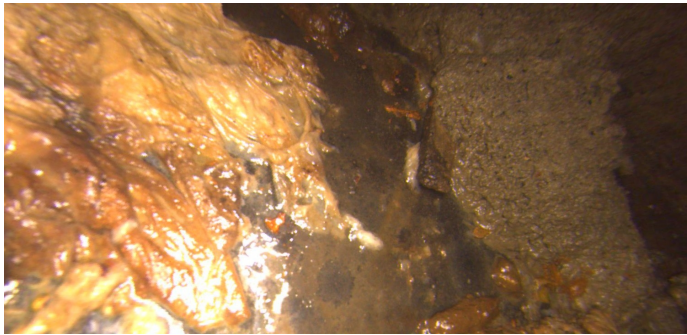
Code: **SRI**
Description: **Surface Roughness Increased**

Distance (ft): **2.6**
Structural Grade: **1**
O&M Grade: **0**
Clock Start/From: **12**
Clock To: **12**
1st Value:
2nd Value:
Value Percent:
Step: **NO**
Remarks:

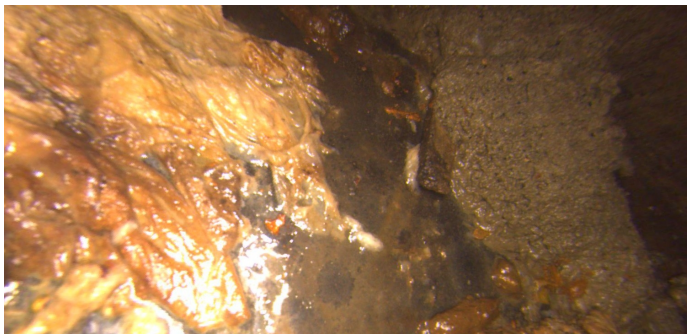
Code: **MGO**
Description: **General Observation**

Distance (ft): **2.6**
Structural Grade: **0**
O&M Grade: **0**
Clock Start/From:
Clock To:
1st Value:
2nd Value:
Value Percent:
Step: **NO**
Remarks: **end of survey**
