Manhole Inspection Report

Date:	05/03/2018	Weather:		Coding:	RZMACP
MH#:	M-704-003	Owner:	NA	Len. Surveyed:	4.0
P.O.#:		Surveyor:	Jen Costello	Rim to Invert:	4.1
Customer:		Cert. #:	U-907-5518	Wall Material:	Concrete (reinforced)

Street:	Linda St. 356' North of Cleveland Av	Project:	Hobart, IN
City:	Hobart, IN	GPS Northing:	2907102.507
Location:		GPS Easting:	2907102.507
Drain Area:	Northeast	GPS Accuracy:	Sub-Meter
Cover Shape:	Circular	Evidence of Surcharge:	No
Cover Size:	22.5	Potential for Runoff:	None
Comments:

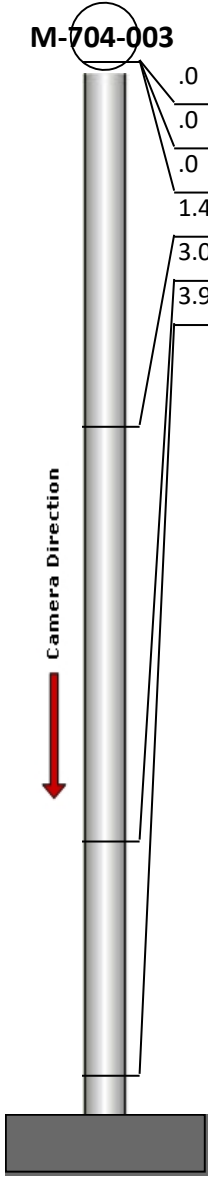
.0	MGO	General Observation	10	NA
	.0	SAP	Surface Aggregate Projecting	22	S 3
	.0	RFJ	Roots Fine Joint	33	M 1
	1.4	MGO	General Observation	49	NA
	3.0	DSF	Deposits Settled Fine	65	M 2
	3.9	MGO	General Observation	78	NA

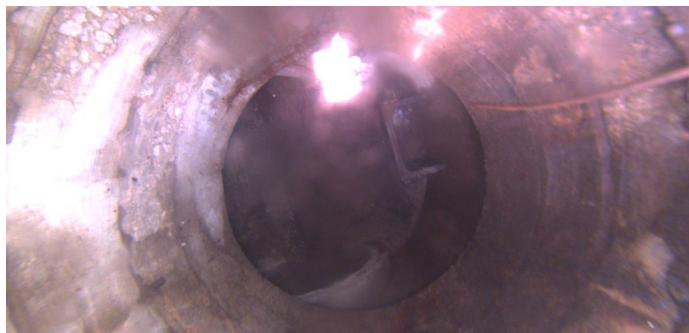
Code: **MGO**
Description: **General Observation**

Distance (ft): **.0**
Structural Grade: **0**
O&M Grade: **0**
Clock Start/From:
Clock To:
1st Value:
2nd Value:
Value Percent:
Step: **NO**
Remarks: **ACCESS MH**

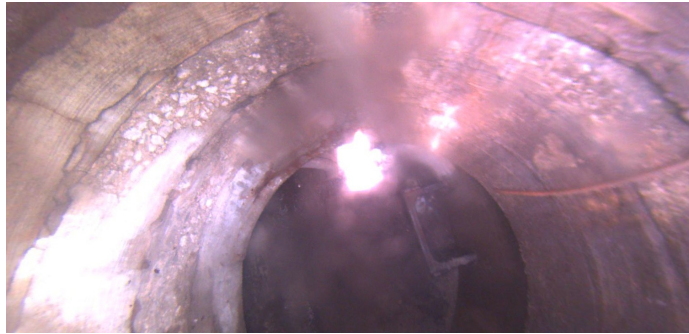
Code:	SAP
Description:	Surface Aggregate Projecting
Distance (ft):	.0
Structural Grade:	3
O&M Grade:	0
Clock Start/From:	9
Clock To:	12
1st Value:	
2nd Value:	
Value Percent:	
Step:	NO
Remarks:

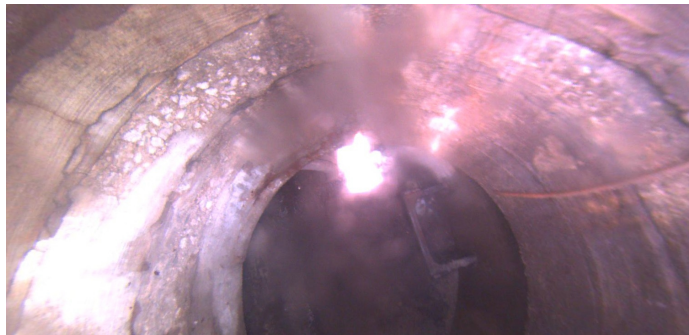
Code:	RFJ
Description:	Roots Fine Joint
Distance (ft):	.0
Structural Grade:	0
O&M Grade:	1
Clock Start/From:	2
Clock To:	
1st Value:	
2nd Value:	
Value Percent:	
Step:	NO
Remarks:

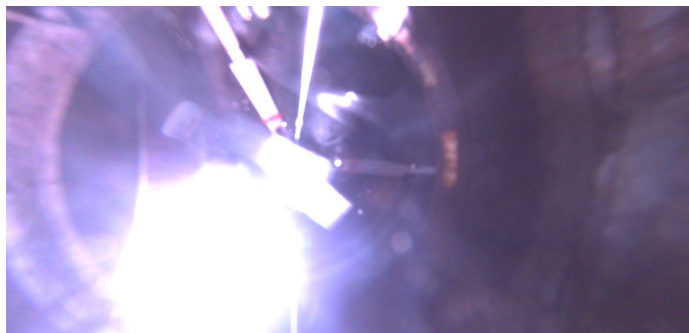
Code:	MGO
Description:	General Observation
Distance (ft):	1.4
Structural Grade:	0
O&M Grade:	0
Clock Start/From:	
Clock To:	
1st Value:	
2nd Value:	
Value Percent:	
Step:	NO
Remarks:	UNDERSIDE OF FRAME

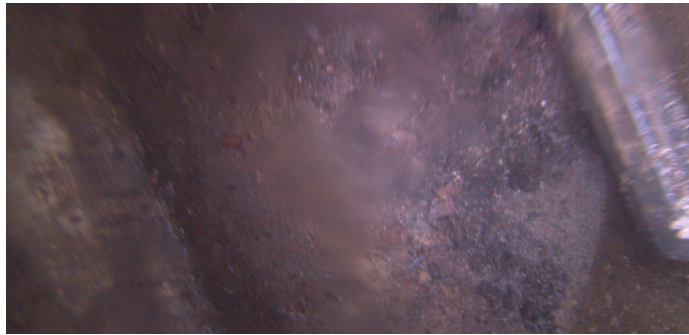
Code:	DSF
Description:	Deposits Settled Fine
Distance (ft):	3.0
Structural Grade:	0
O&M Grade:	2
Clock Start/From:	12
Clock To:	12
1st Value:	
2nd Value:	
Value Percent:	5.000
Step:	NO
Remarks:

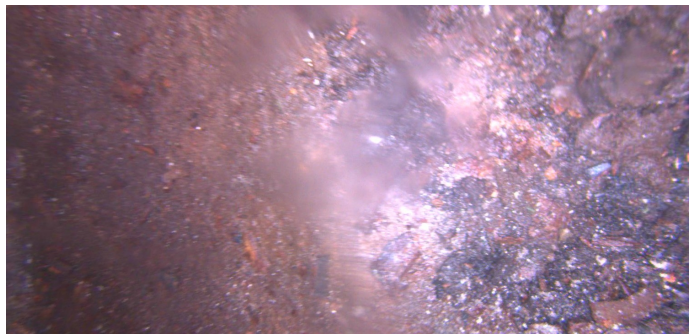
Code:	MGO
Description:	General Observation
Distance (ft):	3.9
Structural Grade:	0
O&M Grade:	0
Clock Start/From:	
Clock To:	
1st Value:	
2nd Value:	
Value Percent:	
Step:	NO
Remarks:	END SURVEY
