Manhole Inspection Report

Date:	05/04/2018	Weather:		Coding:	RZMACP
MH#:	M-704-010	Owner:	NA	Len. Surveyed:	19.1
P.O.#:		Surveyor:	Jen Costello	Rim to Invert:	21.3
Customer:		Cert. #:	U-907-5518	Wall Material:	Concrete (reinforced)

Street:	Cleveland Ave. 96' West of Michigan	Project:	Hobart, IN
City:	Hobart, IN	GPS Northing:	2906423.186
Location:		GPS Easting:	2906423.186
Drain Area:	Northeast	GPS Accuracy:	Sub-Meter
Cover Shape:	Circular	Evidence of Surcharge:	No
Cover Size:	22.5	Potential for Runoff:	None
Comments:

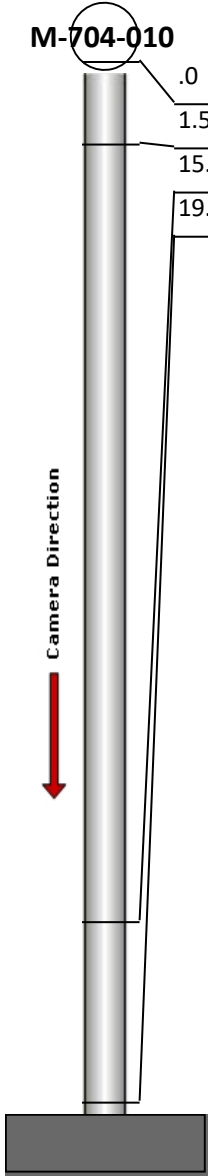
Position	Code	Observation	Video (sec)	Grade

.0	MGP	General Photo	10	NA
	1.5	MGO	General Observation	26	NA
	15.8	IW	Infil Weeper	68	M 2
	19.1	DAR	Deposits Attached Ragging	86	M 2

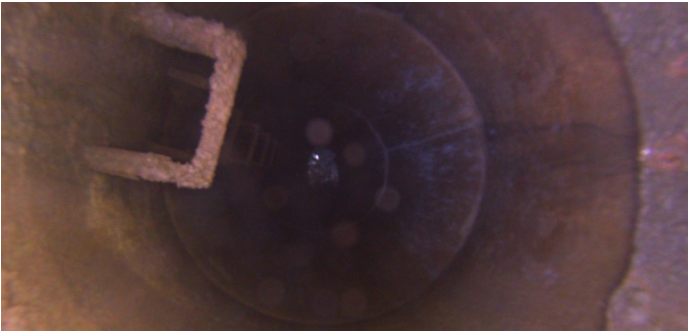
Code:	MGP
Description:	General Photo
Distance (ft):	.0
Structural Grade:	0
O&M Grade:	0
Clock Start/From:	
Clock To:	
1st Value:	
2nd Value:	
Value Percent:	
Step:	NO
Remarks:	access mh

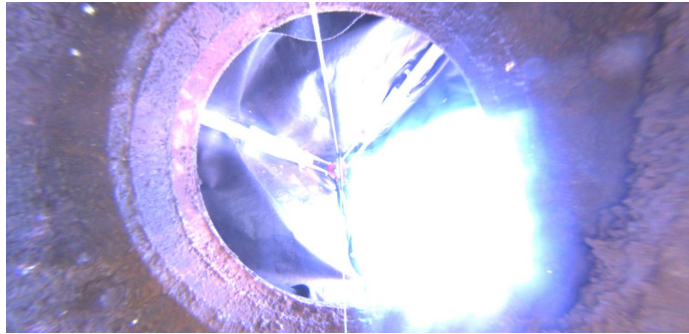
Code: **MGO**
Description: **General Observation**

Distance (ft): **1.5**
Structural Grade: **0**
O&M Grade: **0**
Clock Start/From:
Clock To:
1st Value:
2nd Value:
Value Percent:
Step: **NO**
Remarks: **underside of frame**

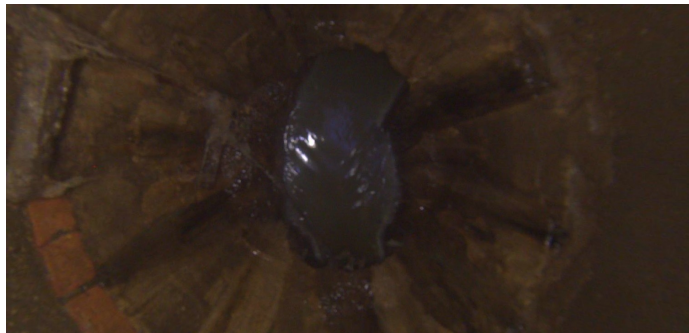
Code: **IW**
Description: **Infil Weeper**

Distance (ft): **15.8**
Structural Grade: **0**
O&M Grade: **2**
Clock Start/From: **12**
Clock To: **12**
1st Value:
2nd Value:
Value Percent:
Step: **NO**
Remarks:

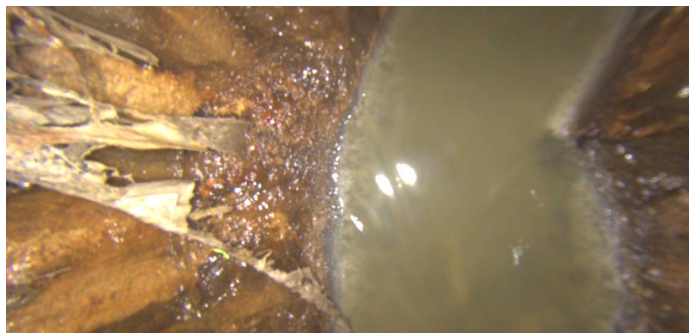
Code: **DAR**
Description: **Deposits Attached Ragging**

Distance (ft): **19.1**
Structural Grade: **0**
O&M Grade: **2**
Clock Start/From: **9**
Clock To: **10**
1st Value:
2nd Value:
Value Percent: **5.000**
Step: **YES**
Remarks:
