# Manhole Inspection Report

Date:	<b>10/11/2022</b>	Weather:		Coding:	<b>RZMACP</b>
MH#:	<b>M-704-016</b>	Owner:	<b>NA</b>	Len. Surveyed:	<b>8.4</b>
P.O.#:		Surveyor:	<b>Jen Costello</b>	Rim to Invert:	<b>10.0</b>
Customer:		Cert. #:	<b>U-907-5518</b>	Wall Material:	<b>Brick</b>

Street:	<b>Michigan Ave. 336' North of Home A</b>	Project:	<b>Hobart, IN</b>
City:	<b>Hobart, IN</b>	GPS Northing:	<b>2291428.782</b>
Location:	<b>Yard</b>	GPS Easting:	<b>2906619.391</b>
Drain Area:	<b>Northeast</b>	GPS Accuracy:	<b>Sub-Meter</b>
Cover Shape:	<b>Circular</b>	Evidence of Surcharge:	<b>No</b>
Cover Size:	<b>24.0</b>	Potential for Runoff:	<b>None</b>
Comments:

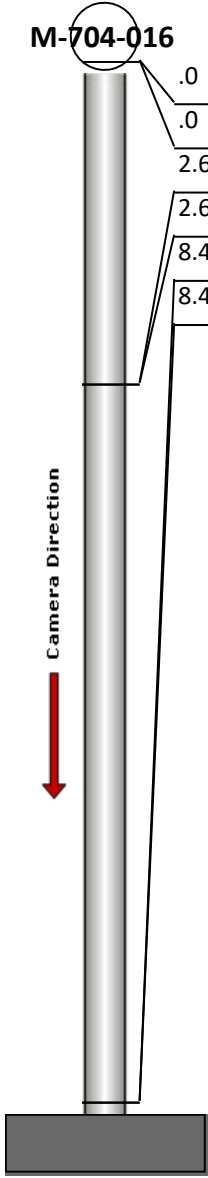
M-704-016				
	.0	MGO	General Observation	10	NA
	.0	SRI	Surface Roughness Increased	21	S 1
	2.6	MMC	Material Change	38	NA
	2.6	MGO	General Observation	51	NA
	8.4	DSF	Deposits Settled Fine	77	M 2
	8.4	MGO	General Observation	89	NA

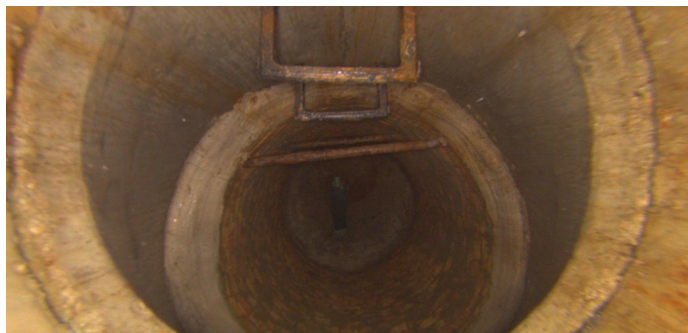
Code: **MGO**  
Description: **General Observation**

Distance (ft): **.0**  
Structural Grade: **0**  
O&M Grade: **0**  
Clock Start/From:  
Clock To:  
1st Value:  
2nd Value:  
Value Percent:  
Step: **NO**  
Remarks: **access mh**

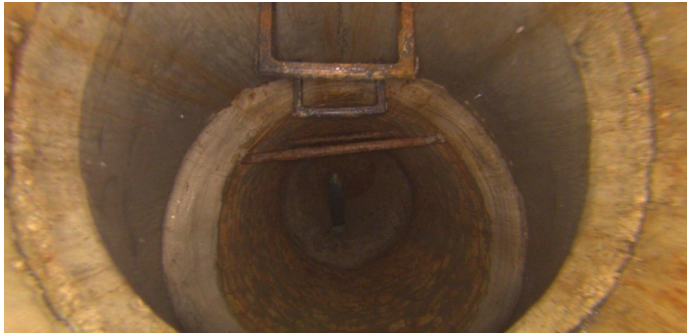
Code: **SRI**  
Description: **Surface Roughness Increased**

Distance (ft): **.0**  
Structural Grade: **1**  
O&M Grade: **0**  
Clock Start/From: **12**  
Clock To: **12**  
1st Value:  
2nd Value:  
Value Percent:  
Step: **NO**  
Remarks:

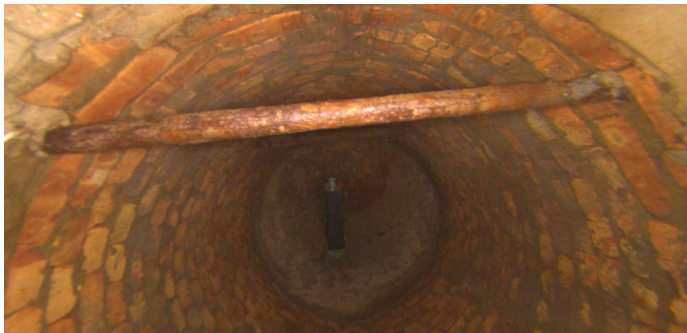
Code: **MMC**  
Description: **Material Change**

Distance (ft): **2.6**  
Structural Grade: **0**  
O&M Grade: **0**  
Clock Start/From:  
Clock To:  
1st Value:  
2nd Value:  
Value Percent:  
Step: **NO**  
Remarks: **brick**

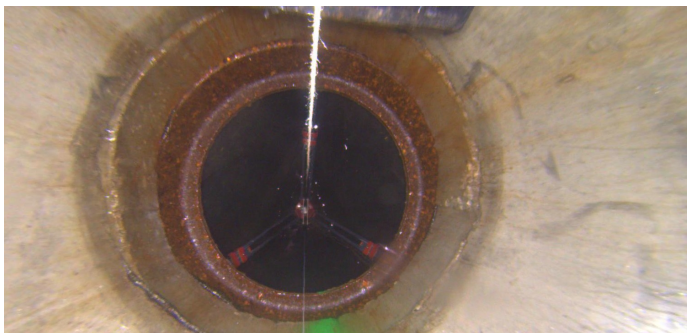
Code: **MGO**  
Description: **General Observation**

Distance (ft): **2.6**  
Structural Grade: **0**  
O&M Grade: **0**  
Clock Start/From:  
Clock To:  
1st Value:  
2nd Value:  
Value Percent:  
Step: **NO**  
Remarks: **underside of frame**

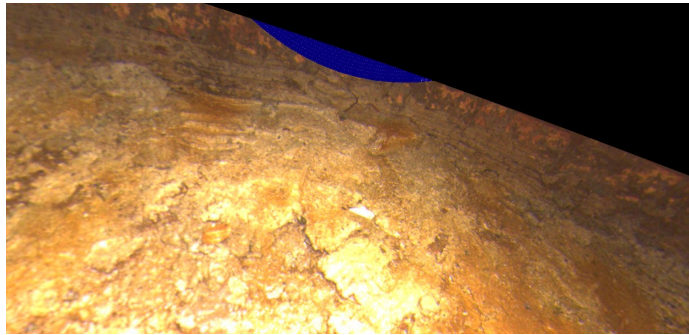
Code: **DSF**  
Description: **Deposits Settled Fine**

Distance (ft): **8.4**  
Structural Grade: **0**  
O&M Grade: **2**  
Clock Start/From: **12**  
Clock To: **12**  
1st Value:  
2nd Value:  
Value Percent: **5.000**  
Step: **NO**  
Remarks:

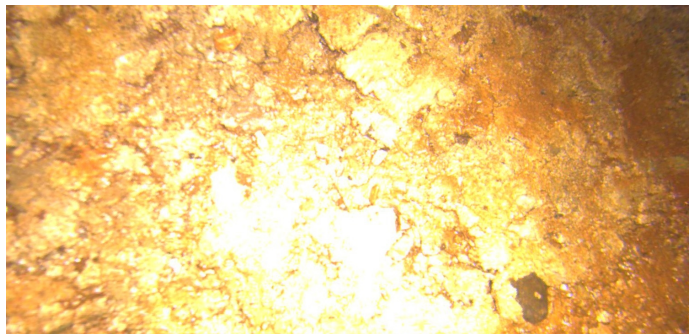
Code: **MGO**  
Description: **General Observation**

Distance (ft): **8.4**  
Structural Grade: **0**  
O&M Grade: **0**  
Clock Start/From:  
Clock To:  
1st Value:  
2nd Value:  
Value Percent:  
Step: **NO**  
Remarks: **end of survey**
