# Manhole Inspection Report

O&M Index:	1.00	O&M Quick:	1100	O&M Rating:	1.00
Structural Index:	0.00	Structural Quick:	0000	Structural Rating:	0.00
Overall Index:	1.00	Overall Quick:	1100	Overall Rating:	1.00

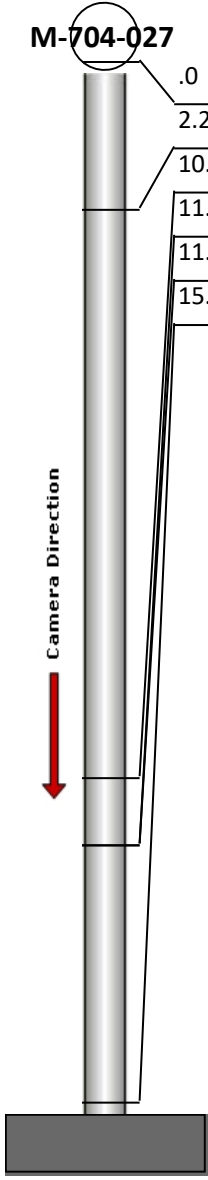
.0	MGP	General Photo	10	NA
	2.2	MGO	General Observation	28	NA
	10.6	MGO	General Observation	59	NA
	11.6	RFJ	Roots Fine Joint	72	M 1
	11.6	IS	Infil Stain	84	NA
	15.4	MGO	General Observation	103	NA

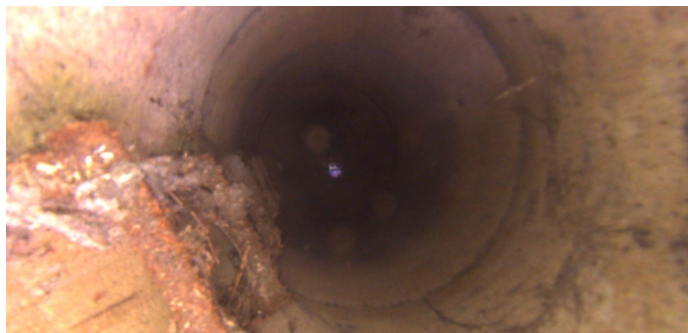
Code: **MGP**  
Description: **General Photo**

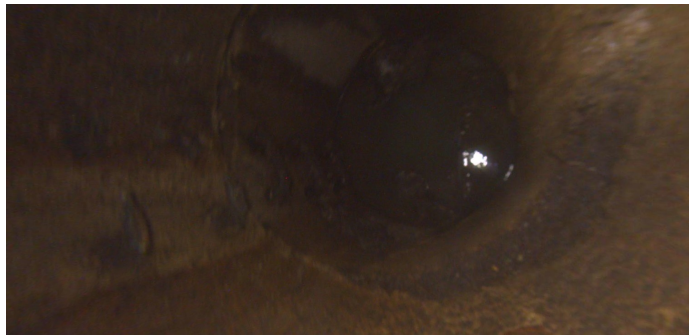
Code: **MGO**  
Description: **General Observation**

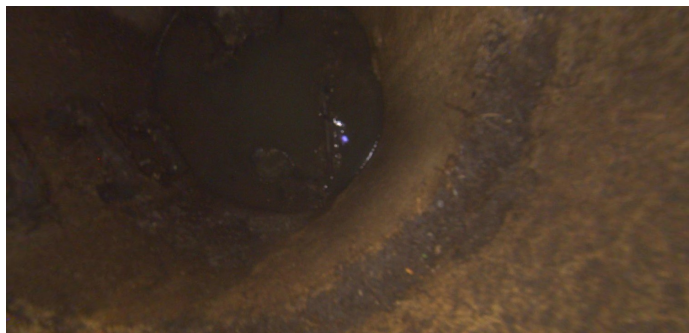
Code: **RFJ**  
Description: **Roots Fine Joint**

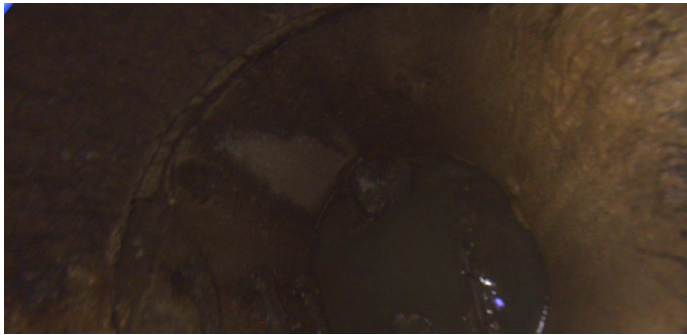
Code: **IS**  
Description: **Infil Stain**

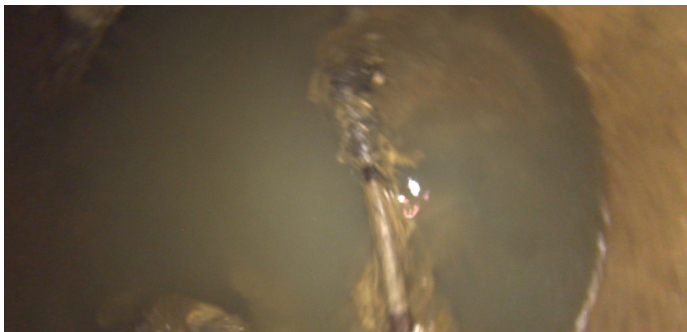
Code: **MGO**  
Description: **General Observation**
