# Manhole Inspection Report

Date:	05/06/2018	Weather:		Coding:	RZMACP
MH#:	M-704-046	Owner:	NA	Len. Surveyed:	9.3
P.O.#:		Surveyor:	Jen Costello	Rim to Invert:	10.2
Customer:		Cert. #:	U-907-5518	Wall Material:	Concrete (reinforced)

Street:	North of Ridge Road. 600'. East. Wes	Project:	Hobart, IN
City:	Hobart, IN	GPS Northing:	2905635.138
Location:		GPS Easting:	2905635.138
Drain Area:	North	GPS Accuracy:	Sub-Meter
Cover Shape:	Circular	Evidence of Surcharge:	No
Cover Size:	22.5	Potential for Runoff:	None
Comments:

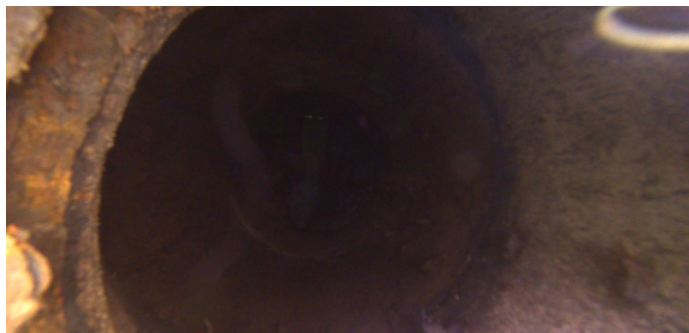
Code: **MGP**  
Description: **General Photo**

Distance (ft): **.0**  
Structural Grade: **0**  
O&M Grade: **0**  
Clock Start/From:  
Clock To:  
1st Value:  
2nd Value:  
Value Percent:  
Step: **NO**  
Remarks: **ACCESS MH**

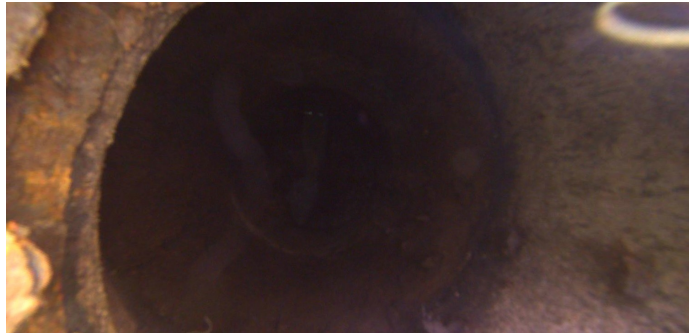
Code:	<b>MGO</b>
Description:	<b>General Observation</b>
Distance (ft):	<b>.0</b>
Structural Grade:	<b>0</b>
O&M Grade:	<b>0</b>
Clock Start/From:	
Clock To:	
1st Value:	
2nd Value:	
Value Percent:	
Step:	<b>NO</b>
Remarks:	<b>MISSING AND BROKEN STEPS</b>

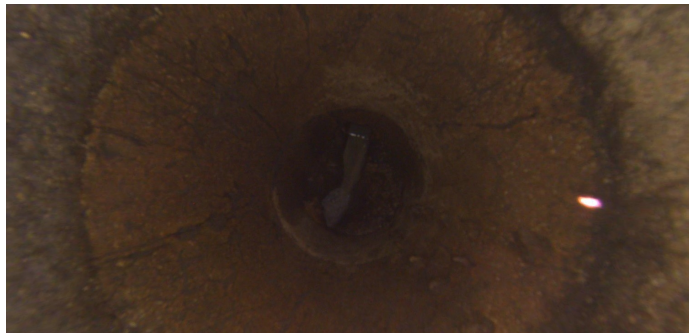
Code:	<b>RFJ</b>
Description:	<b>Roots Fine Joint</b>
Distance (ft):	<b>1.0</b>
Structural Grade:	<b>0</b>
O&M Grade:	<b>1</b>
Clock Start/From:	<b>12</b>
Clock To:	<b>12</b>
1st Value:	
2nd Value:	
Value Percent:	
Step:	<b>NO</b>
Remarks:

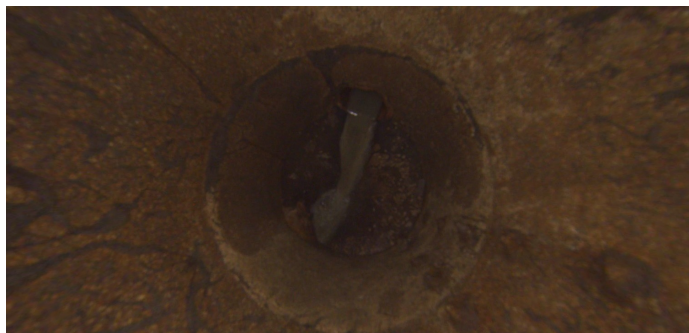
Code:	<b>SAV</b>
Description:	<b>Surface Aggregate Visible</b>
Distance (ft):	<b>3.6</b>
Structural Grade:	<b>3</b>
O&M Grade:	<b>0</b>
Clock Start/From:	<b>12</b>
Clock To:	<b>12</b>
1st Value:	
2nd Value:	
Value Percent:	
Step:	<b>NO</b>
Remarks:

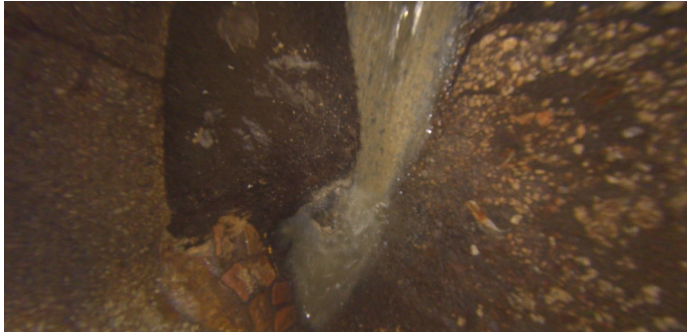
Code: **B**  
Description: **Broken**

Distance (ft): **8.2**  
Structural Grade: **4**  
O&M Grade: **0**  
Clock Start/From: **6**  
Clock To: **7**  
1st Value:  
2nd Value:  
Value Percent:  
Step: **NO**  
Remarks:

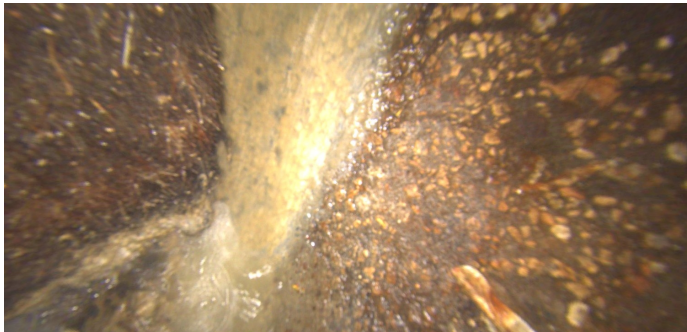
Code: **SAP**  
Description: **Surface Aggregate Projecting**

Distance (ft): **9.4**  
Structural Grade: **3**  
O&M Grade: **0**  
Clock Start/From: **12**  
Clock To: **12**  
1st Value:  
2nd Value:  
Value Percent:  
Step: **NO**  
Remarks:
