Manhole Inspection Report

Date:	05/06/2018	Weather:		Coding:	RZMACP
MH#:	M-704-047	Owner:	NA	Len. Surveyed:	4.9
P.O.#:		Surveyor:	Jen Costello	Rim to Invert:	5.9
Customer:		Cert. #:	U-907-5518	Wall Material:	Concrete (reinforced)

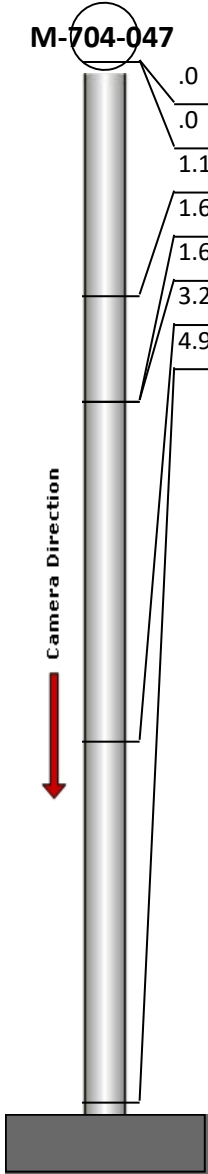
.0	MGP	General Photo	10	NA
	.0	SAV	Surface Aggregate Visible	22	S 3
	1.1	RFJ	Roots Fine Joint	35	M 1
	1.6	MGO	General Observation	50	NA
	1.6	MGO	General Observation	62	NA
	3.2	DSF	Deposits Settled Fine	77	M 2
	4.9	MGO	General Observation	92	NA

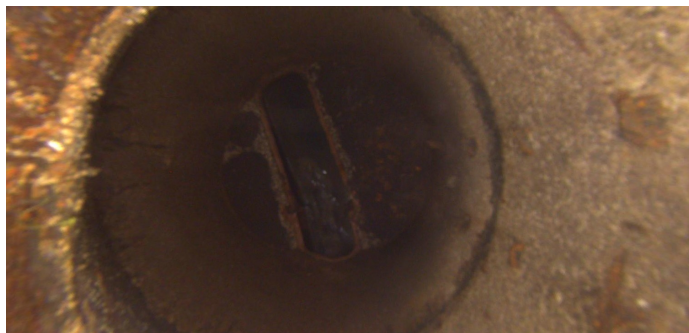
Code: **MGP**
Description: **General Photo**

Distance (ft): **.0**
Structural Grade: **0**
O&M Grade: **0**
Clock Start/From:
Clock To:
1st Value:
2nd Value:
Value Percent:
Step: **NO**
Remarks: **access mh**

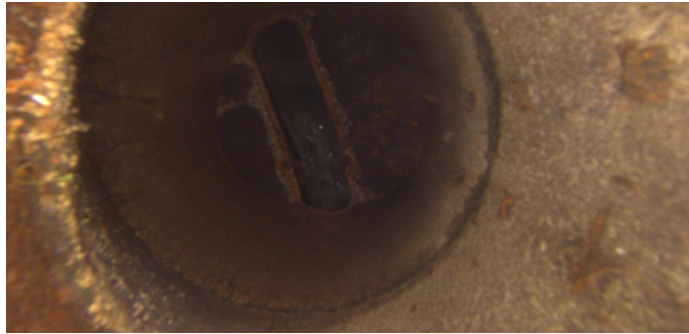
Code: **SAV**
Description: **Surface Aggregate Visible**

Distance (ft): **.0**
Structural Grade: **3**
O&M Grade: **0**
Clock Start/From: **12**
Clock To: **12**
1st Value:
2nd Value:
Value Percent:
Step: **NO**
Remarks:

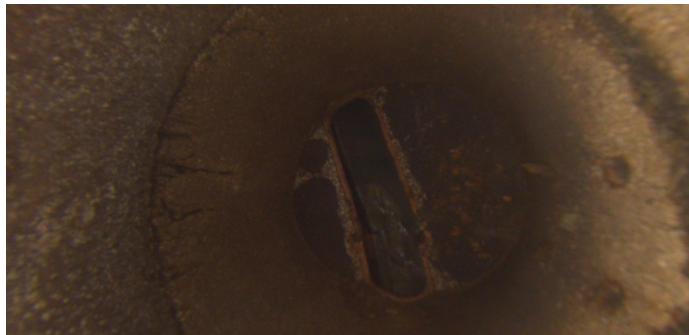
Code: **RFJ**
Description: **Roots Fine Joint**

Distance (ft): **1.1**
Structural Grade: **0**
O&M Grade: **1**
Clock Start/From: **8**
Clock To: **12**
1st Value:
2nd Value:
Value Percent:
Step: **NO**
Remarks:

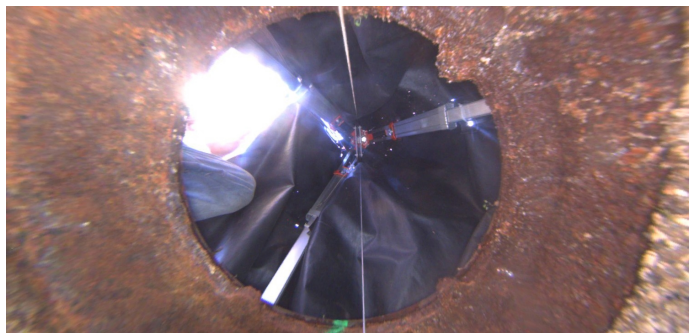
Code: **MGO**
Description: **General Observation**

Distance (ft): **1.6**
Structural Grade: **0**
O&M Grade: **0**
Clock Start/From:
Clock To:
1st Value:
2nd Value:
Value Percent:
Step: **NO**
Remarks: **underside of frame**

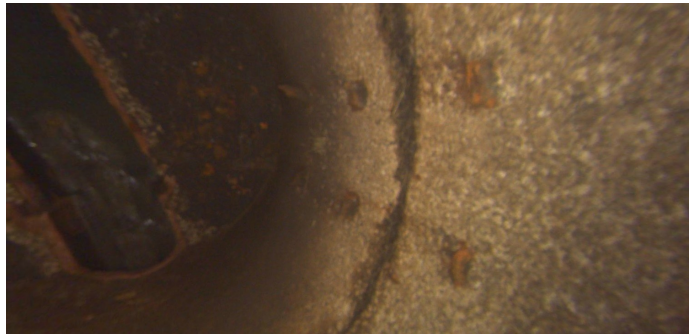
Code:	MGO
Description:	General Observation
Distance (ft):	1.6
Structural Grade:	0
O&M Grade:	0
Clock Start/From:	
Clock To:	
1st Value:	
2nd Value:	
Value Percent:	
Step:	NO
Remarks:	missing and broken steps

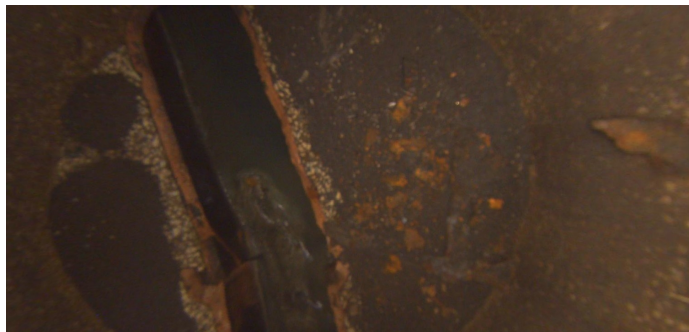
Code:	DSF
Description:	Deposits Settled Fine
Distance (ft):	3.2
Structural Grade:	0
O&M Grade:	2
Clock Start/From:	12
Clock To:	12
1st Value:	
2nd Value:	
Value Percent:	5.000
Step:	NO
Remarks:

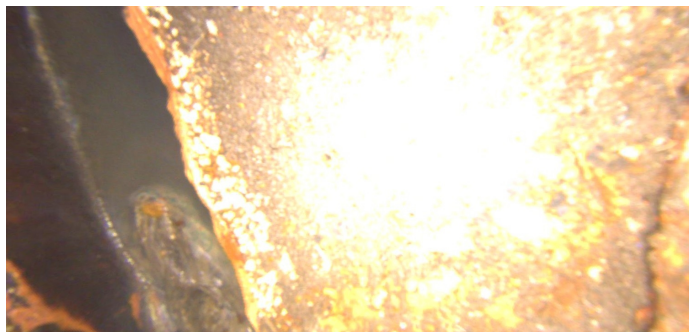
Code:	MGO
Description:	General Observation
Distance (ft):	4.9
Structural Grade:	0
O&M Grade:	0
Clock Start/From:	
Clock To:	
1st Value:	
2nd Value:	
Value Percent:	
Step:	NO
Remarks:	end survey
