Manhole Inspection Report

Date:	10/13/2022	Weather:		Coding:	RZMACP
MH#:	M-704-048	Owner:	NA	Len. Surveyed:	5.9
P.O.#:		Surveyor:	Jen Costello	Rim to Invert:	7.3
Customer:		Cert. #:	U-907-5518	Wall Material:	Concrete (precast)

Street:	North of Ridge Road. 924'. East of La	Project:	Hobart, IN
City:	Hobart, IN	GPS Northing:	2291279.294
Location:	Local Rural Streets	GPS Easting:	2905259.306
Drain Area:	North	GPS Accuracy:	Sub-Meter
Cover Shape:	Circular	Evidence of Surcharge:	Yes
Cover Size:	24.0	Potential for Runoff:	None
Comments:

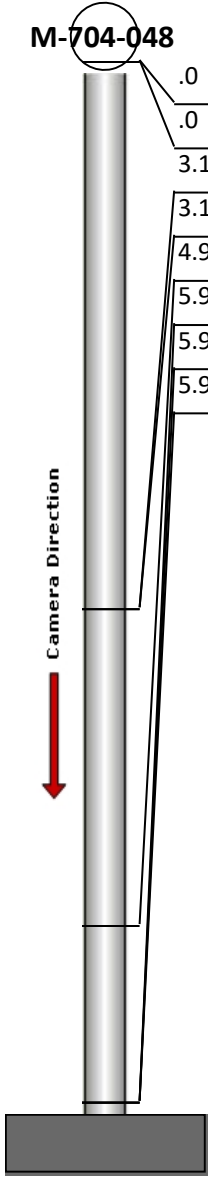
.0	MGO	General Observation	10	NA
	.0	SAV	Surface Aggregate Visible	21	S 3
	3.1	MGO	General Observation	41	NA
	3.1	SRV	Surface Reinforcement Visible	54	S 5
	4.9	DAR	Deposits Attached Ragging	70	M 2
	5.9	SAV	Surface Aggregate Visible	84	S 3
	5.9	SAV	Surface Aggregate Visible	95	S 3
	5.9	MGO	General Observation	106	NA

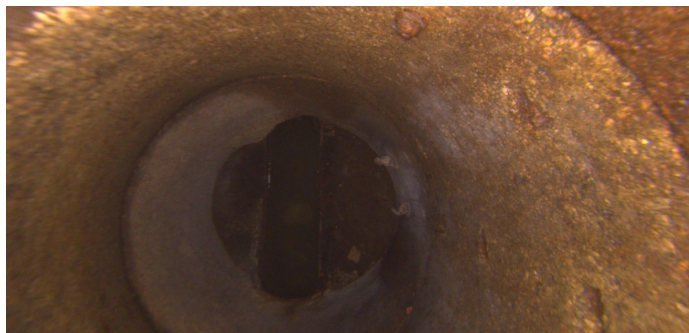
Code: **MGO**
Description: **General Observation**

Distance (ft): **.0**
Structural Grade: **0**
O&M Grade: **0**
Clock Start/From:
Clock To:
1st Value:
2nd Value:
Value Percent:
Step: **NO**
Remarks: **access mh**

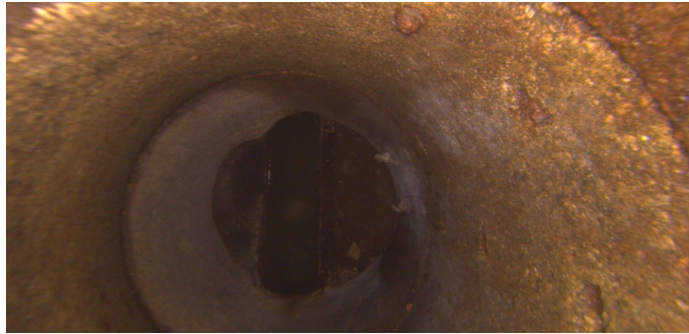
Code: **SAV**
Description: **Surface Aggregate Visible**

Distance (ft): **.0**
Structural Grade: **3**
O&M Grade: **0**
Clock Start/From: **12**
Clock To: **12**
1st Value:
2nd Value:
Value Percent:
Step: **NO**
Remarks:

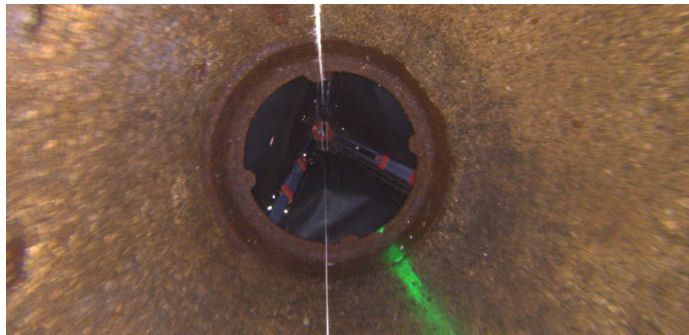
Code: **MGO**
Description: **General Observation**

Distance (ft): **3.1**
Structural Grade: **0**
O&M Grade: **0**
Clock Start/From:
Clock To:
1st Value:
2nd Value:
Value Percent:
Step: **NO**
Remarks: **underside of frame**

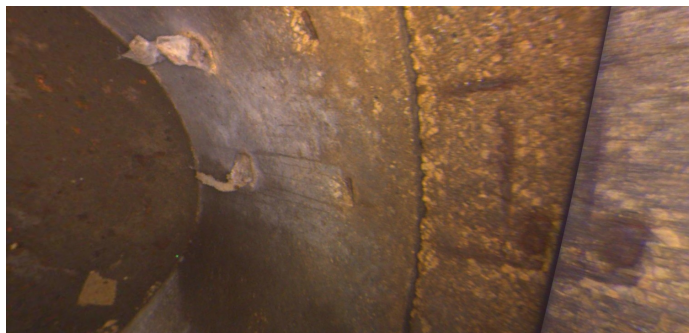
Code: **SRV**
Description: **Surface Reinforcement Visible**

Distance (ft): **3.1**
Structural Grade: **5**
O&M Grade: **0**
Clock Start/From: **3**
Clock To: **4**
1st Value:
2nd Value:
Value Percent:
Step: **NO**
Remarks:

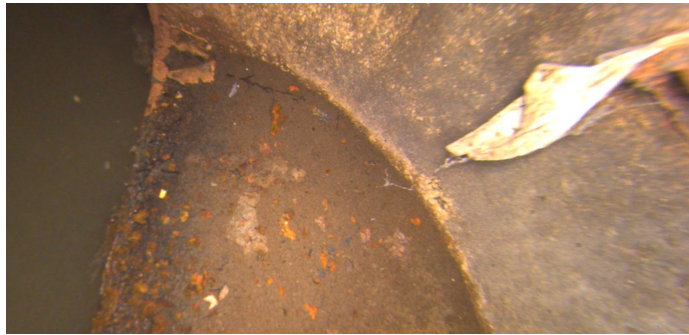
Code:	DAR
Description:	Deposits Attached Ragging
Distance (ft):	4.9
Structural Grade:	0
O&M Grade:	2
Clock Start/From:	2
Clock To:	
1st Value:	
2nd Value:	
Value Percent:	5.000
Step:	NO
Remarks:

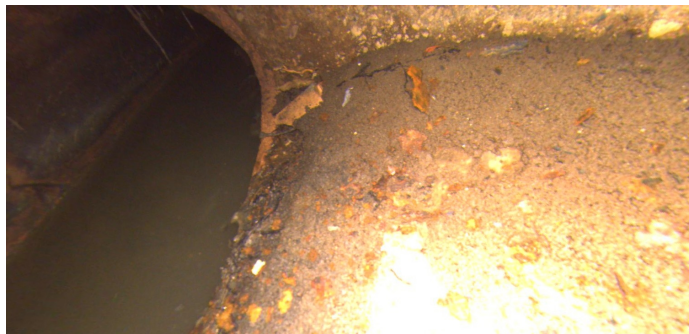
Code:	SAV
Description:	Surface Aggregate Visible
Distance (ft):	5.9
Structural Grade:	3
O&M Grade:	0
Clock Start/From:	12
Clock To:	12
1st Value:	
2nd Value:	
Value Percent:	
Step:	NO
Remarks:

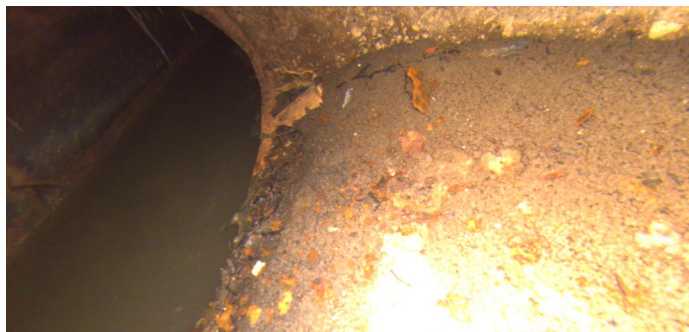
Code:	SAV
Description:	Surface Aggregate Visible
Distance (ft):	5.9
Structural Grade:	3
O&M Grade:	0
Clock Start/From:	12
Clock To:	12
1st Value:	
2nd Value:	
Value Percent:	
Step:	NO
Remarks:

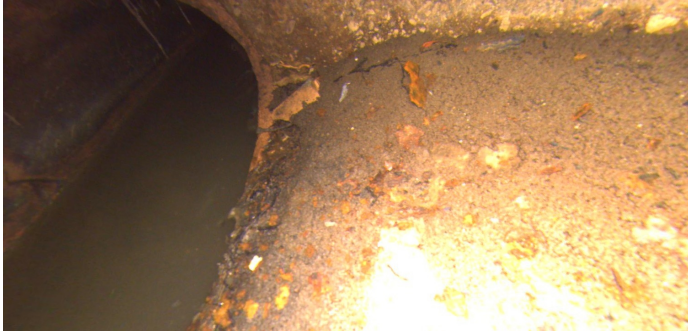
Code:	MGO
Description:	General Observation
Distance (ft):	5.9
Structural Grade:	0
O&M Grade:	0
Clock Start/From:	
Clock To:	
1st Value:	
2nd Value:	
Value Percent:	
Step:	NO
Remarks:	end of survey
