Manhole Inspection Report

Date:	05/16/2018	Weather:		Coding:	RZMACP
MH#:	M-704-055	Owner:	NA	Len. Surveyed:	8.0
P.O.#:		Surveyor:	Jen Costello	Rim to Invert:	9.0
Customer:		Cert. #:	U-907-5518	Wall Material:	Concrete (reinforced)

Street:	East of Lake Park Ave. North of Lake	Project:	Hobart, IN
City:	Hobart, IN	GPS Northing:	2905208.254
Location:		GPS Easting:	2905208.254
Drain Area:	North	GPS Accuracy:	Sub-Meter
Cover Shape:	Circular	Evidence of Surcharge:	No
Cover Size:	22.5	Potential for Runoff:	None
Comments:

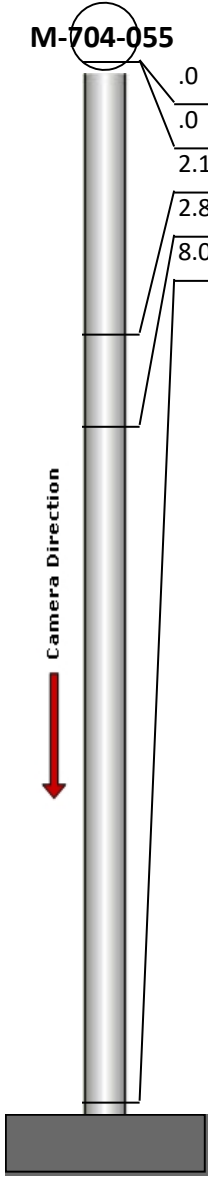
.0	MGP	General Photo	10	NA
	.0	SAV	Surface Aggregate Visible	21	S 3
	2.1	MGO	General Observation	39	NA
	2.8	OBZ	Obstacle Other	54	M 2
	8.0	MGO	General Observation	76	NA

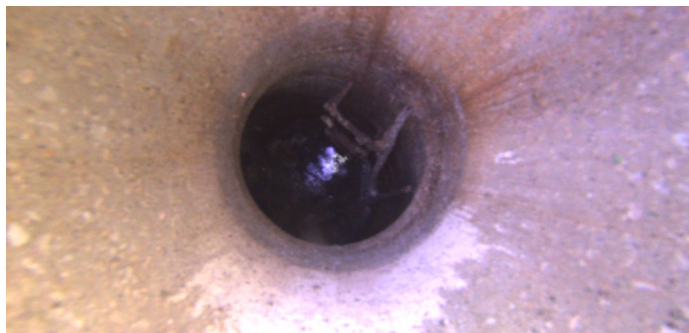
Code: **MGP**
Description: **General Photo**

Distance (ft): **.0**
Structural Grade: **0**
O&M Grade: **0**
Clock Start/From:
Clock To:
1st Value:
2nd Value:
Value Percent:
Step: **NO**
Remarks: **ACCESS MH**

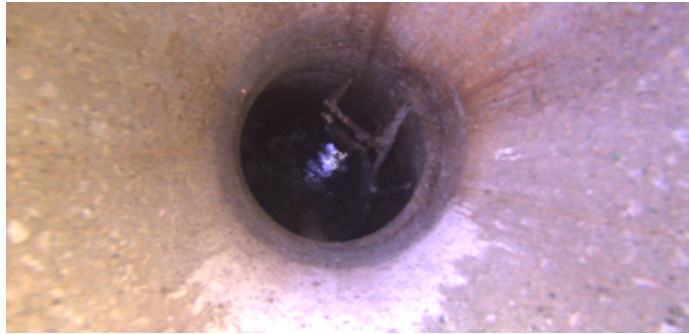
Code: **SAV**
Description: **Surface Aggregate Visible**

Distance (ft): **.0**
Structural Grade: **3**
O&M Grade: **0**
Clock Start/From: **12**
Clock To: **12**
1st Value:
2nd Value:
Value Percent:
Step: **NO**
Remarks:

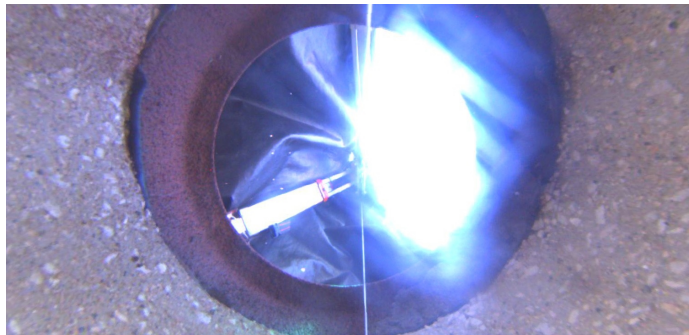
Code: **MGO**
Description: **General Observation**

Distance (ft): **2.1**
Structural Grade: **0**
O&M Grade: **0**
Clock Start/From:
Clock To:
1st Value:
2nd Value:
Value Percent:
Step: **NO**
Remarks: **UNDERSIDE OF FRAME**

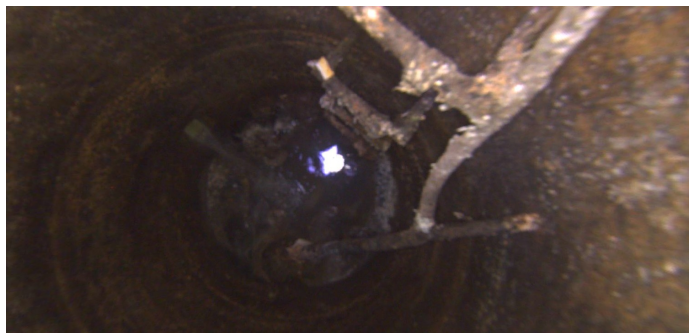
Code: **OBZ**
Description: **Obstacle Other**

Distance (ft): **2.8**
Structural Grade: **0**
O&M Grade: **2**
Clock Start/From: **2**
Clock To: **4**
1st Value:
2nd Value:
Value Percent: **5.000**
Step: **NO**
Remarks: **STICK**

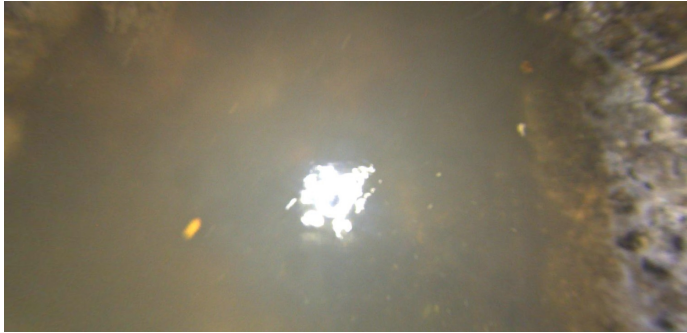
Code:	MGO
Description:	General Observation
Distance (ft):	8.0
Structural Grade:	0
O&M Grade:	0
Clock Start/From:	
Clock To:	
1st Value:	
2nd Value:	
Value Percent:	
Step:	NO
Remarks:	END SURVEY
