Manhole Inspection Report

Date:	05/16/2018	Weather:		Coding:	RZMACP
MH#:	M-704-056	Owner:	NA	Len. Surveyed:	6.5
P.O.#:		Surveyor:	Jen Costello	Rim to Invert:	8.2
Customer:		Cert. #:	U-907-5518	Wall Material:	Concrete (reinforced)

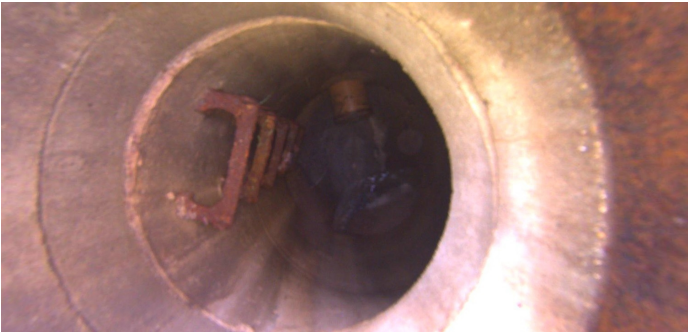
MGP

General Photo

.0

access MH

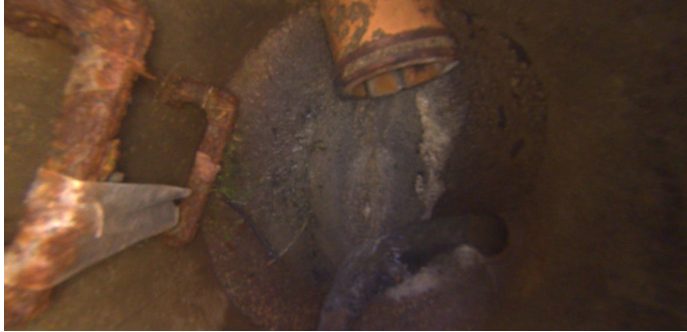
Code:	DAR
Description:	Deposits Attached Ragging
Distance (ft):	4.4
Structural Grade:	0
O&M Grade:	2
Clock Start/From:	9
Clock To:	
1st Value:	
2nd Value:	
Value Percent:	5.000
Step:	YES
Remarks:

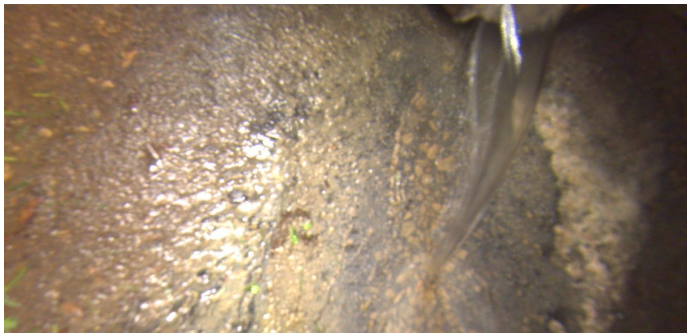
Code:	MGO
Description:	General Observation
Distance (ft):	6.5
Structural Grade:	0
O&M Grade:	0
Clock Start/From:	
Clock To:	
1st Value:	
2nd Value:	
Value Percent:	
Step:	NO
Remarks:	END SURVEY
