Manhole Inspection Report

Date:	10/10/2022	Weather:		Coding:	RZMACP
MH#:	M-704-064	Owner:	NA	Len. Surveyed:	3.8
P.O.#:		Surveyor:	Jen Costello	Rim to Invert:	4.7
Customer:		Cert. #:	U-907-5518	Wall Material:	Concrete (cast in place)

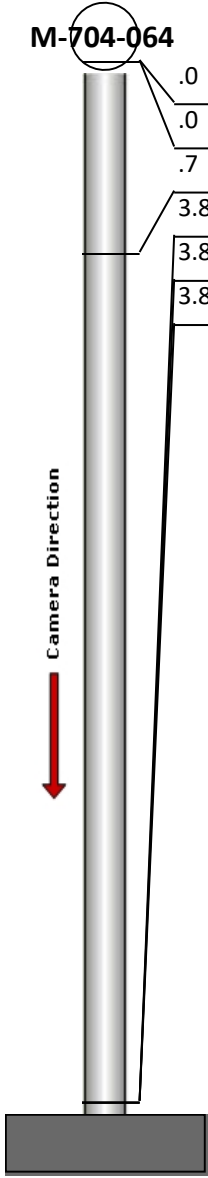
.0	MGO	General Observation	10	NA
	.0	SRI	Surface Roughness Increased	21	S 1
	.7	MGO	General Observation	36	NA
	3.8	DSZ	Deposits Settled Other	55	M 5
	3.8	SRI	Surface Roughness Increased	65	S 1
	3.8	MGO	General Observation	75	NA

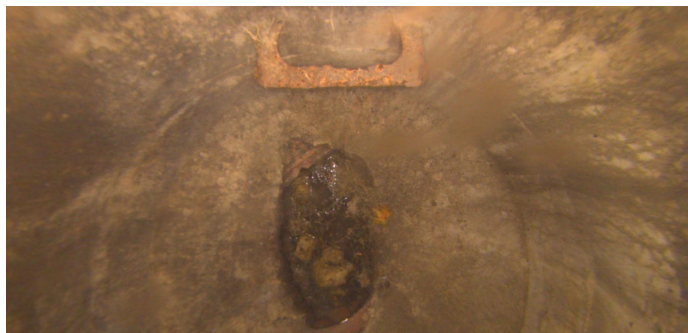
Code: **MGO**
Description: **General Observation**

Distance (ft): **.0**
Structural Grade: **0**
O&M Grade: **0**
Clock Start/From:
Clock To:
1st Value:
2nd Value:
Value Percent:
Step: **NO**
Remarks: **access mh**

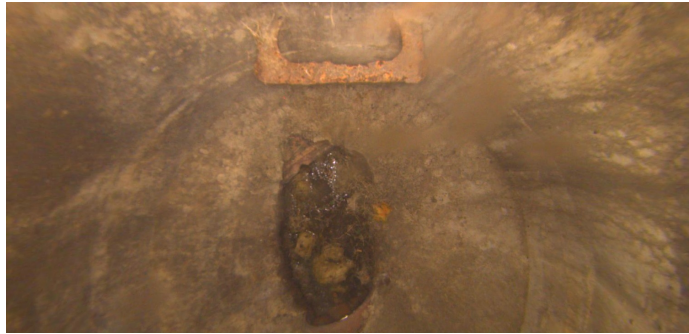
Code:	SRI
Description:	Surface Roughness Increased
Distance (ft):	.0
Structural Grade:	1
O&M Grade:	0
Clock Start/From:	12
Clock To:	12
1st Value:	
2nd Value:	
Value Percent:	
Step:	NO
Remarks:

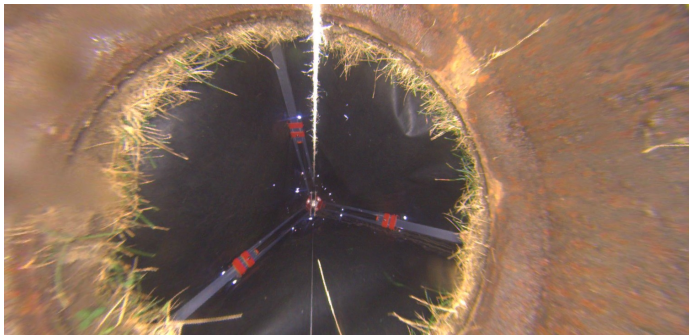
Code:	MGO
Description:	General Observation
Distance (ft):	.7
Structural Grade:	0
O&M Grade:	0
Clock Start/From:	
Clock To:	
1st Value:	
2nd Value:	
Value Percent:	
Step:	NO
Remarks:	underside of frame

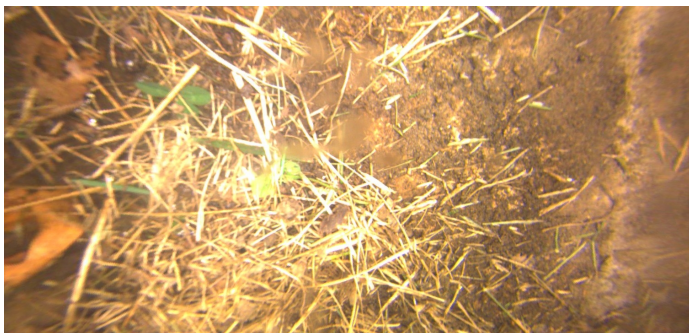
Code:	DSZ
Description:	Deposits Settled Other
Distance (ft):	3.8
Structural Grade:	0
O&M Grade:	5
Clock Start/From:	4
Clock To:	8
1st Value:	
2nd Value:	
Value Percent:	40.000
Step:	NO
Remarks:	misc

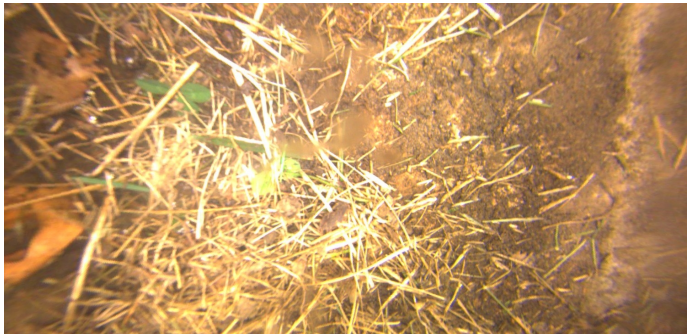
Code: **SRI**
Description: **Surface Roughness Increased**

Distance (ft): **3.8**
Structural Grade: **1**
O&M Grade: **0**
Clock Start/From: **12**
Clock To: **12**
1st Value:
2nd Value:
Value Percent:
Step: **NO**
Remarks:

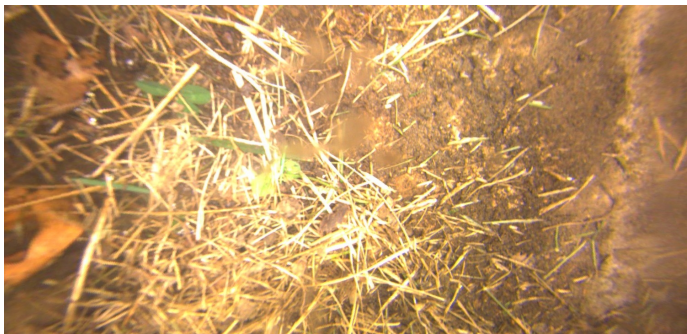
Code: **MGO**
Description: **General Observation**

Distance (ft): **3.8**
Structural Grade: **0**
O&M Grade: **0**
Clock Start/From:
Clock To:
1st Value:
2nd Value:
Value Percent:
Step: **NO**
Remarks: **end of survey**
