# Manhole Inspection Report

Date:	<b>05/16/2018</b>	Weather:		Coding:	<b>RZMACP</b>
MH#:	<b>M-704-072</b>	Owner:	<b>NA</b>	Len. Surveyed:	<b>5.6</b>
P.O.#:		Surveyor:	<b>Jen Costello</b>	Rim to Invert:	<b>6.8</b>
Customer:		Cert. #:	<b>U-907-5518</b>	Wall Material:	<b>Concrete (reinforced)</b>

Street:	<b>Lakewood Dr. and Shore Side Dr. To</b>	Project:	<b>Hobart, IN</b>
City:	<b>Hobart, IN</b>	GPS Northing:	<b>2905033.994</b>
Location:		GPS Easting:	<b>2905033.994</b>
Drain Area:	<b>North</b>	GPS Accuracy:	<b>Sub-Meter</b>
Cover Shape:	<b>Circular</b>	Evidence of Surcharge:	<b>No</b>
Cover Size:	<b>22.5</b>	Potential for Runoff:	<b>None</b>
Comments:

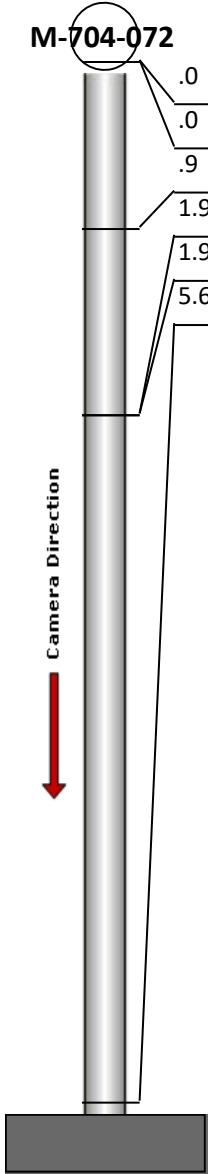
Position	Code	Observation	Video (sec)	Grade

0.0	MGP	General Photo	10	NA
	0.0	DAR	Deposits Attached Ragging	22	M 2
	0.9	RTB	Roots Tap Barrel	35	M 3
	1.9	MGO	General Observation	49	NA
	1.9	MGO	General Observation	62	NA
	5.6	MGO	General Observation	83	NA

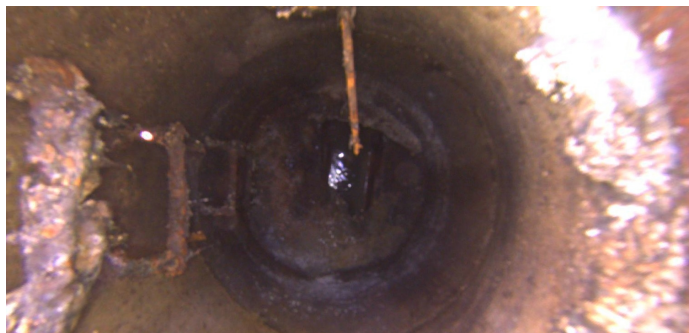
Code: **MGP**  
Description: **General Photo**

Distance (ft): **.0**  
Structural Grade: **0**  
O&M Grade: **0**  
Clock Start/From:  
Clock To:  
1st Value:  
2nd Value:  
Value Percent:  
Step: **NO**  
Remarks: **ACCESS MH**

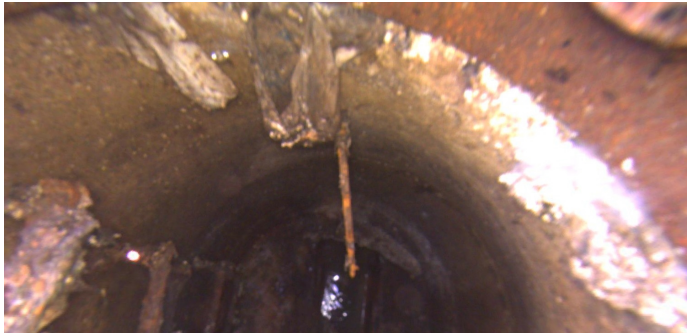
Code: **DAR**  
Description: **Deposits Attached Ragging**

Distance (ft): **.0**  
Structural Grade: **0**  
O&M Grade: **2**  
Clock Start/From: **11**  
Clock To: **1**  
1st Value:  
2nd Value:  
Value Percent: **5.000**  
Step: **NO**  
Remarks:

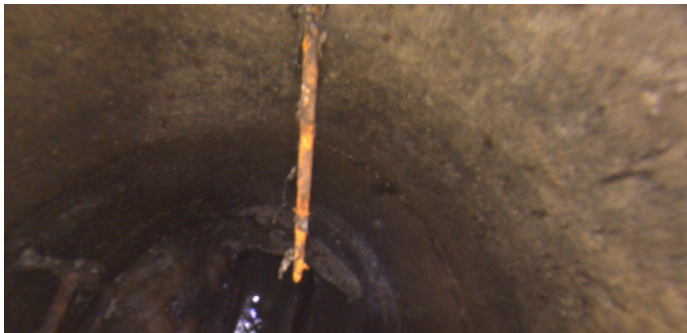
Code: **RTB**  
Description: **Roots Tap Barrel**

Distance (ft): **.9**  
Structural Grade: **0**  
O&M Grade: **3**  
Clock Start/From: **12**  
Clock To:  
1st Value:  
2nd Value:  
Value Percent: **5.000**  
Step: **NO**  
Remarks:

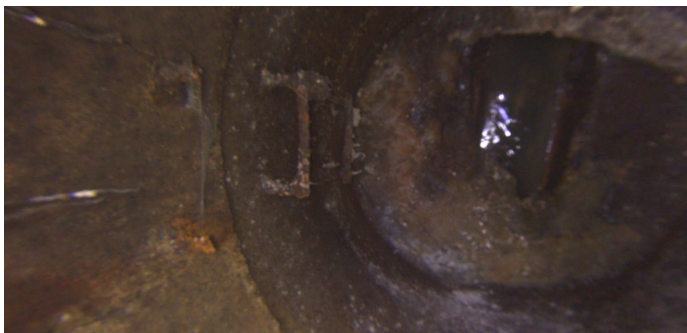
Code: **MGO**  
Description: **General Observation**

Distance (ft): **1.9**  
Structural Grade: **0**  
O&M Grade: **0**  
Clock Start/From:  
Clock To:  
1st Value:  
2nd Value:  
Value Percent:  
Step: **NO**  
Remarks: **BROKEN STEPS**

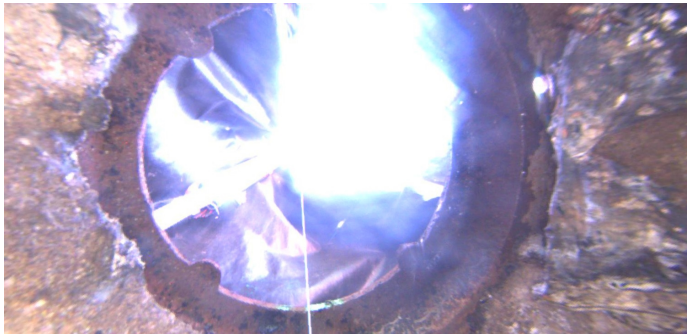
Code:	<b>MGO</b>
Description:	<b>General Observation</b>
Distance (ft):	<b>1.9</b>
Structural Grade:	<b>0</b>
O&M Grade:	<b>0</b>
Clock Start/From:	
Clock To:	
1st Value:	
2nd Value:	
Value Percent:	
Step:	<b>NO</b>
Remarks:	<b>UNDERSIDE OF FRAME</b>

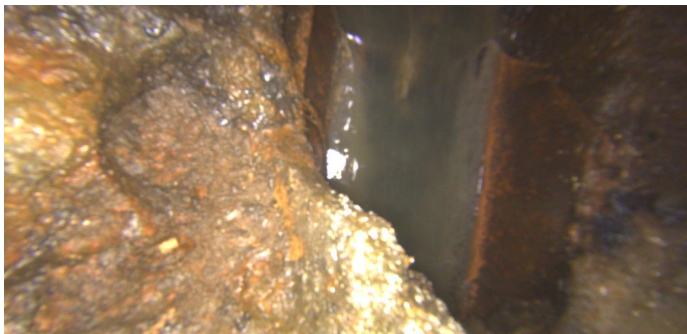
Code:	<b>MGO</b>
Description:	<b>General Observation</b>
Distance (ft):	<b>5.6</b>
Structural Grade:	<b>0</b>
O&M Grade:	<b>0</b>
Clock Start/From:	
Clock To:	
1st Value:	
2nd Value:	
Value Percent:	
Step:	<b>NO</b>
Remarks:	<b>END SURVEY</b>
