Manhole Inspection Report

Date:	05/06/2018	Weather:		Coding:	RZMACP
MH#:	M-704-076	Owner:	NA	Len. Surveyed:	6.2
P.O.#:		Surveyor:	Jen Costello	Rim to Invert:	7.2
Customer:		Cert. #:	U-907-5518	Wall Material:	Concrete (reinforced)

Street:	Old Ridge Road. North of Rail Road	Project:	Hobart, IN
City:	Hobart, IN	GPS Northing:	2905533.083
Location:		GPS Easting:	2905533.083
Drain Area:	North	GPS Accuracy:	Sub-Meter
Cover Shape:	Circular	Evidence of Surcharge:	No
Cover Size:	22.5	Potential for Runoff:	None
Comments:

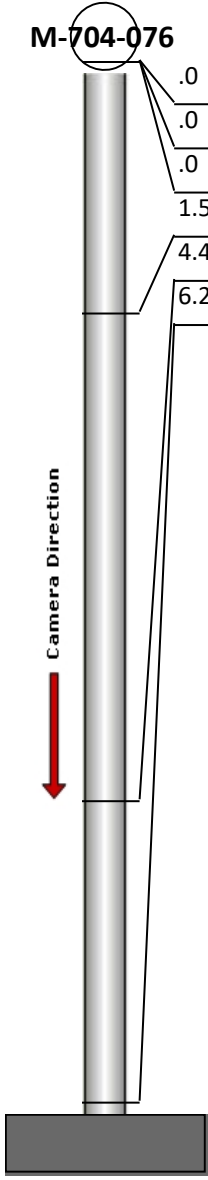
Position	Code	Observation	Video (sec)	Grade

.0	MGP	General Photo	10	NA
	.0	SAP	Surface Aggregate Projecting	21	S 3
	.0	MGO	General Observation	32	NA
	1.5	MGO	General Observation	48	NA
	4.4	DSF	Deposits Settled Fine	67	M 2
	6.2	MGO	General Observation	82	NA

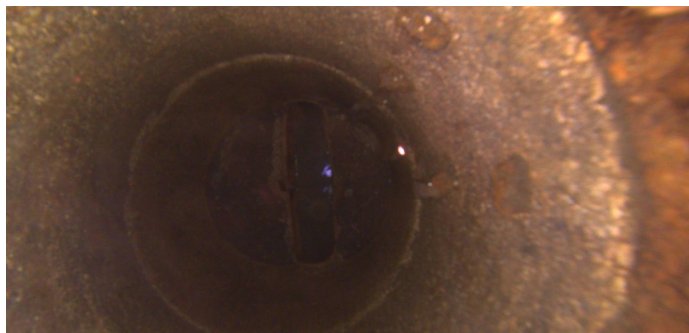
Code: **MGP**
Description: **General Photo**

Distance (ft): **.0**
Structural Grade: **0**
O&M Grade: **0**
Clock Start/From:
Clock To:
1st Value:
2nd Value:
Value Percent:
Step: **NO**
Remarks: **ACCESS MH**

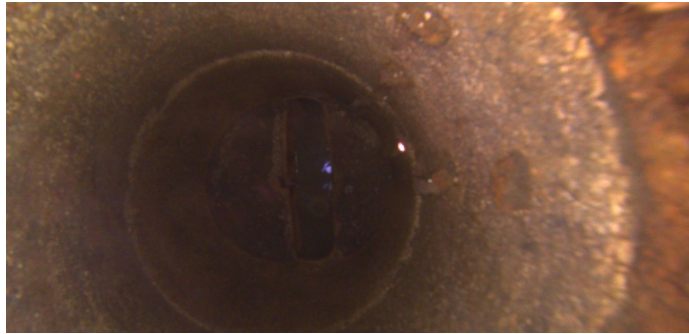
Code: **SAP**
Description: **Surface Aggregate Projecting**

Distance (ft): **.0**
Structural Grade: **3**
O&M Grade: **0**
Clock Start/From: **12**
Clock To: **12**
1st Value:
2nd Value:
Value Percent:
Step: **NO**
Remarks:

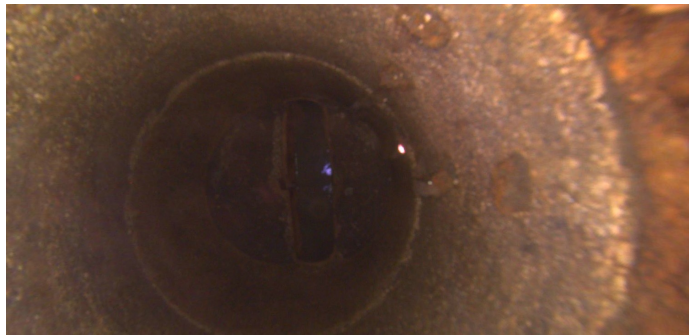
Code: **MGO**
Description: **General Observation**

Distance (ft): **.0**
Structural Grade: **0**
O&M Grade: **0**
Clock Start/From:
Clock To:
1st Value:
2nd Value:
Value Percent:
Step: **NO**
Remarks: **MISSING STEPS**

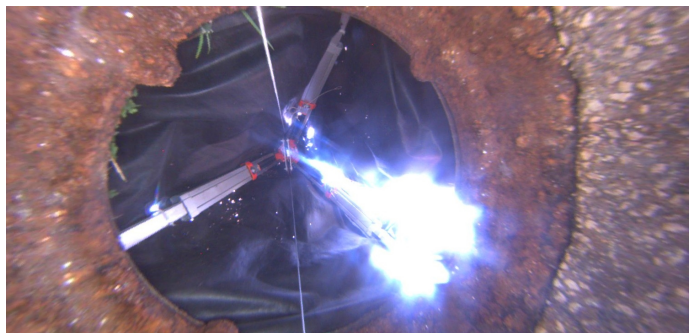
Code: **MGO**
Description: **General Observation**

Distance (ft): **1.5**
Structural Grade: **0**
O&M Grade: **0**
Clock Start/From:
Clock To:
1st Value:
2nd Value:
Value Percent:
Step: **NO**
Remarks: **UNDERSIDE OF FRAME**

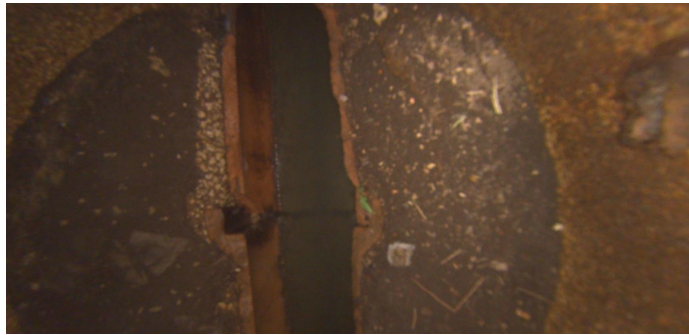
Code: **DSF**
Description: **Deposits Settled Fine**

Distance (ft): **4.4**
Structural Grade: **0**
O&M Grade: **2**
Clock Start/From: **12**
Clock To: **12**
1st Value:
2nd Value:
Value Percent: **5.000**
Step: **NO**
Remarks:

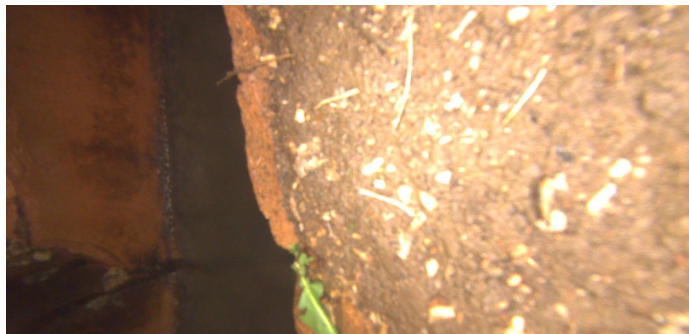
Code: **MGO**
Description: **General Observation**

Distance (ft): **6.2**
Structural Grade: **0**
O&M Grade: **0**
Clock Start/From:
Clock To:
1st Value:
2nd Value:
Value Percent:
Step: **NO**
Remarks: **END SURVEY**
