# Manhole Inspection Report

Date:	05/06/2018	Weather:		Coding:	RZMACP
MH#:	M-704-077	Owner:	NA	Len. Surveyed:	5.0
P.O.#:		Surveyor:	Jen Costello	Rim to Invert:	6.1
Customer:		Cert. #:	U-907-5518	Wall Material:	Concrete (reinforced)

Street:	North of Soccer Field .North of Rail	Project:	Hobart, IN
City:	Hobart, IN	GPS Northing:	2905393.937
Location:		GPS Easting:	2905393.937
Drain Area:	North	GPS Accuracy:	Sub-Meter
Cover Shape:	Circular	Evidence of Surcharge:	No
Cover Size:	22.5	Potential for Runoff:	None
Comments:

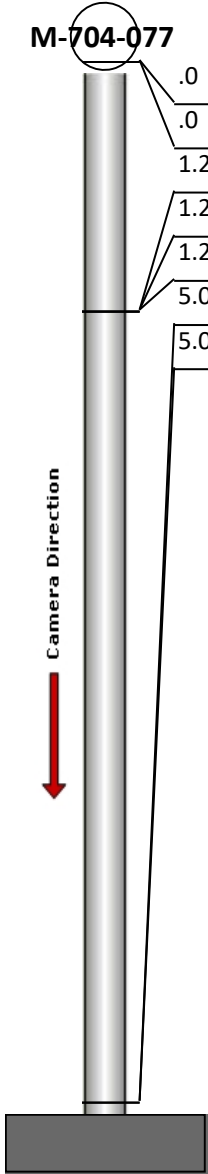
M-704-077				
	.0	MGP	General Photo	10	NA
	.0	SAV	Surface Aggregate Visible	21	S 3
	1.2	MGO	General Observation	37	NA
	1.2	RFJ	Roots Fine Joint	49	M 1
	1.2	MGO	General Observation	60	NA
	5.0	DSGV	Deposits Settled Gravel	78	M 2
	5.0	MGO	General Observation	88	NA

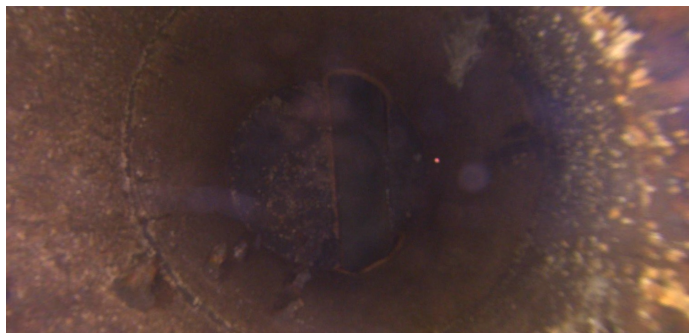
Code: **MGP**  
 Description: **General Photo**

Distance (ft): **.0**  
 Structural Grade: **0**  
 O&M Grade: **0**  
 Clock Start/From:  
 Clock To:  
 1st Value:  
 2nd Value:  
 Value Percent:  
 Step: **NO**  
 Remarks: **ACCESS MH**

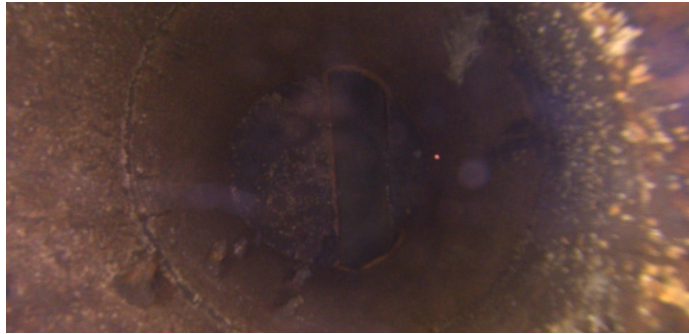
Code: **SAV**  
Description: **Surface Aggregate Visible**

Distance (ft): **.0**  
Structural Grade: **3**  
O&M Grade: **0**  
Clock Start/From: **12**  
Clock To: **12**  
1st Value:  
2nd Value:  
Value Percent:  
Step: **NO**  
Remarks:

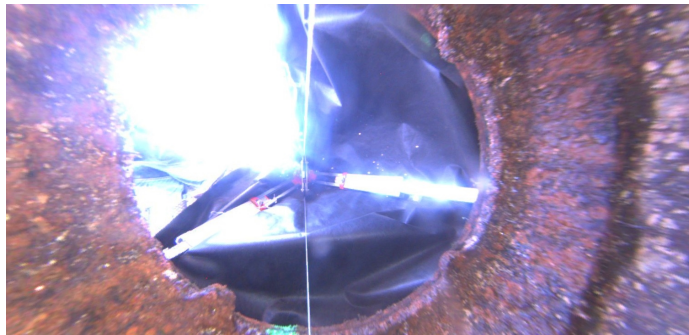
Code: **MGO**  
Description: **General Observation**

Distance (ft): **1.2**  
Structural Grade: **0**  
O&M Grade: **0**  
Clock Start/From:  
Clock To:  
1st Value:  
2nd Value:  
Value Percent:  
Step: **NO**  
Remarks: **UNDERSIDE OF FRAME**

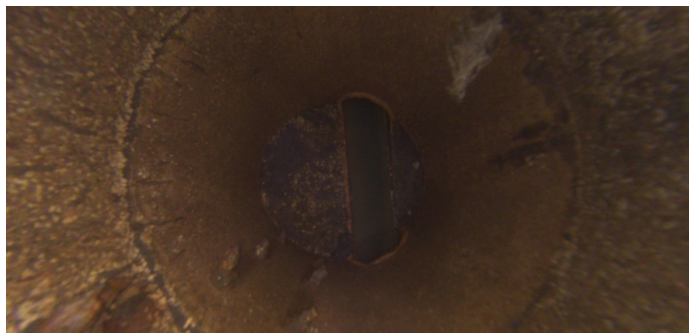
Code: **RFJ**  
Description: **Roots Fine Joint**

Distance (ft): **1.2**  
Structural Grade: **0**  
O&M Grade: **1**  
Clock Start/From: **12**  
Clock To: **12**  
1st Value:  
2nd Value:  
Value Percent:  
Step: **NO**  
Remarks:

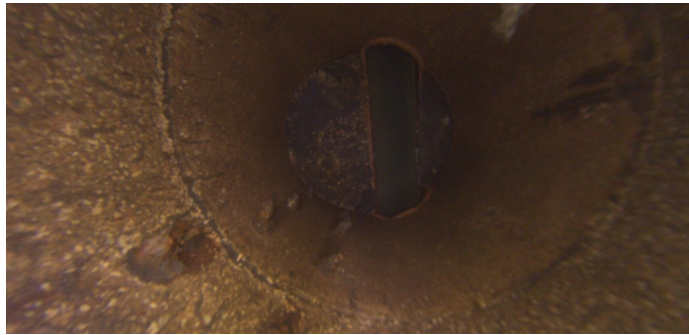
Code:	<b>MGO</b>
Description:	<b>General Observation</b>
Distance (ft):	<b>1.2</b>
Structural Grade:	<b>0</b>
O&M Grade:	<b>0</b>
Clock Start/From:	
Clock To:	
1st Value:	
2nd Value:	
Value Percent:	
Step:	<b>NO</b>
Remarks:	<b>MISSING AND BROKEN STEPS</b>

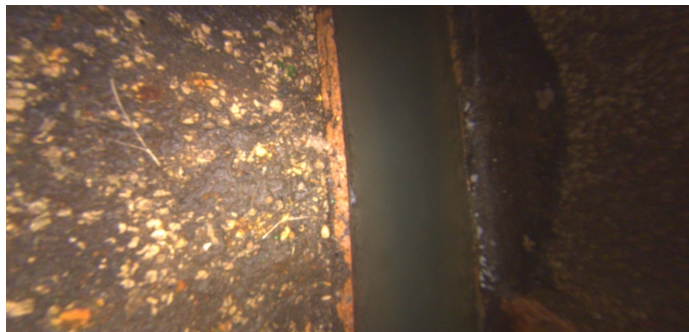
Code:	<b>DSGV</b>
Description:	<b>Deposits Settled Gravel</b>
Distance (ft):	<b>5.0</b>
Structural Grade:	<b>0</b>
O&M Grade:	<b>2</b>
Clock Start/From:	<b>12</b>
Clock To:	<b>12</b>
1st Value:	
2nd Value:	
Value Percent:	<b>5.000</b>
Step:	<b>NO</b>
Remarks:

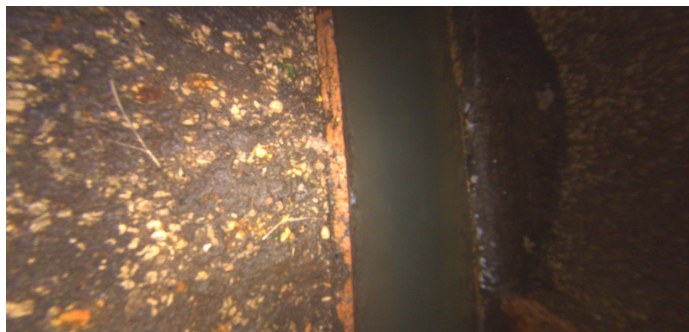
Code:	<b>MGO</b>
Description:	<b>General Observation</b>
Distance (ft):	<b>5.0</b>
Structural Grade:	<b>0</b>
O&M Grade:	<b>0</b>
Clock Start/From:	
Clock To:	
1st Value:	
2nd Value:	
Value Percent:	
Step:	<b>NO</b>
Remarks:	<b>END SURVEY</b>
